City of Brantford

# Lorne Bridge (Structures 117, 131, 132) Structural Evaluation Report

**GMBP File: 119104**  
**May 2021**

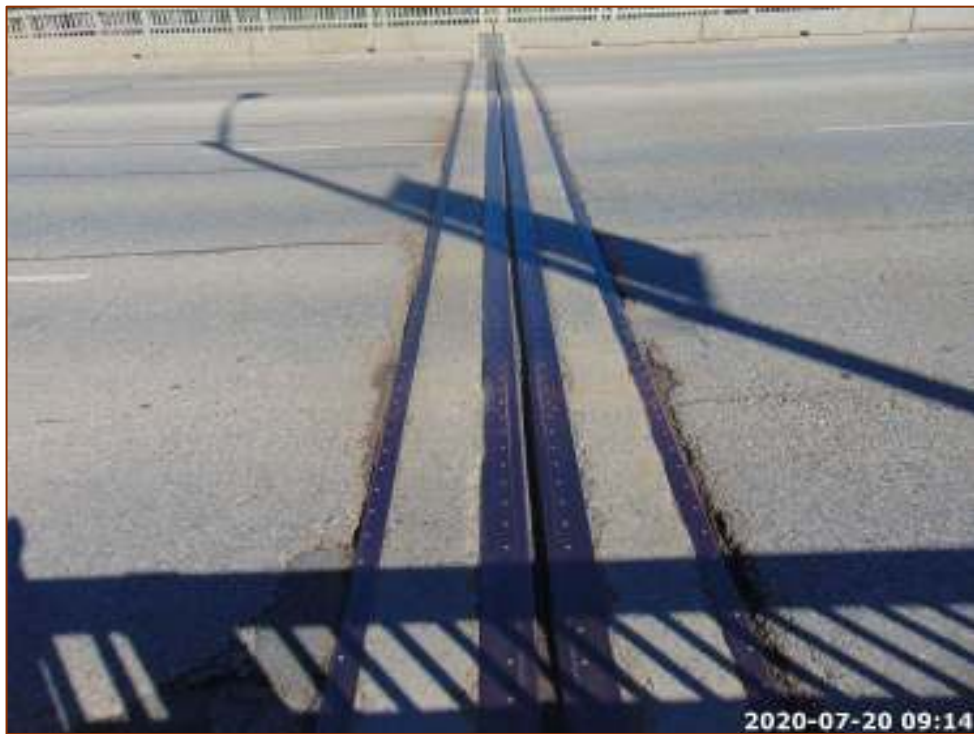
*Photo 4 – West Expansion Joint*

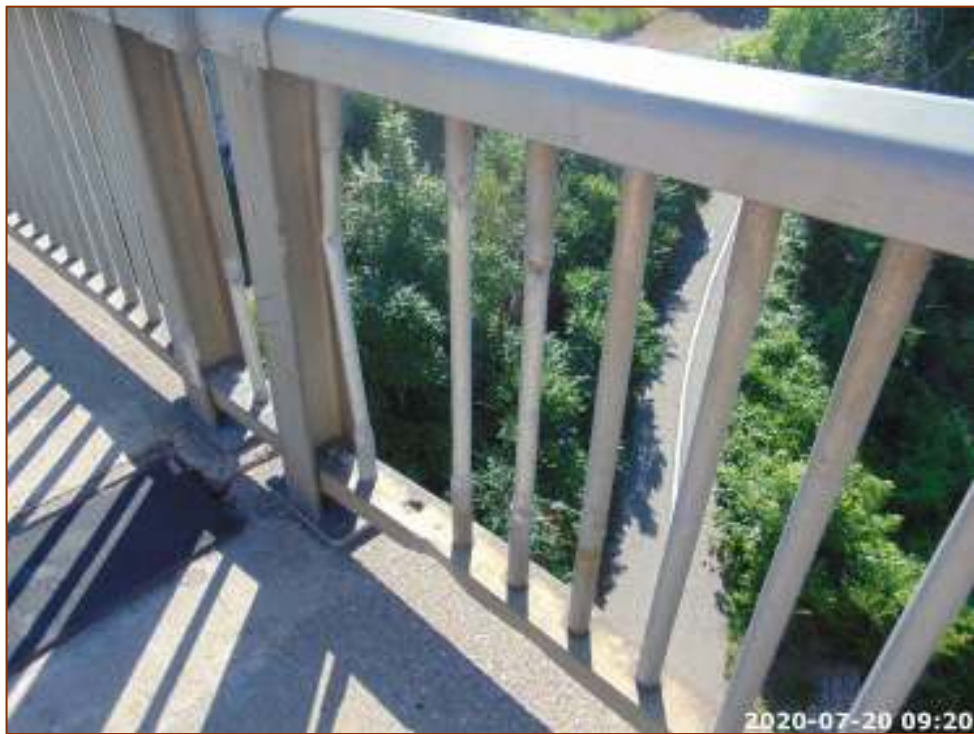
*Photo 12 – South Exterior Railing, Impact Damage and Missing Spindle*

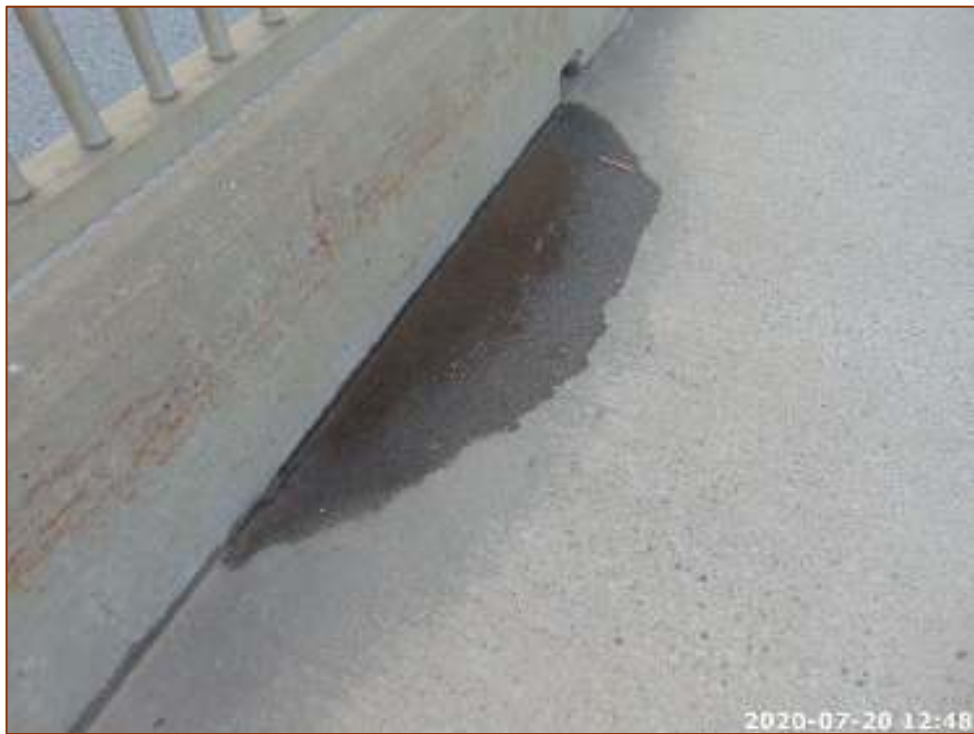
*Photo 14 – North Sidewalk, Ponding*

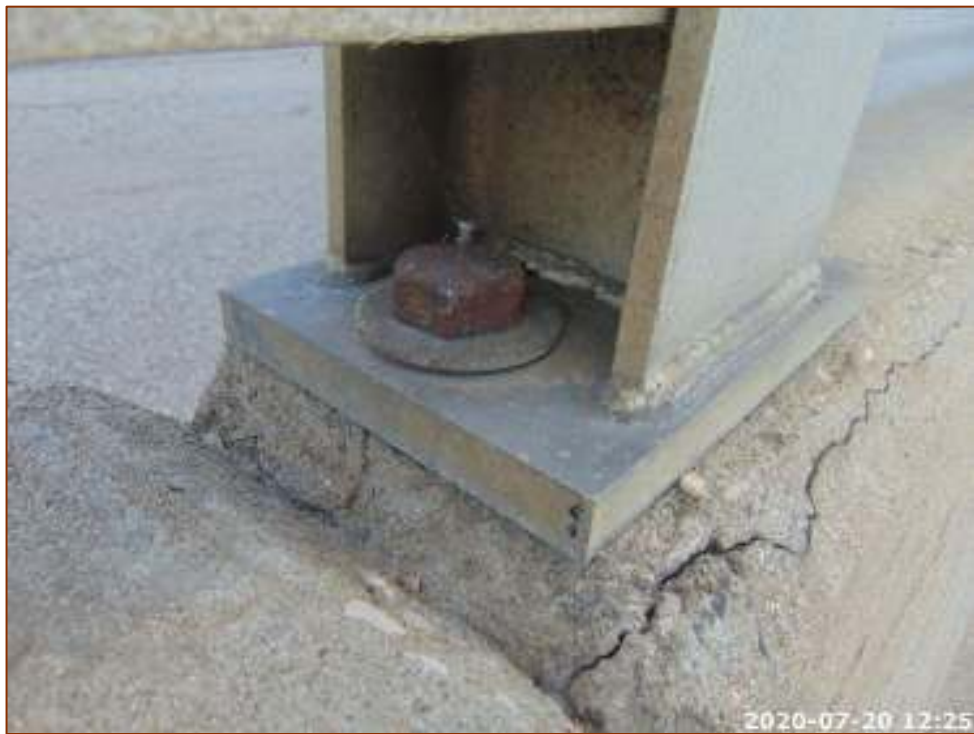
*Photo 16 – Light Rusting of Bolts*

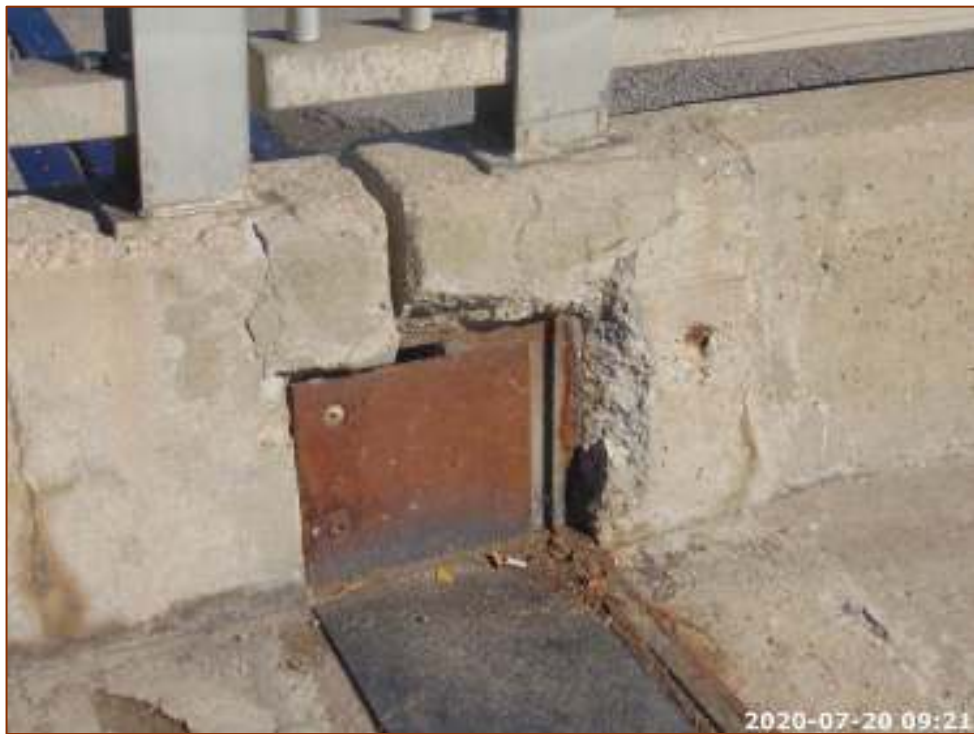
*Photo 18 – South Interior Barrier, SE Approach Expansion Joint, Spall & Delamination*

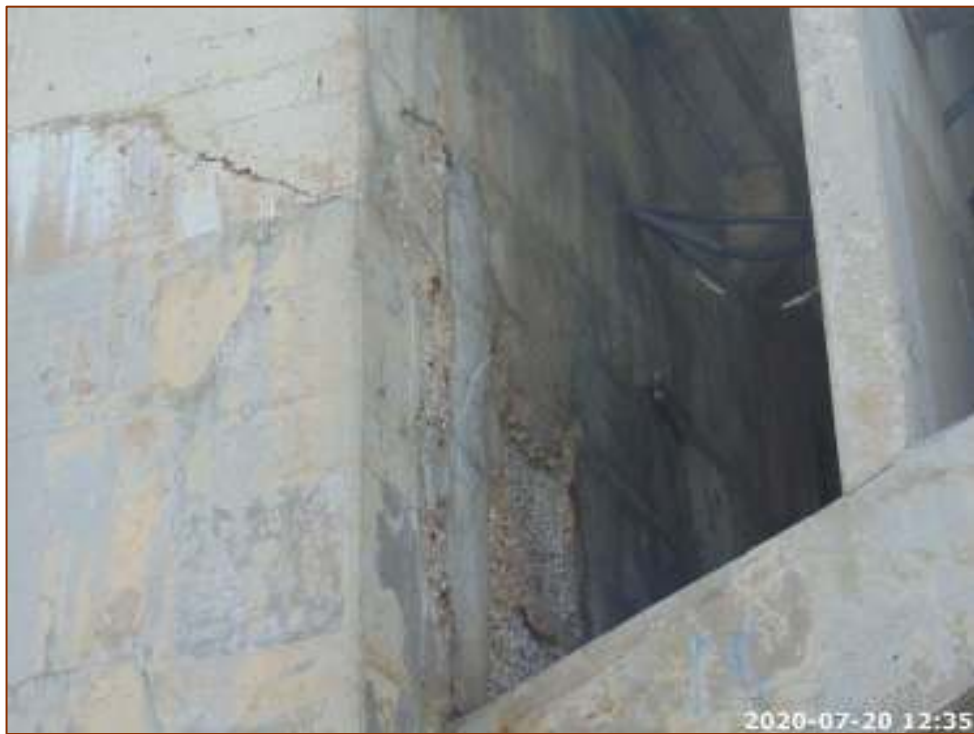
*Photo 22 – East Abutment, NE Corner, Spalls & Delamination*

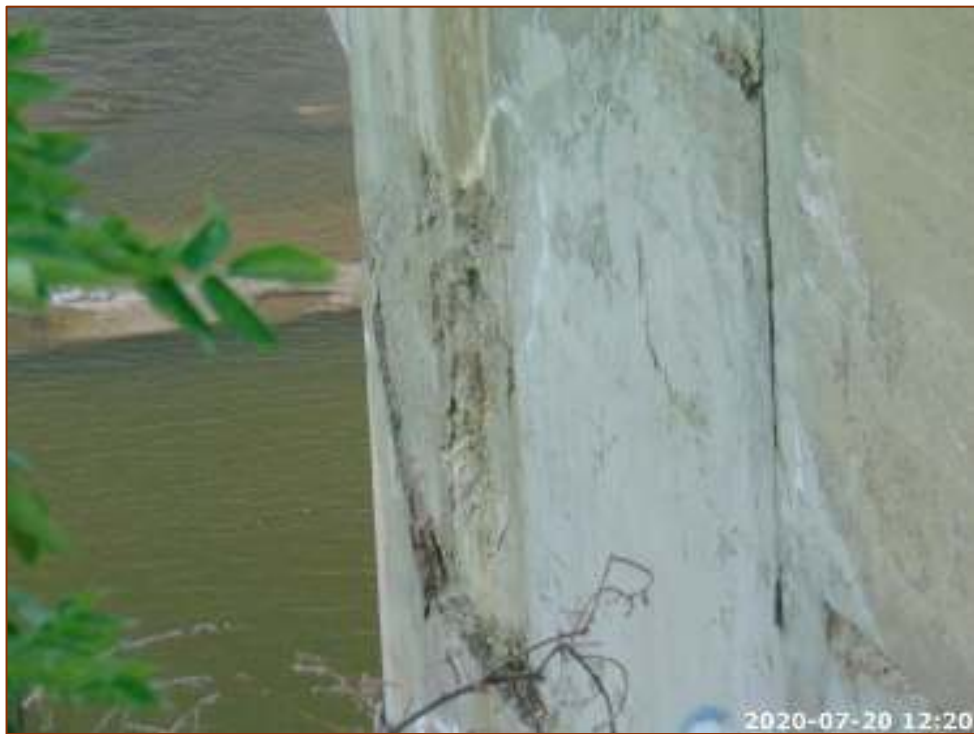
*Photo 26 - NW Wingwall, Delamination & Spall*

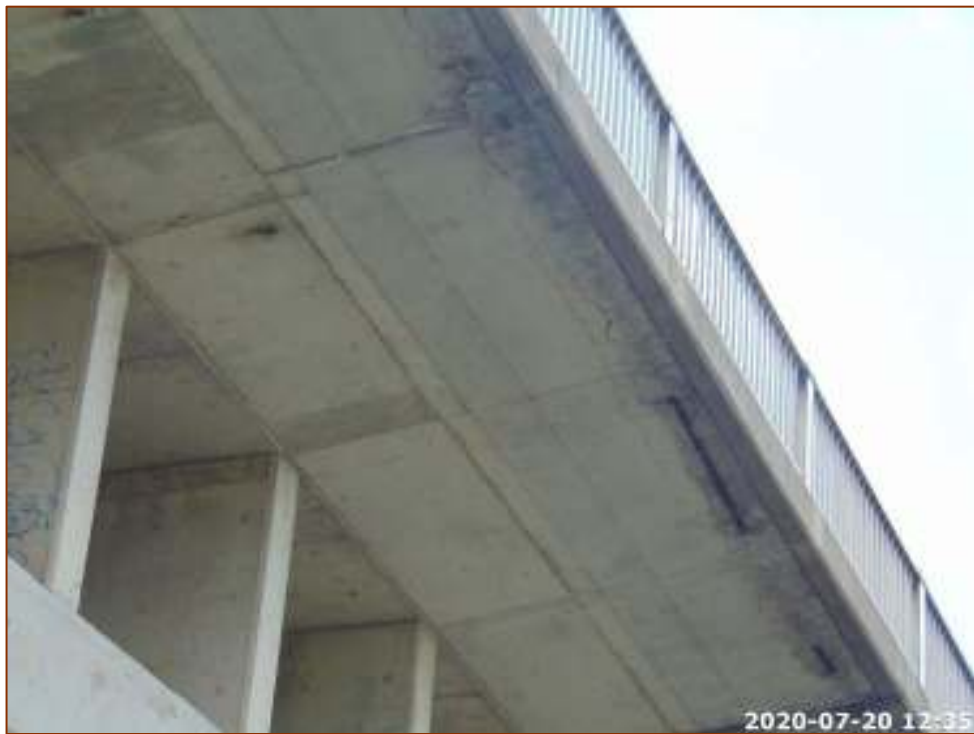
*Photo 28 - North Overhang, Delaminations & Spalls with Exposed Rebar*

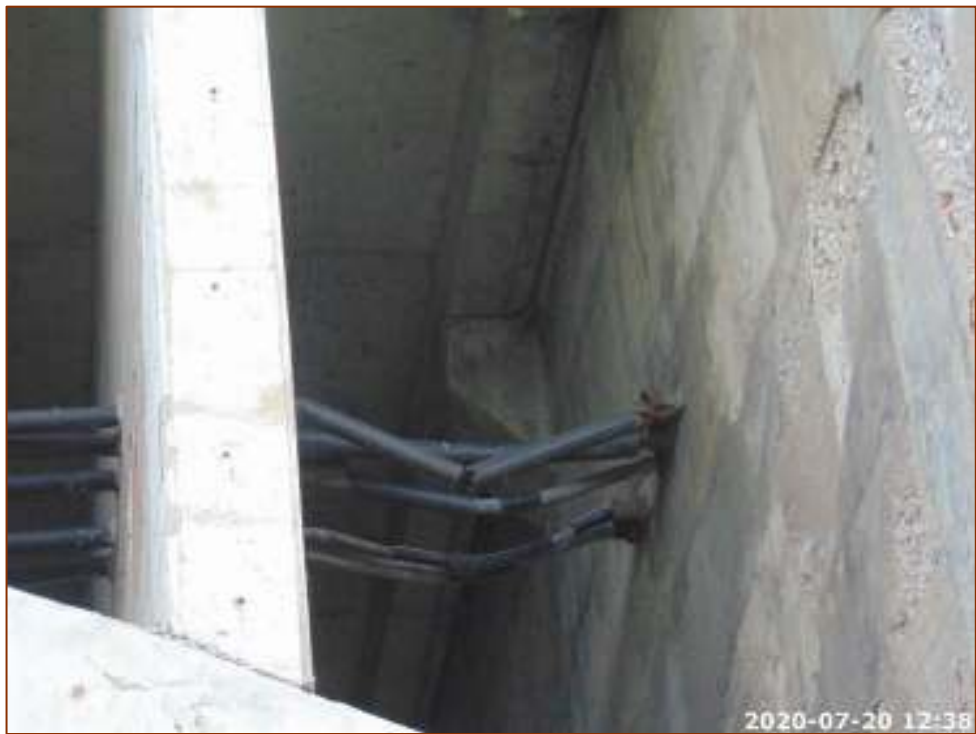
*Photo 32 - Utilities @ Southeast, Ducts Disconnected & Broken*

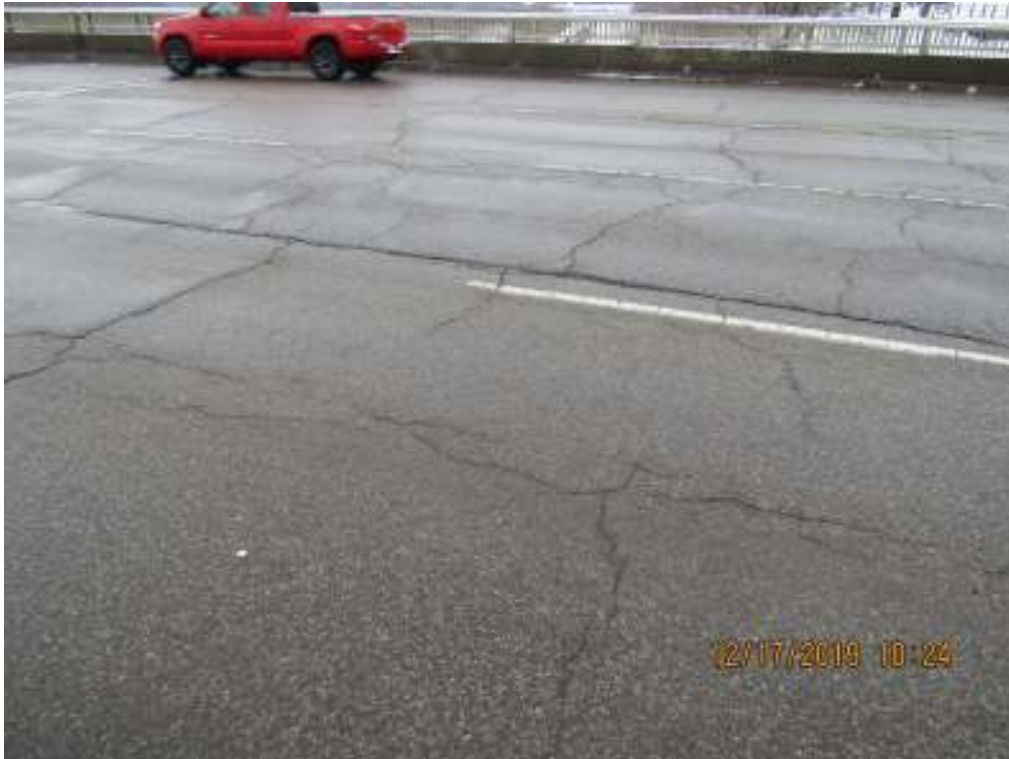
05 Numerous longitudinal and transverse cracks on deck wearing surface

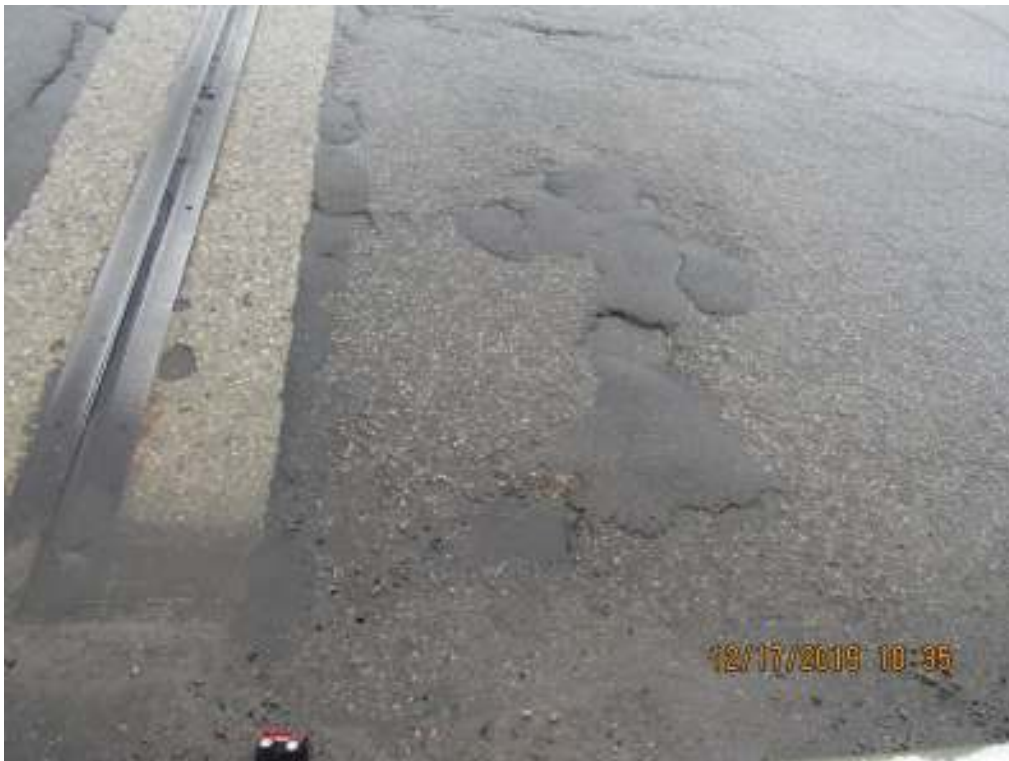
06 Potholes on wearing surface near east expansion joint

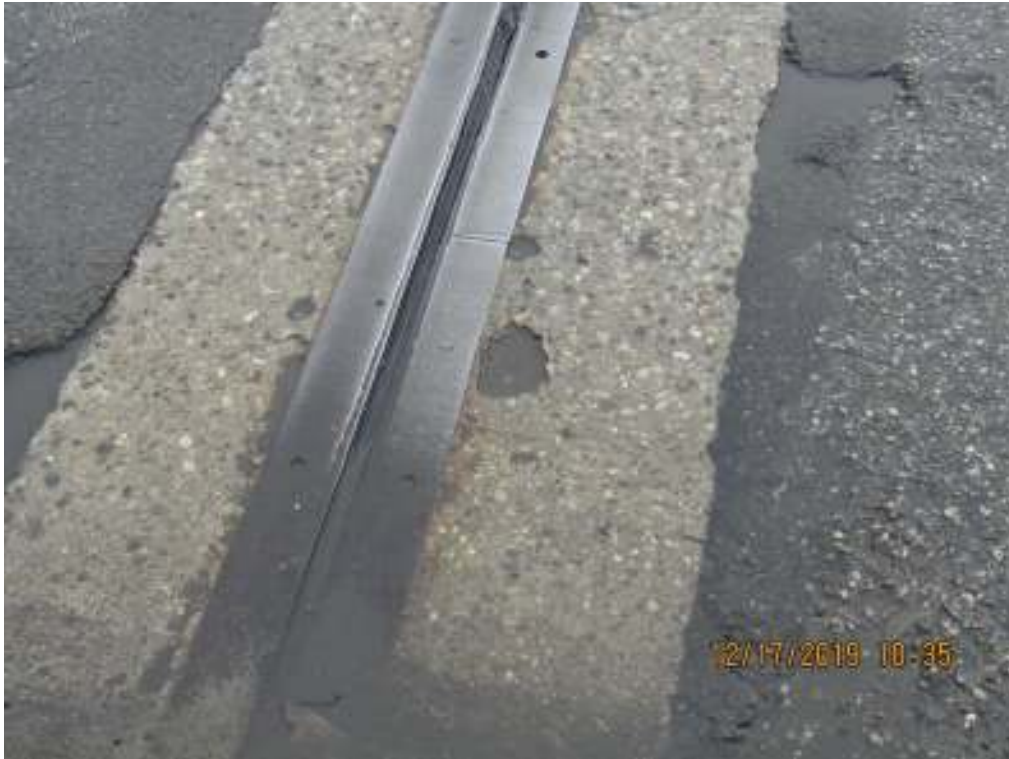
09 Spall on east expansion joint end dam

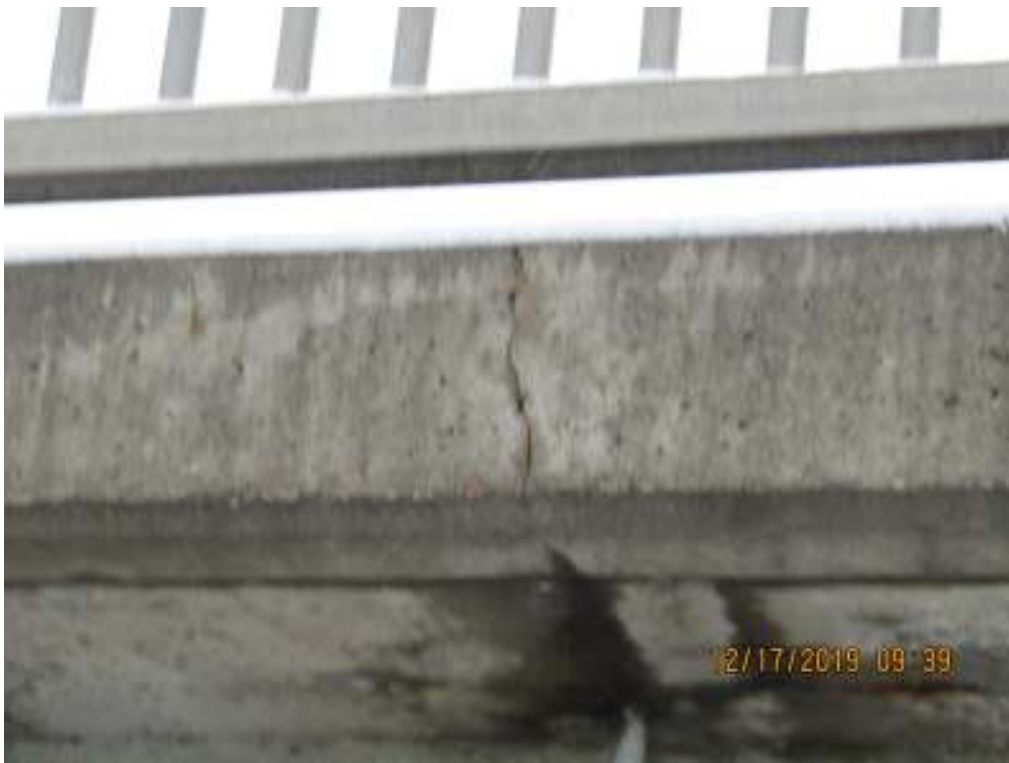
12 Vertical crack on north fascia

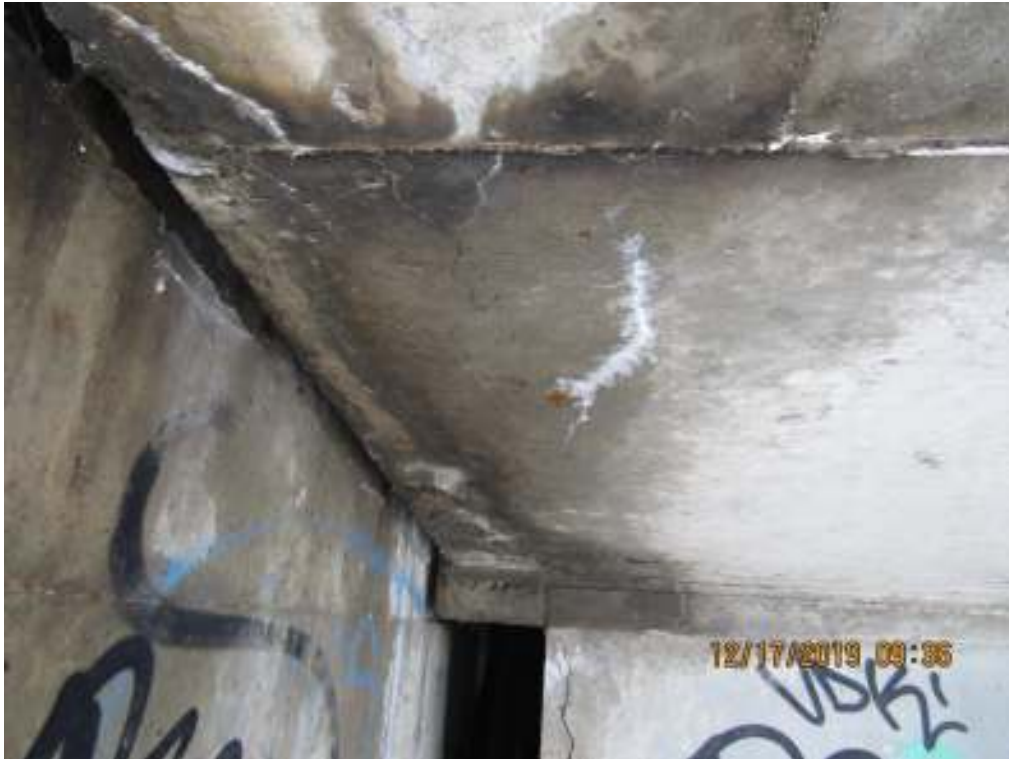
17 Cracks and delamination on north exterior soffit at east end

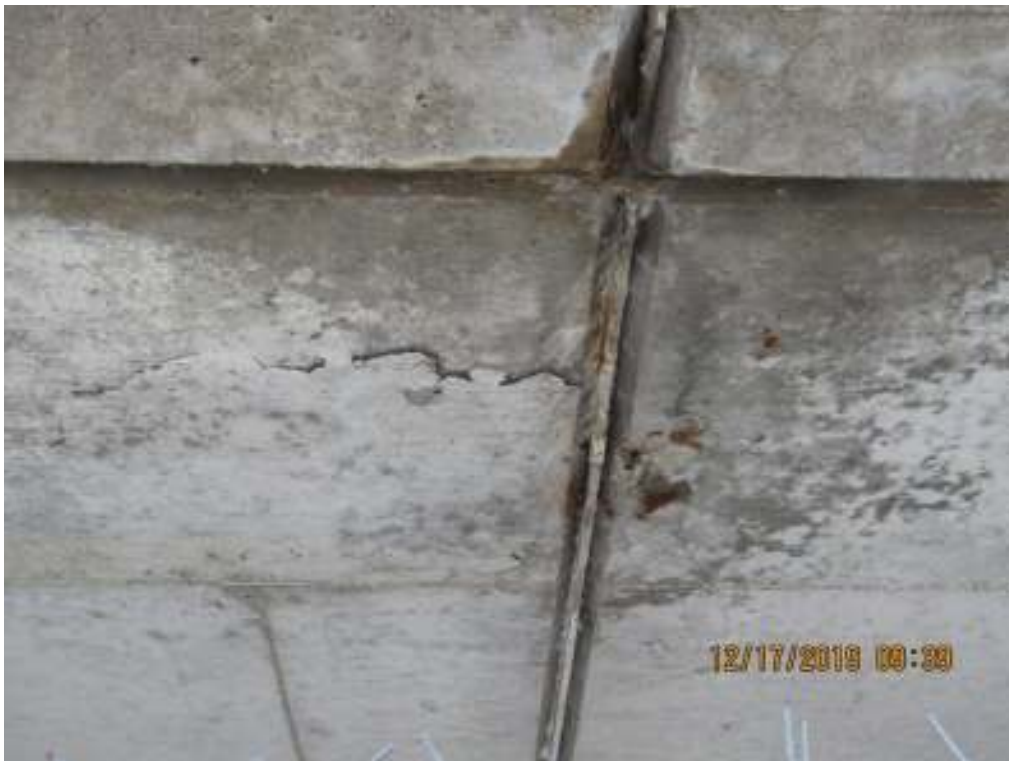
18 Delamination on north exterior soffit

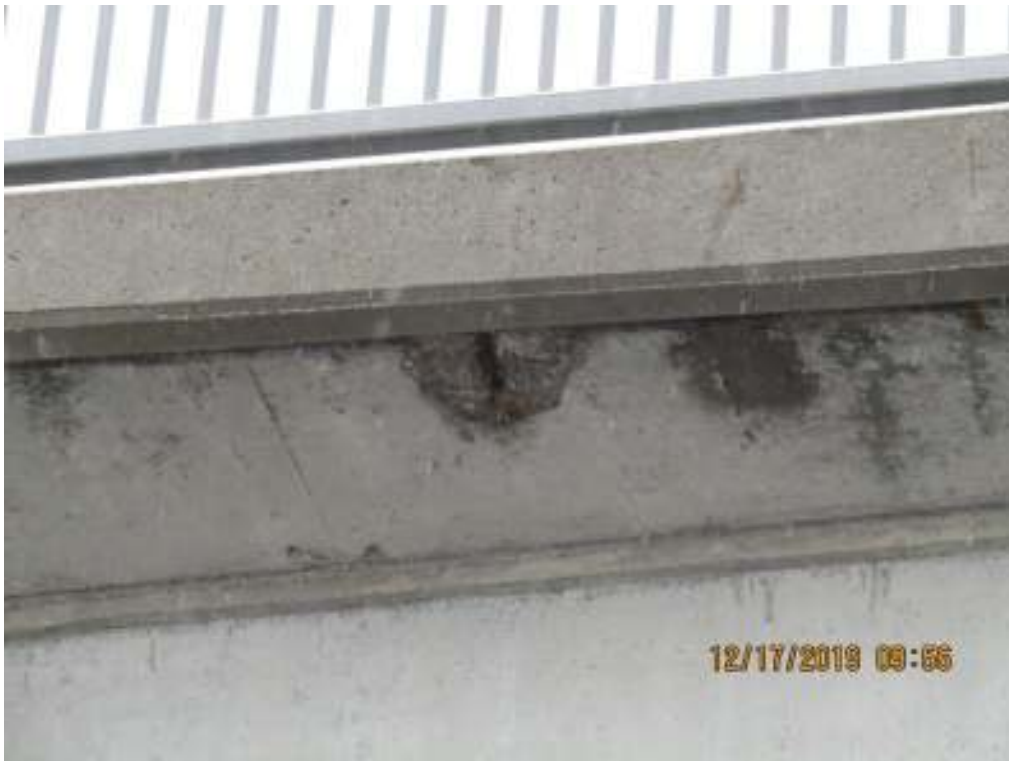
20 Spalls and delamination on south exterior soffit

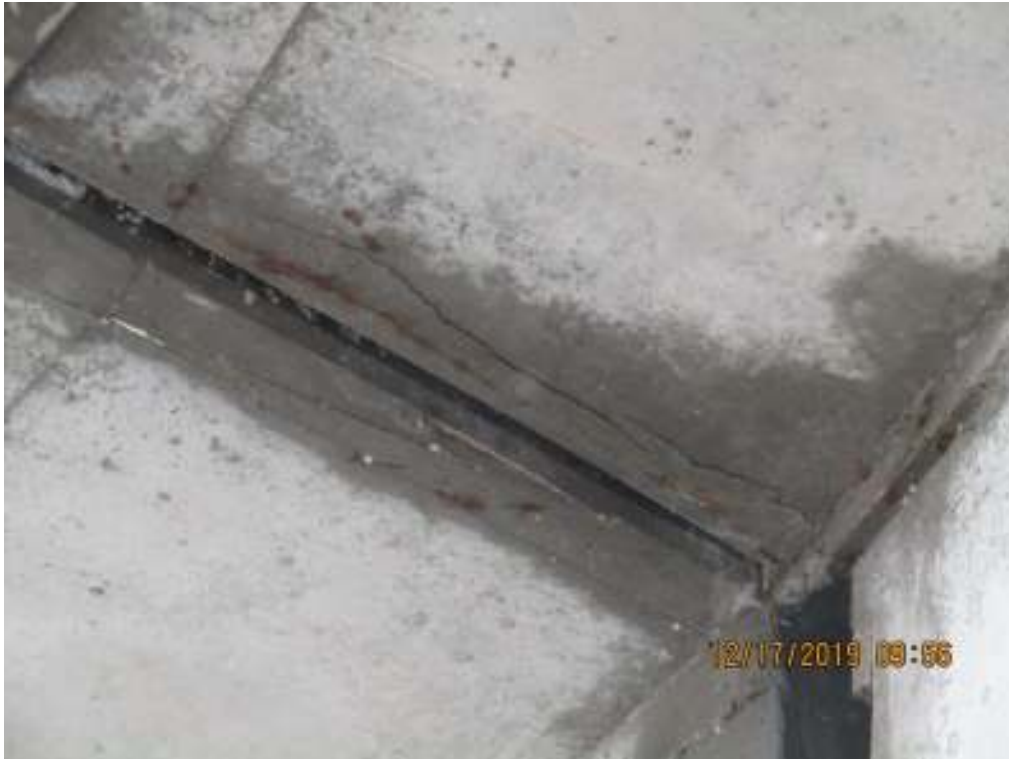
21 Delamination on south exterior soffit

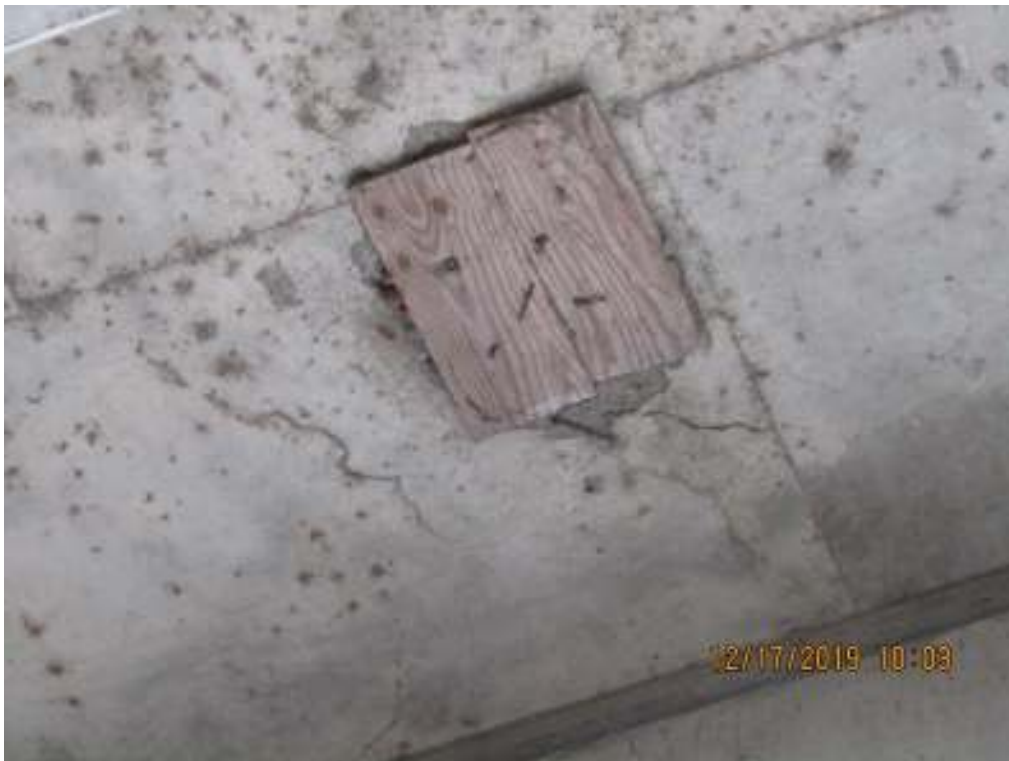
22 Board covering suspected spall

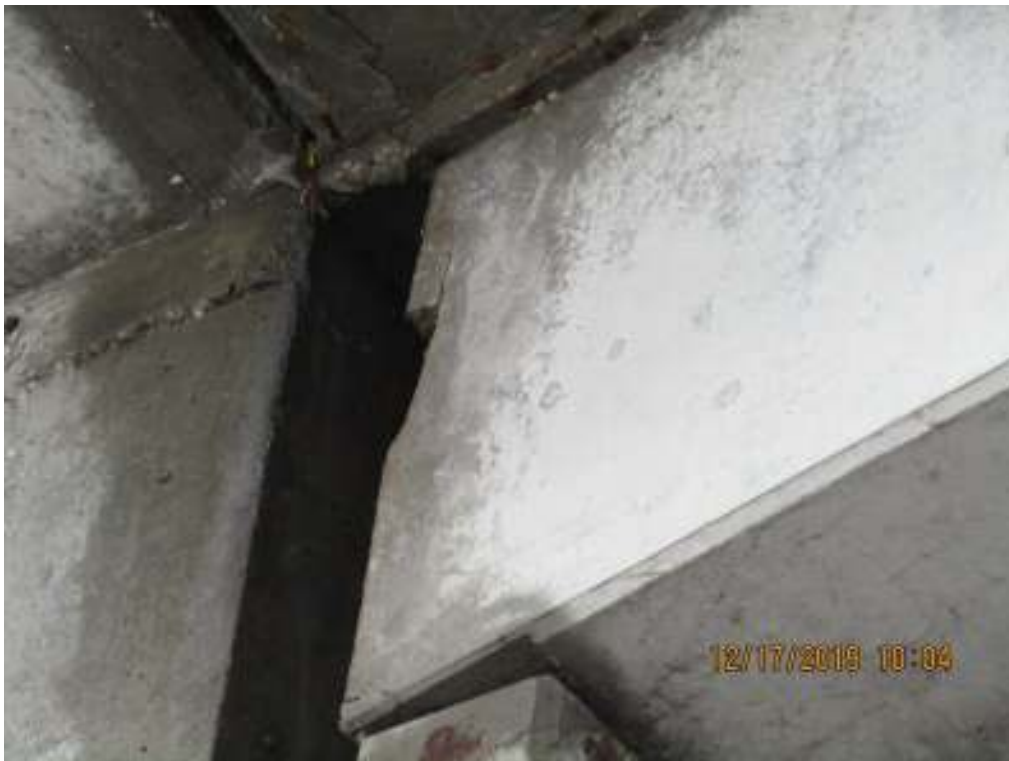
26 Spall on south exterior girder end at west end

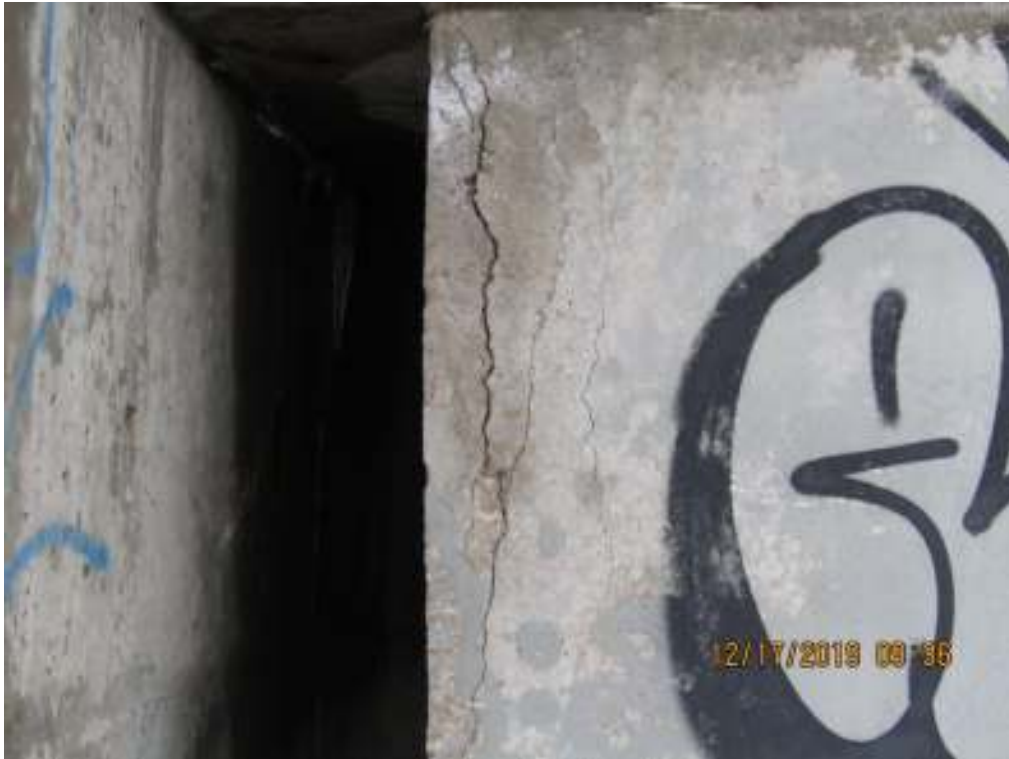
27 Vertical cracks on exter girder ends at north east

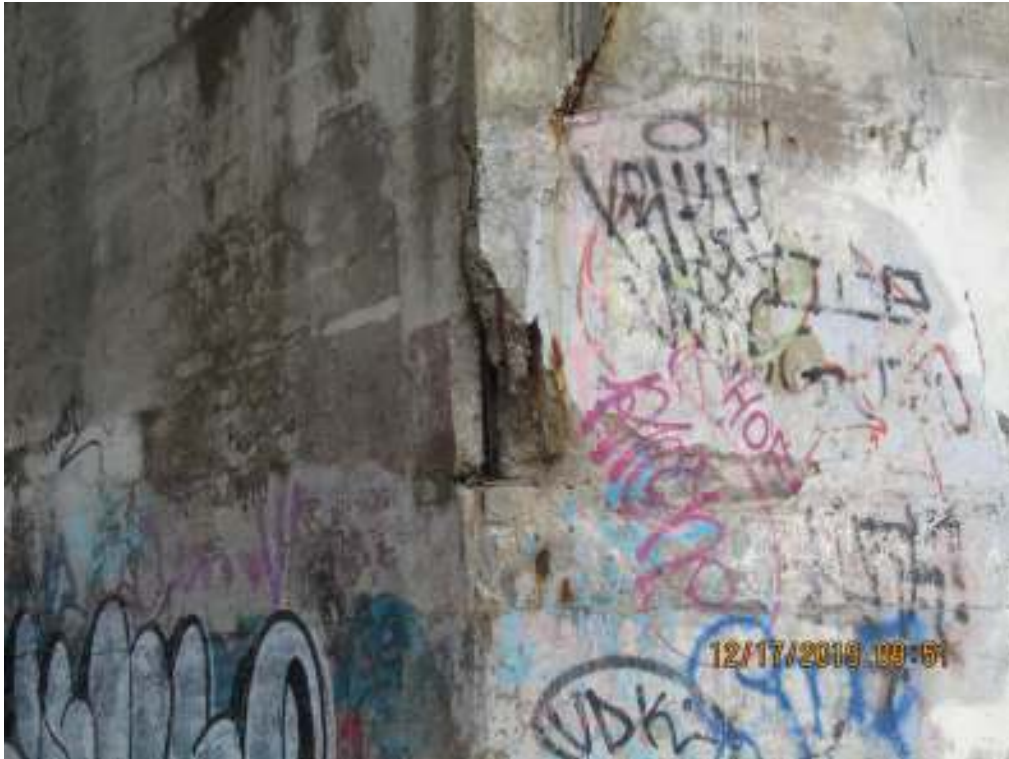
31 Spall with exposed rebar on west abutment

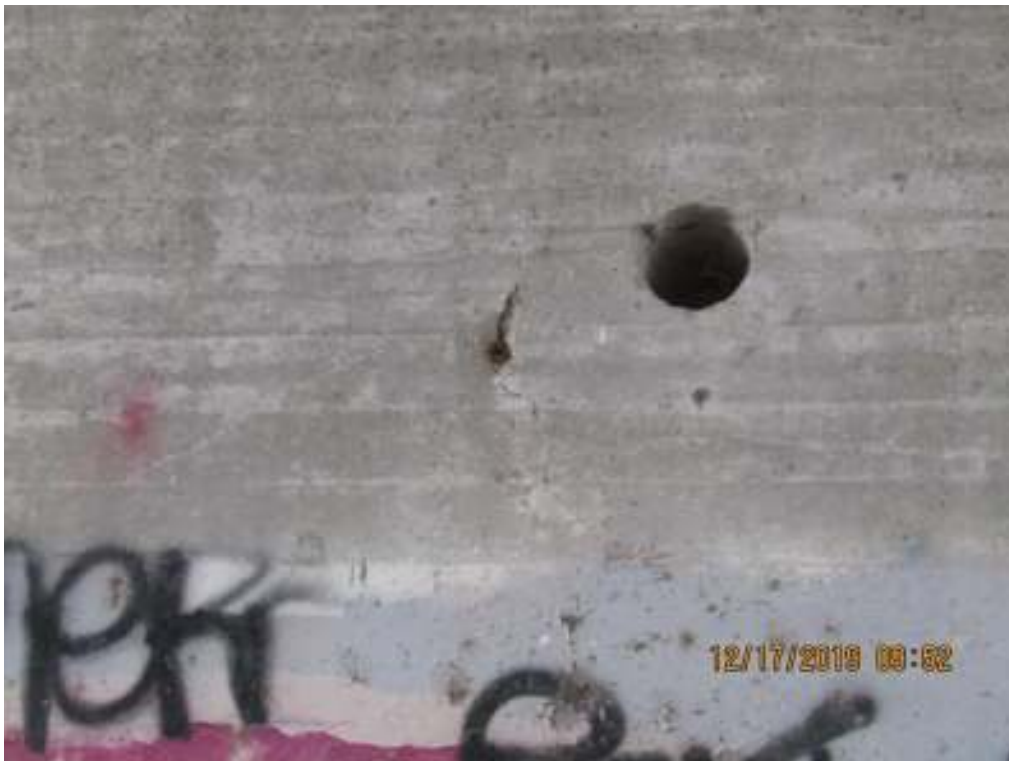
32 Narrow crack on west abutment

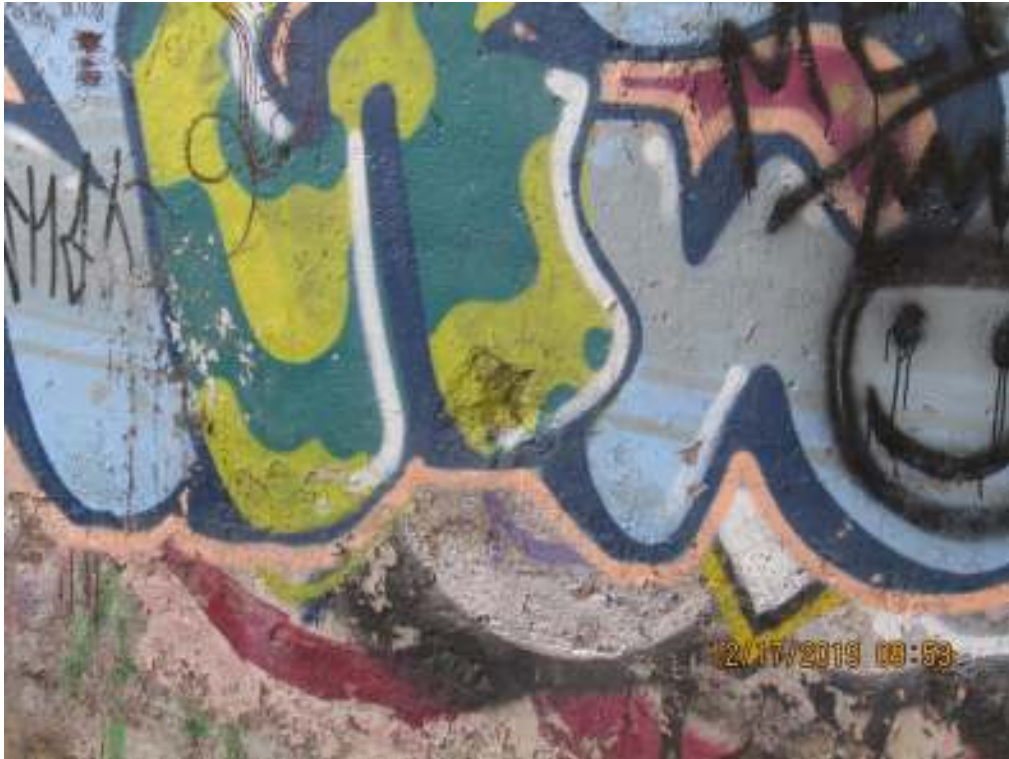
33 Minor spall on west abutment

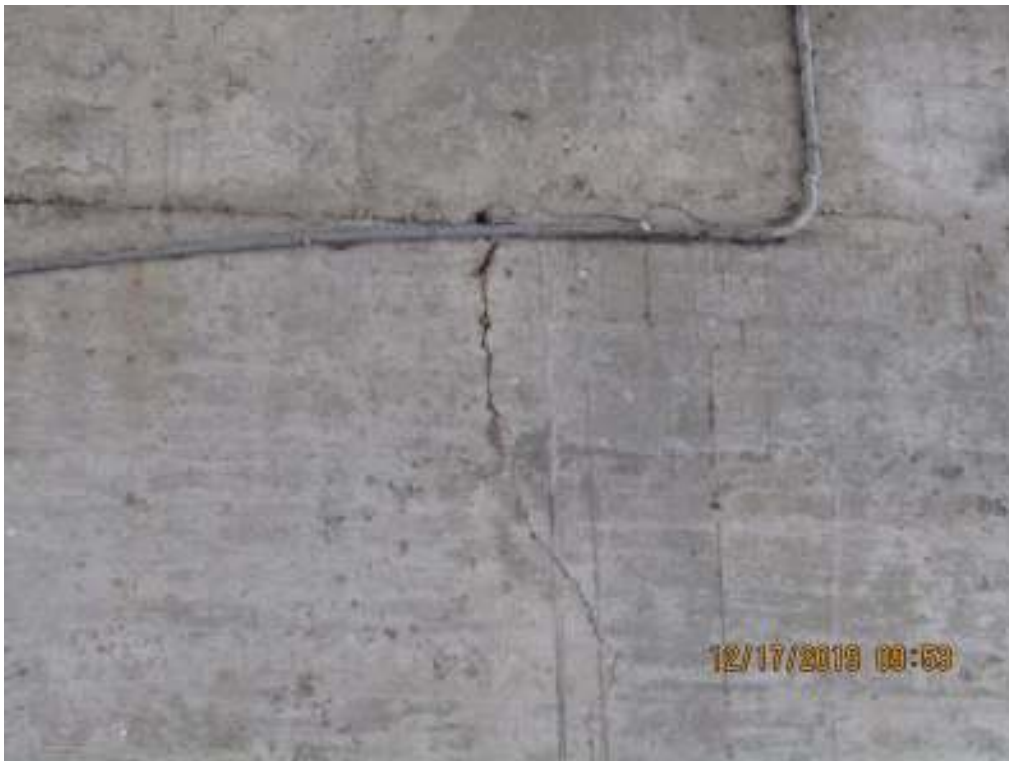
34 Vertical crack on west abutment

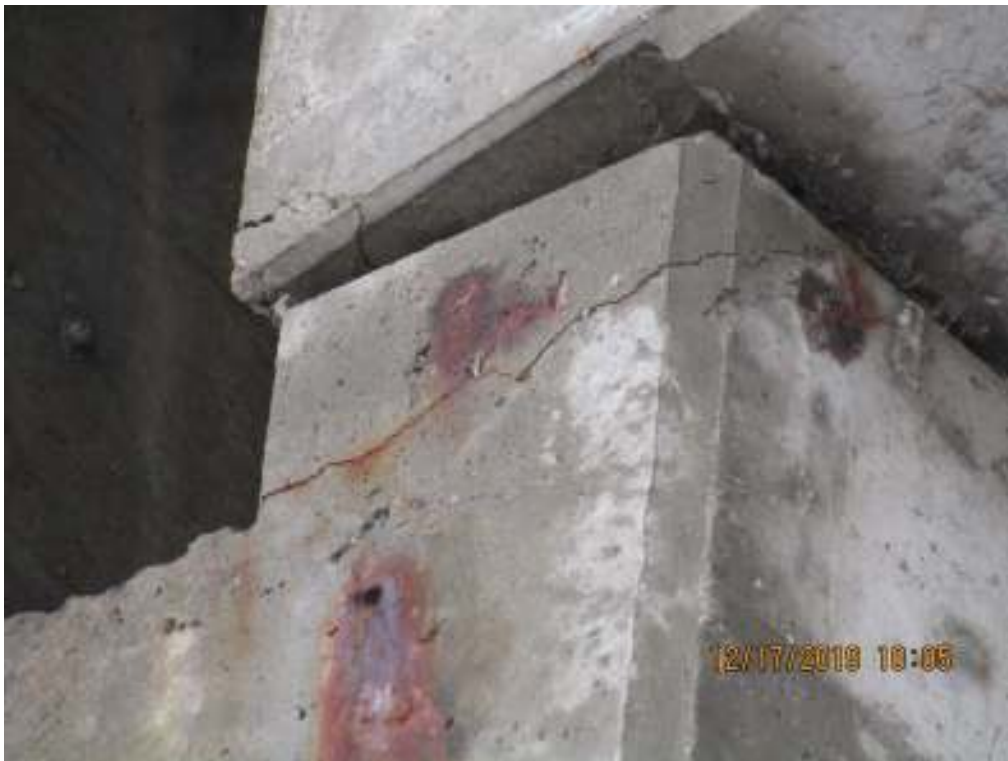
36 Crack on concrete pedestal on west abutment at south end

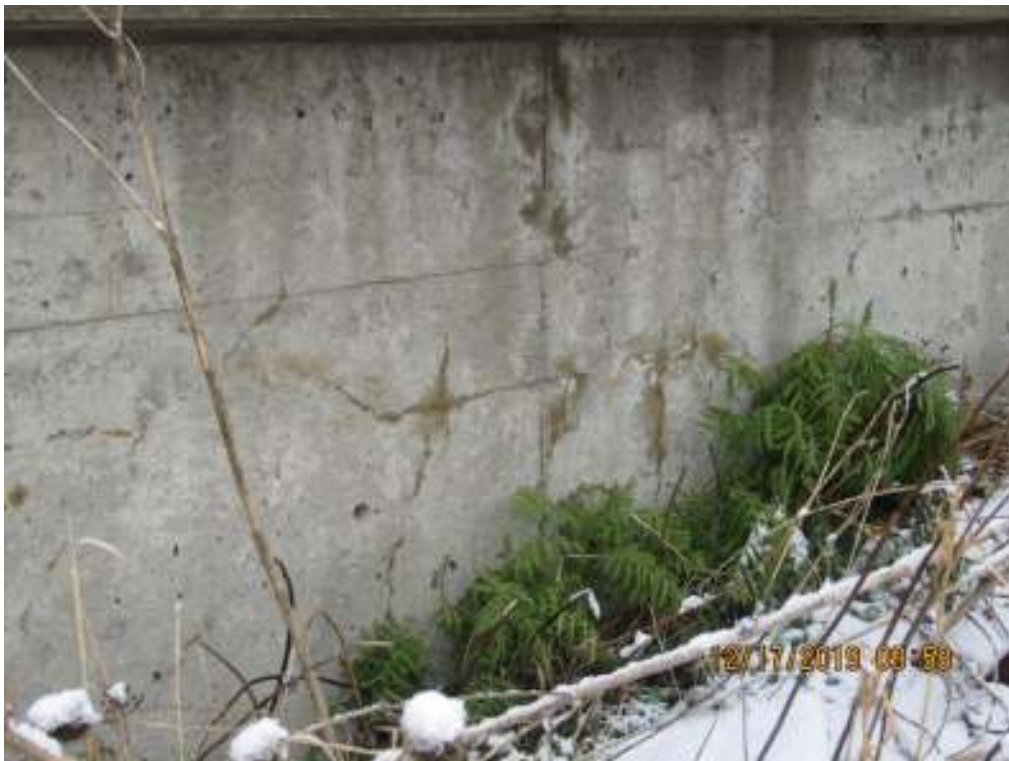
40 Pattern crack on south east wingwall

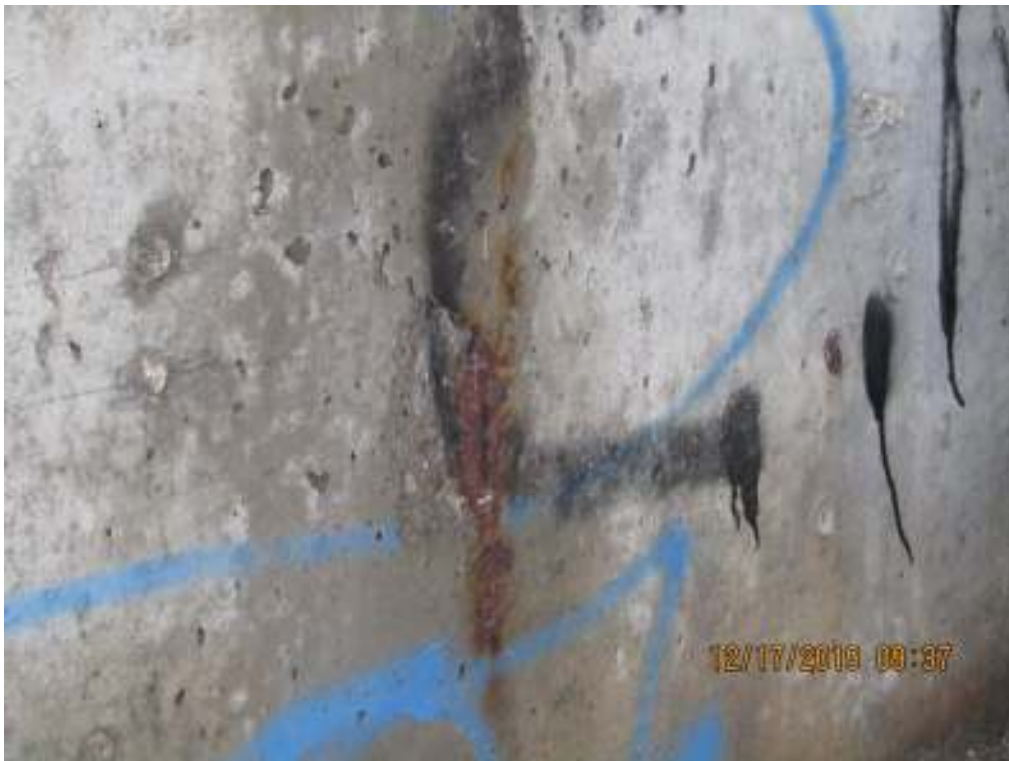
42 Delamination and spall on north ballast wall

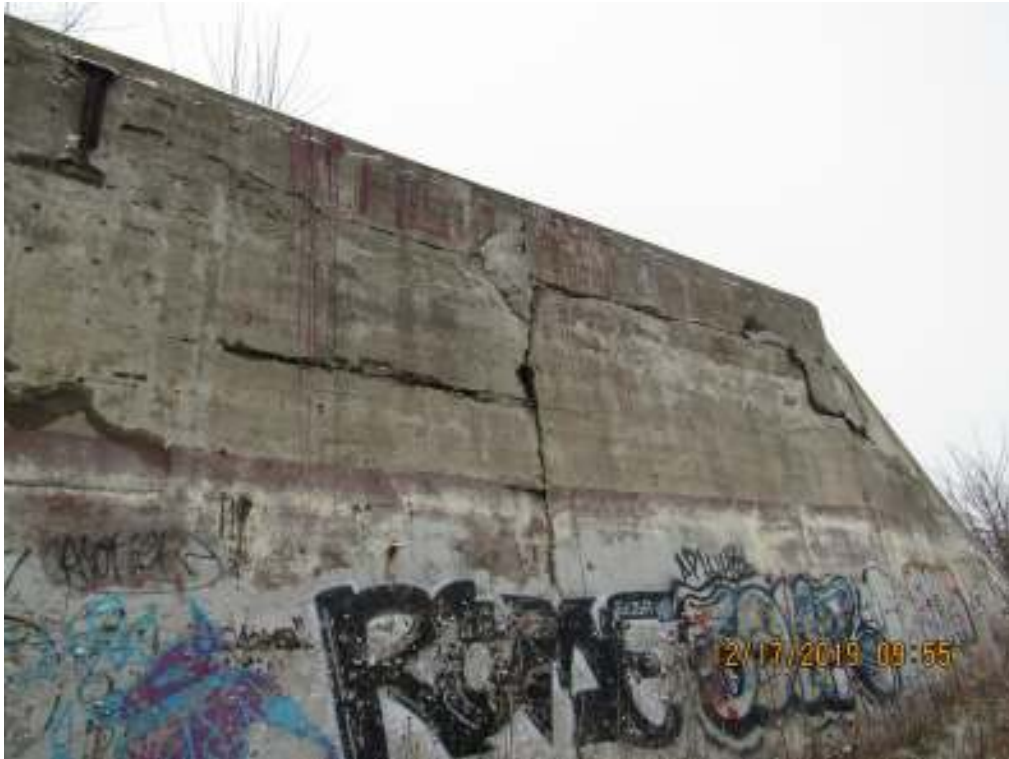
51 Cracks and spalls on east retaining wall on section south of bridge

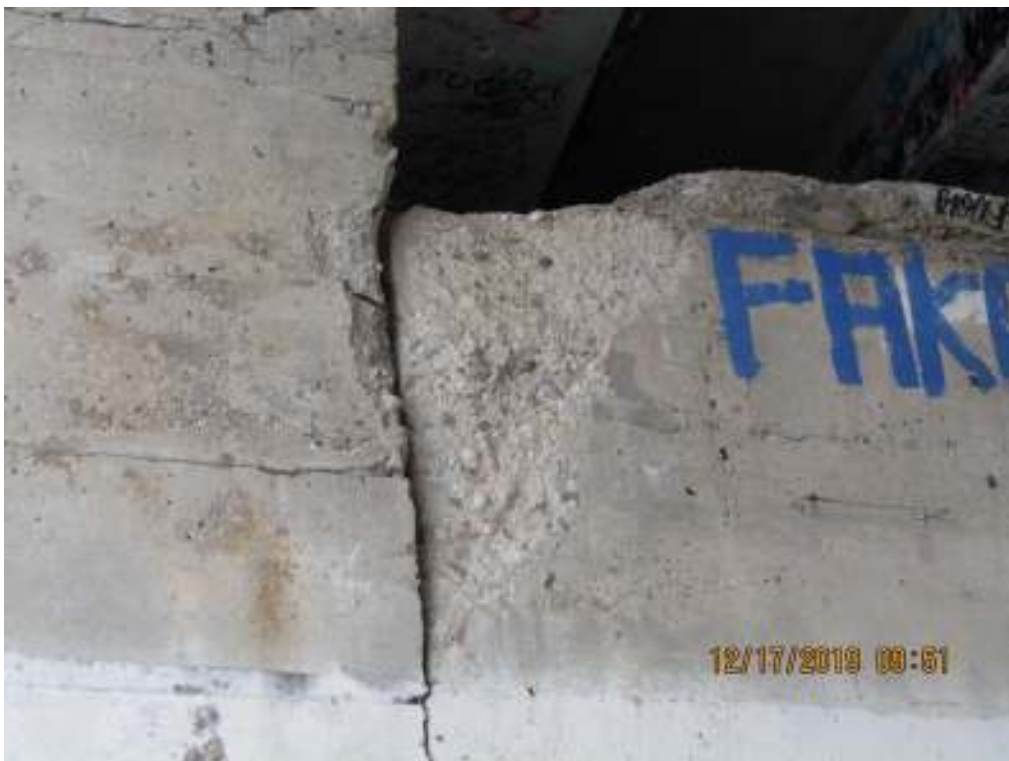
52 Section loss on east retaining wall

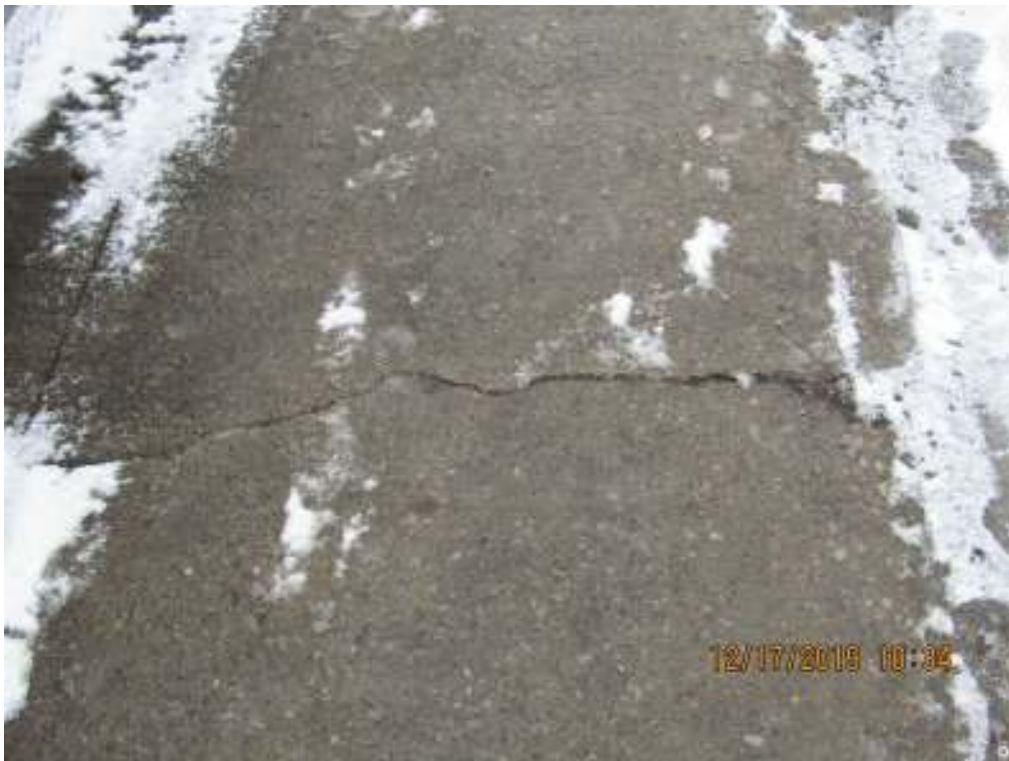
55 Transverse crack on north sidewalk (1)
