City of Brantford

# Lorne Bridge (Structures 117, 131, 132) Structural Evaluation Report

**GMBP File: 119104**  
**May 2021**

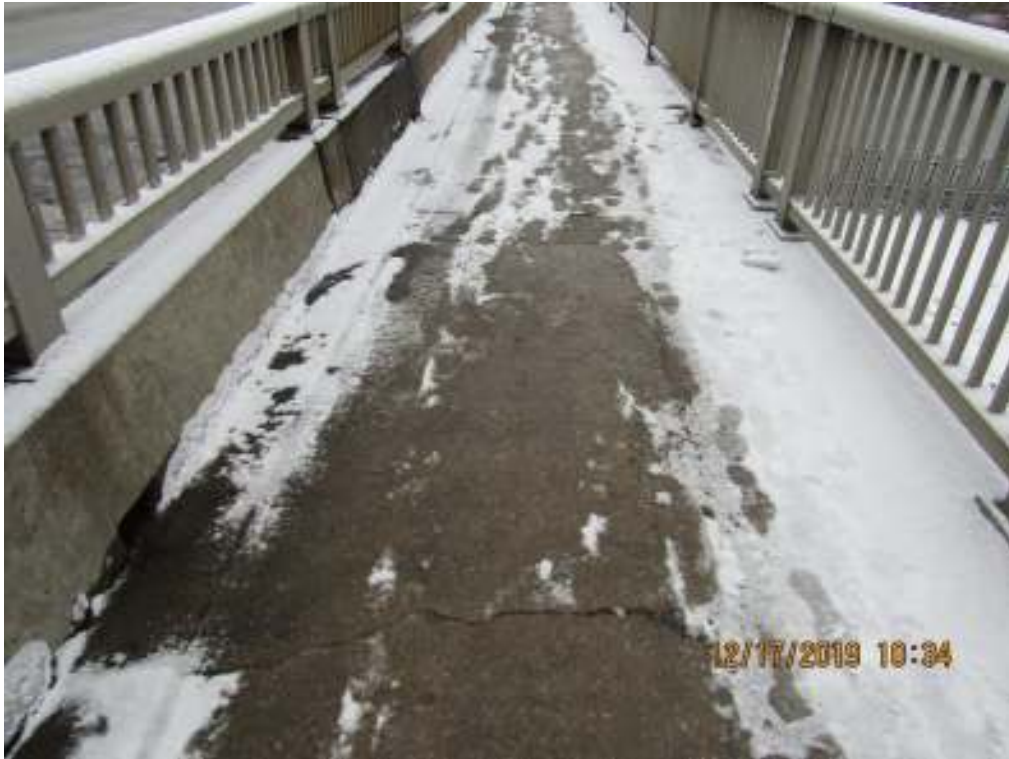
55 Transverse crack on north sidewalk (2)

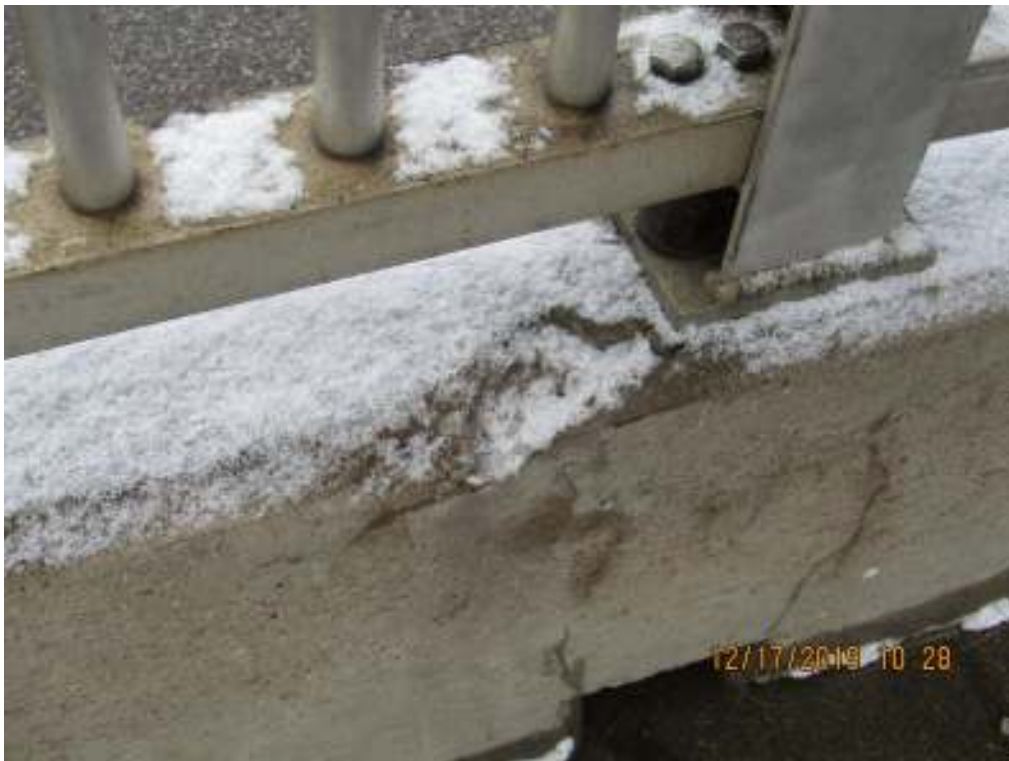
58 Spall on south barrier wall

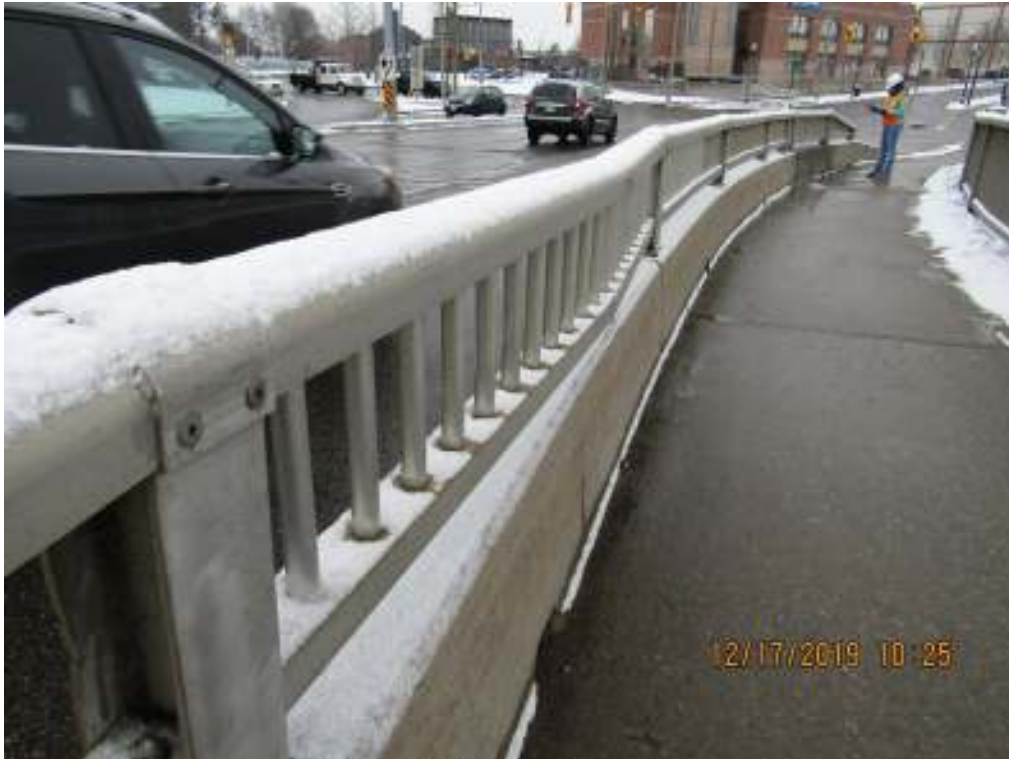
61 Impact damage on south handrailing at west end

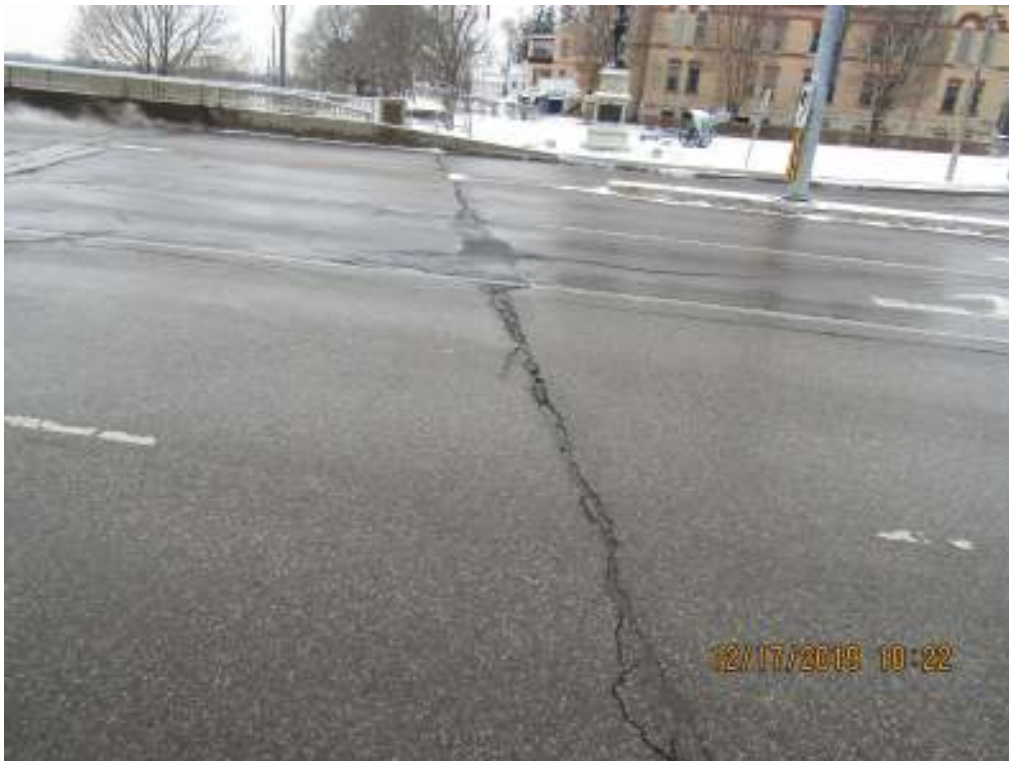
68 Cracks at joint between east approach slab and approach

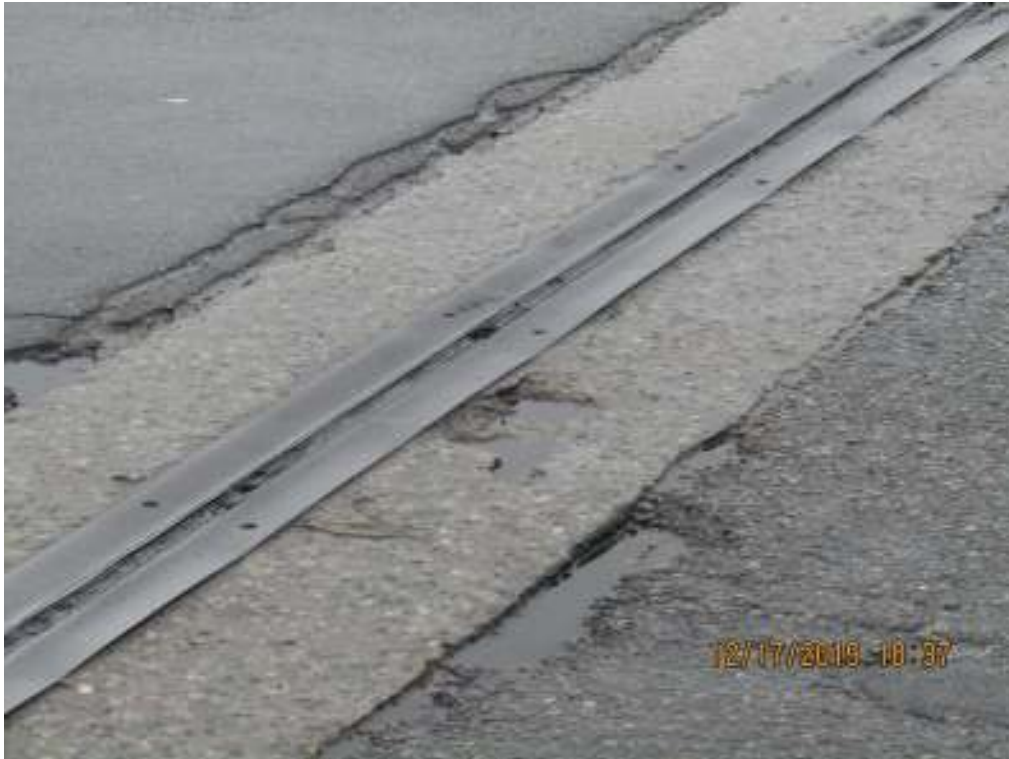
69 Potholes on end dam of east expansion joint

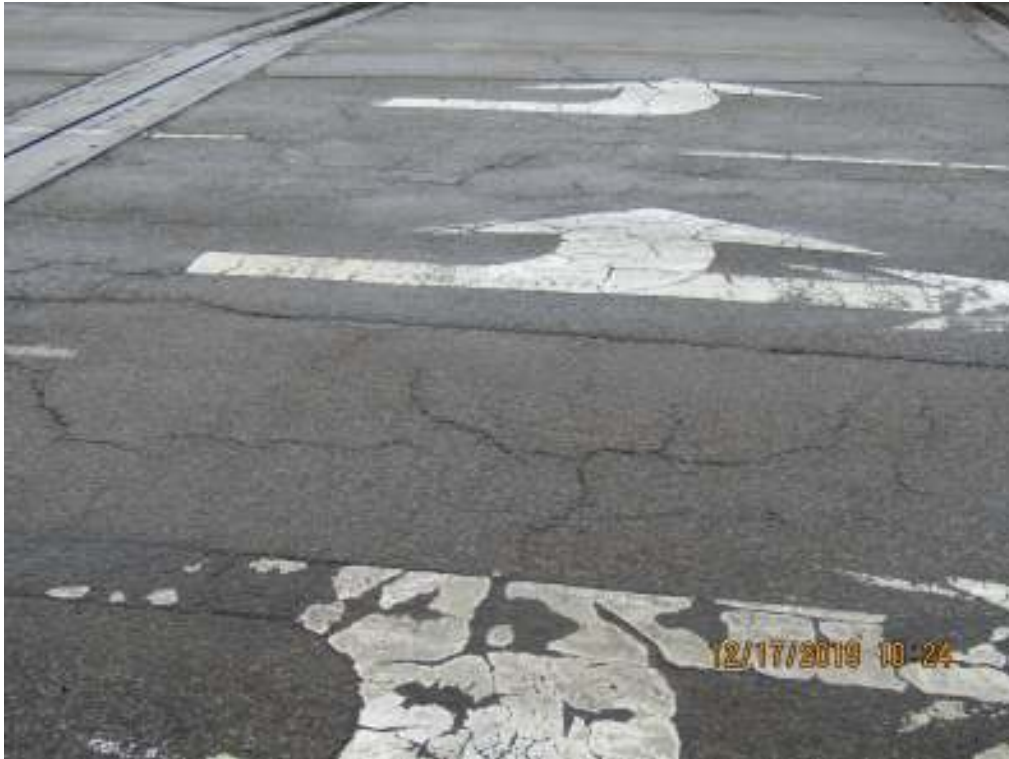
71 Cracks on west approach slab

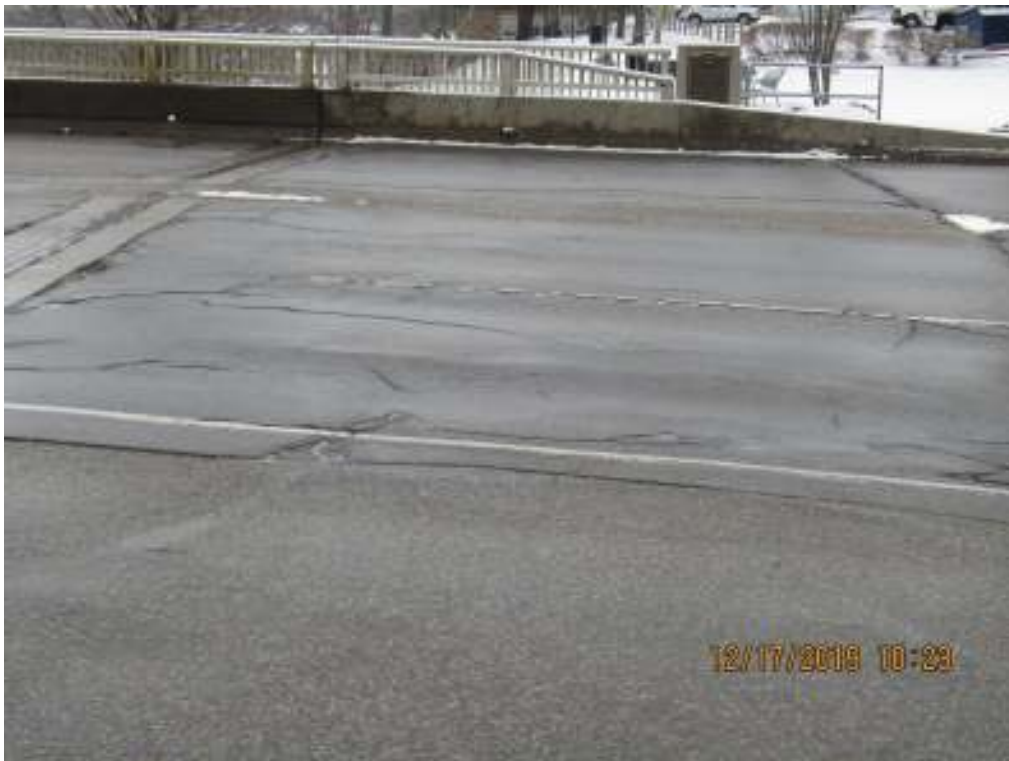
72 Longitudinal and transverse cracks on east approach slab

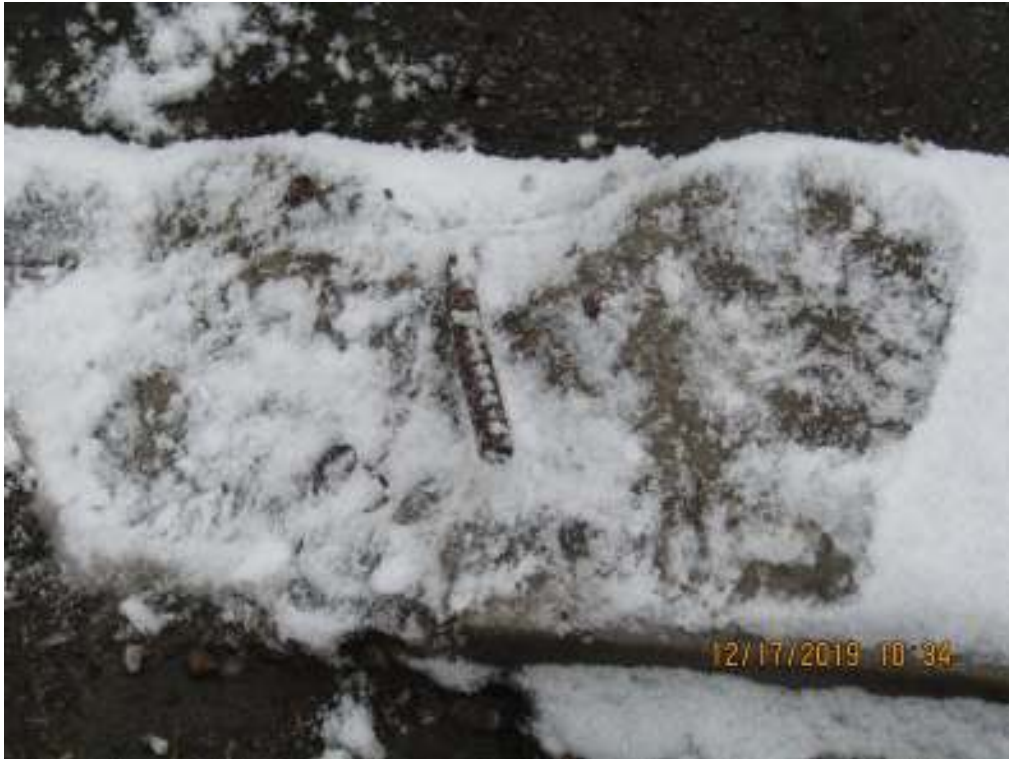
73 Exposed rebar on north concrete curb

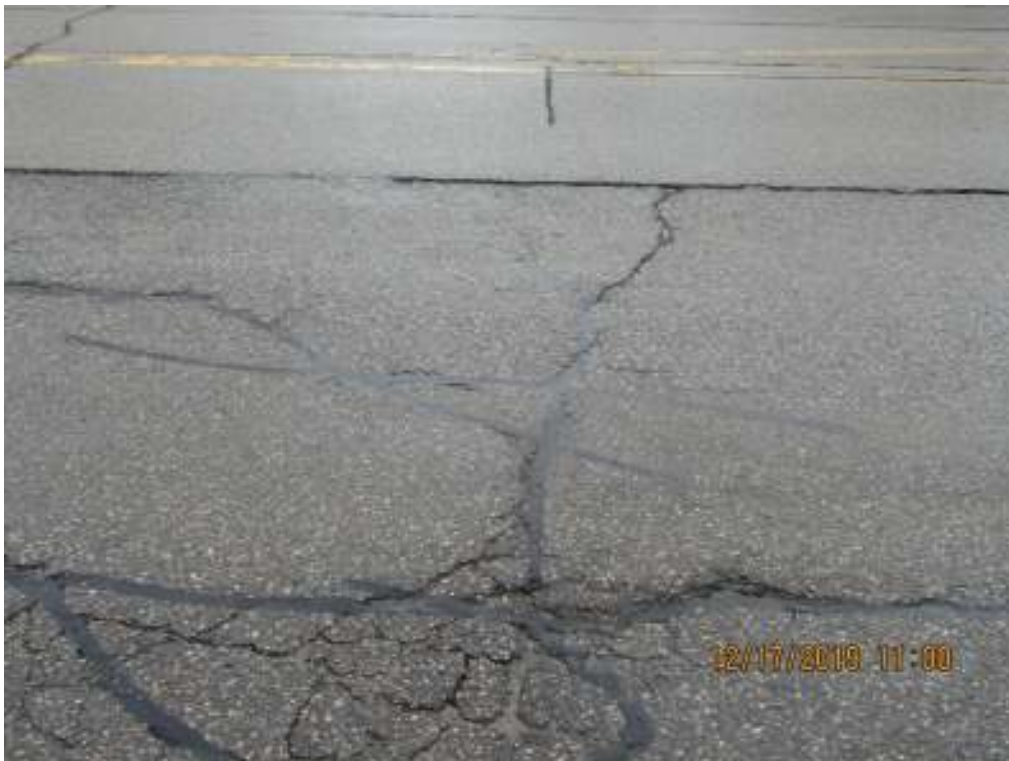
04 Transverse and longitudinal sealed and unsealed cracks on wearing surface

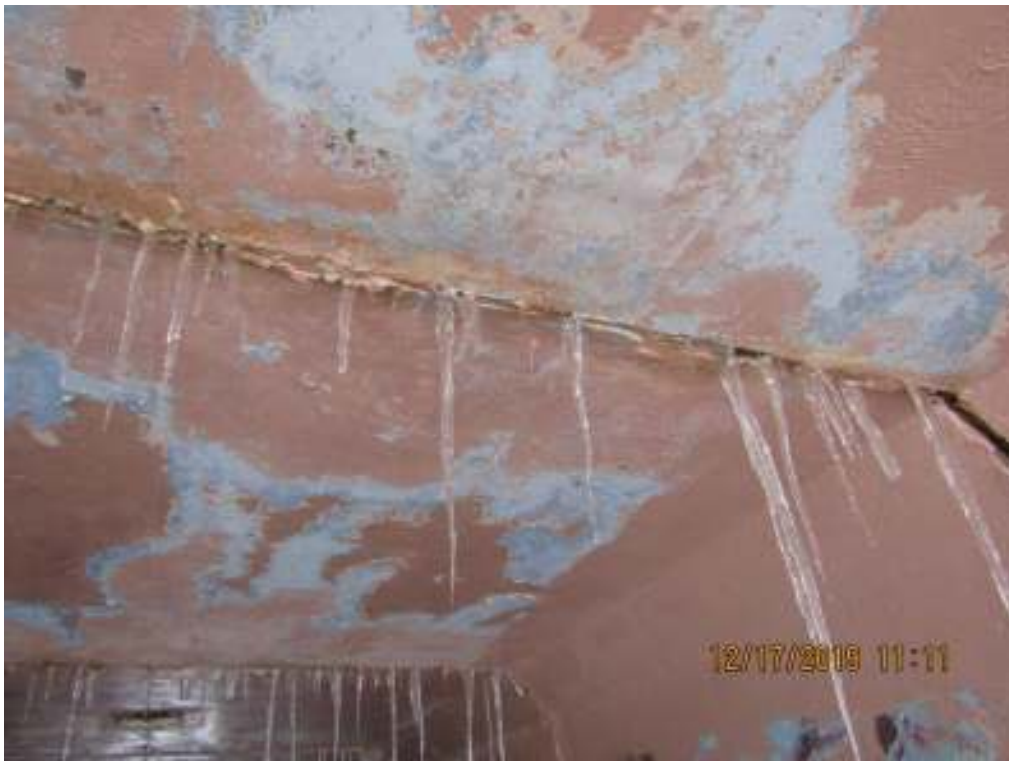
10 Active leakage of construction joints at south

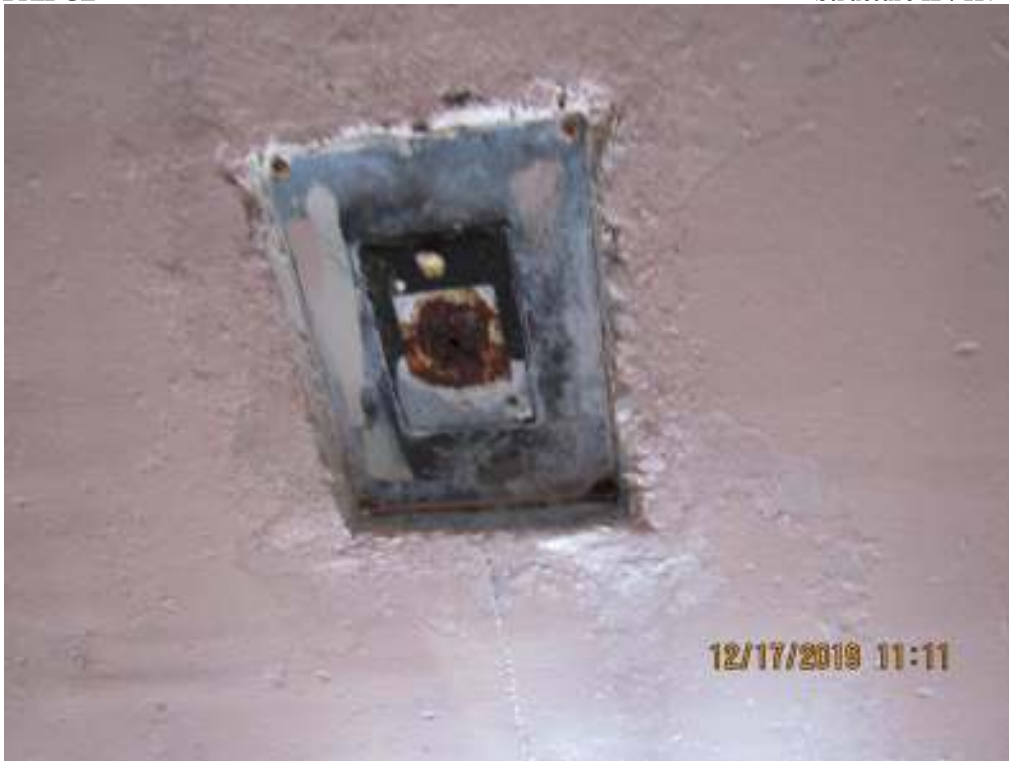
11 Broken lighting cover on soffit

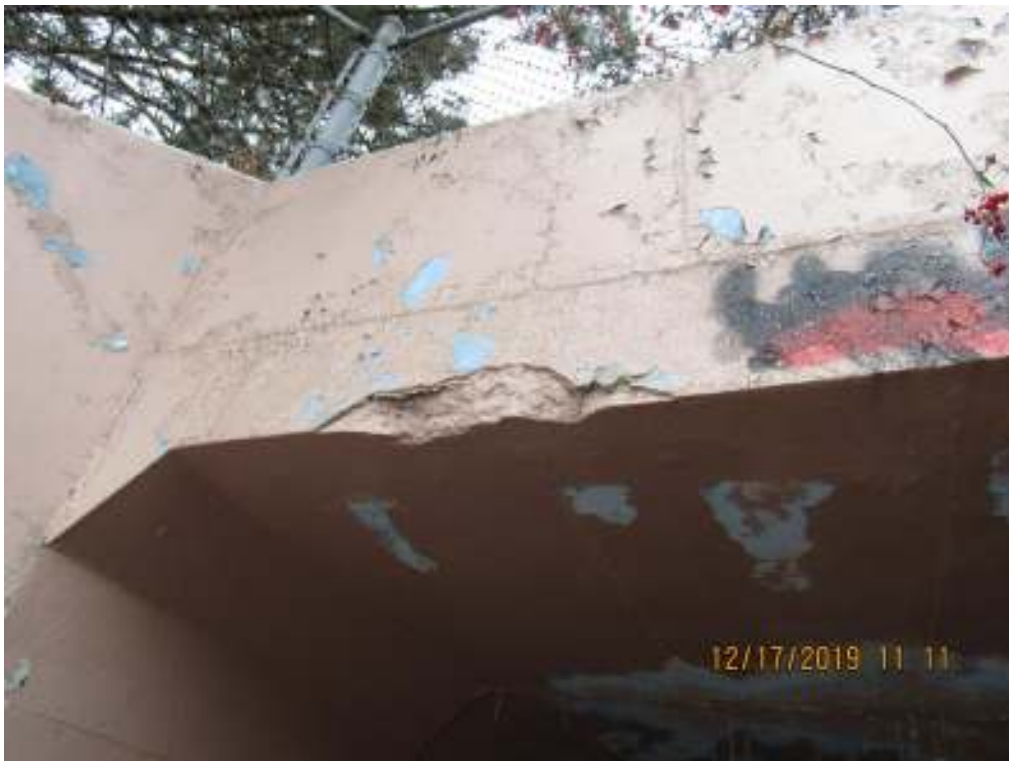
12 Spall on south face

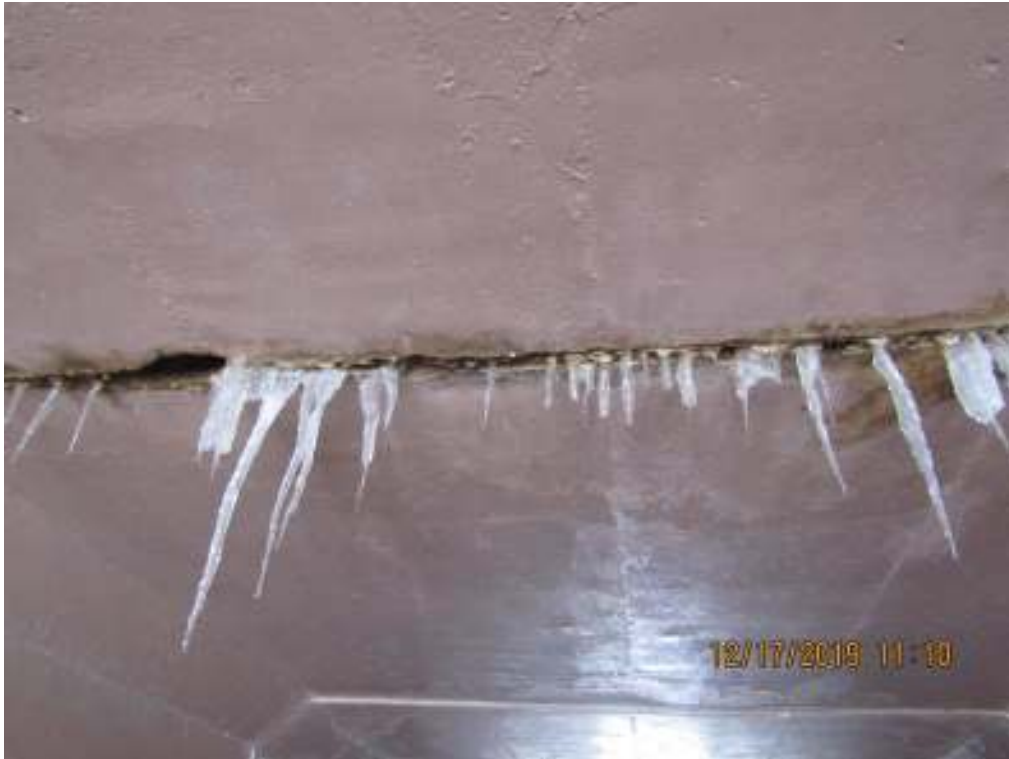
13 Light to medium spalls on joints and active leakage on soffit

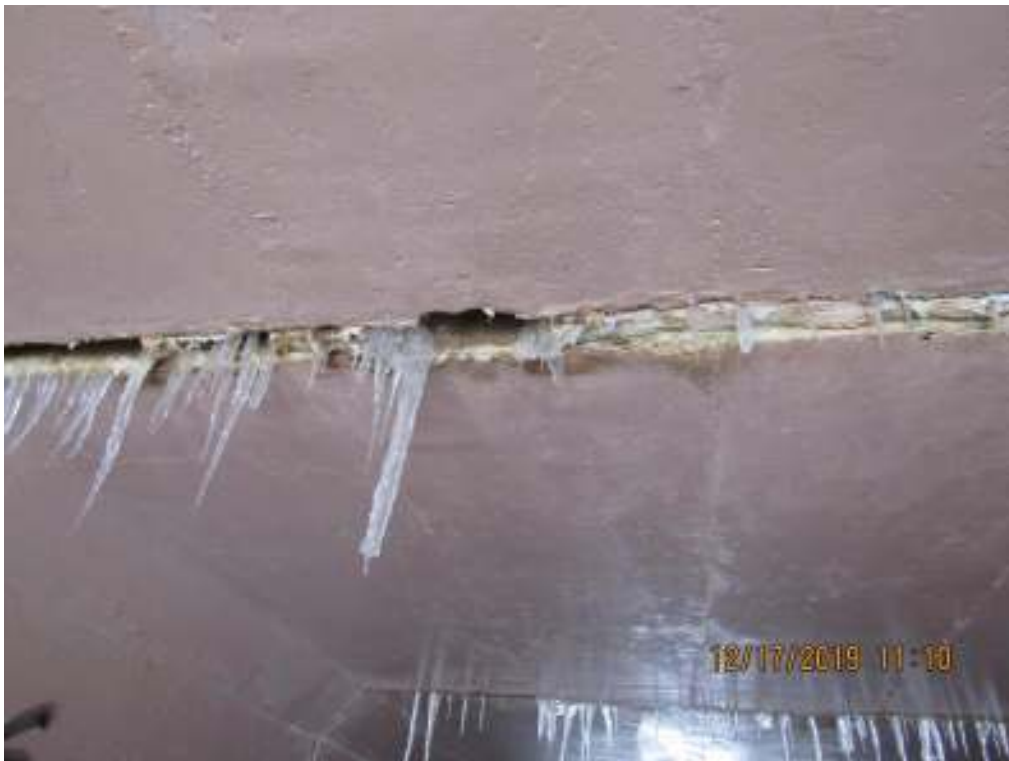
14 Active leakage at construction joint at north end on soffit

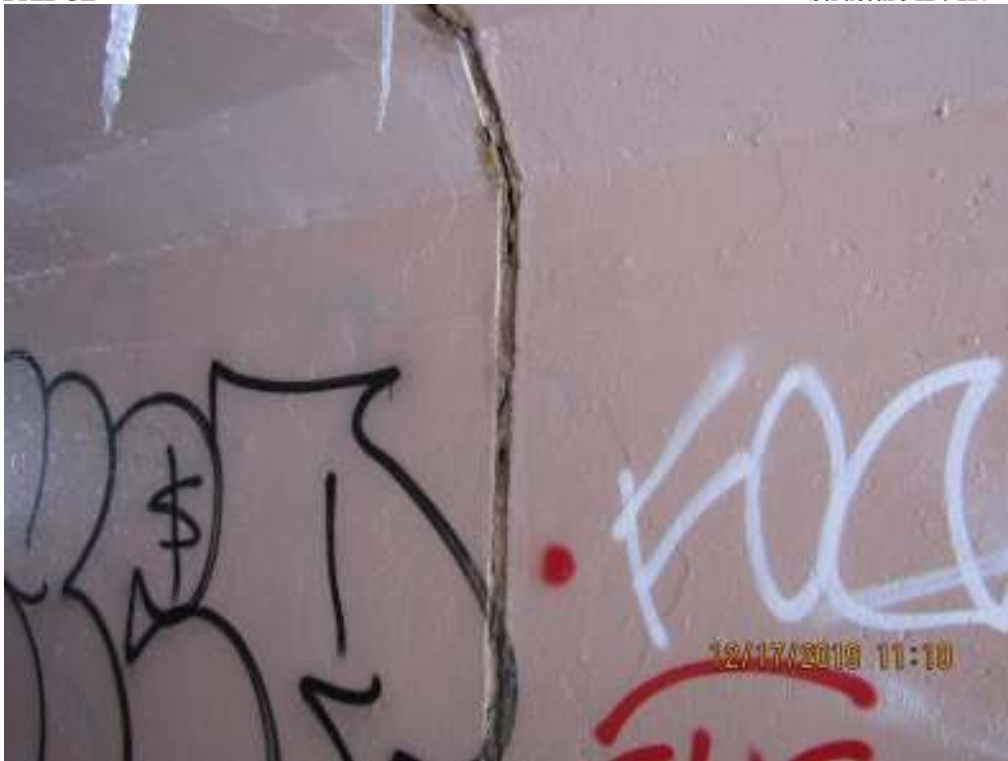
15 Poor seal condition on construction joints

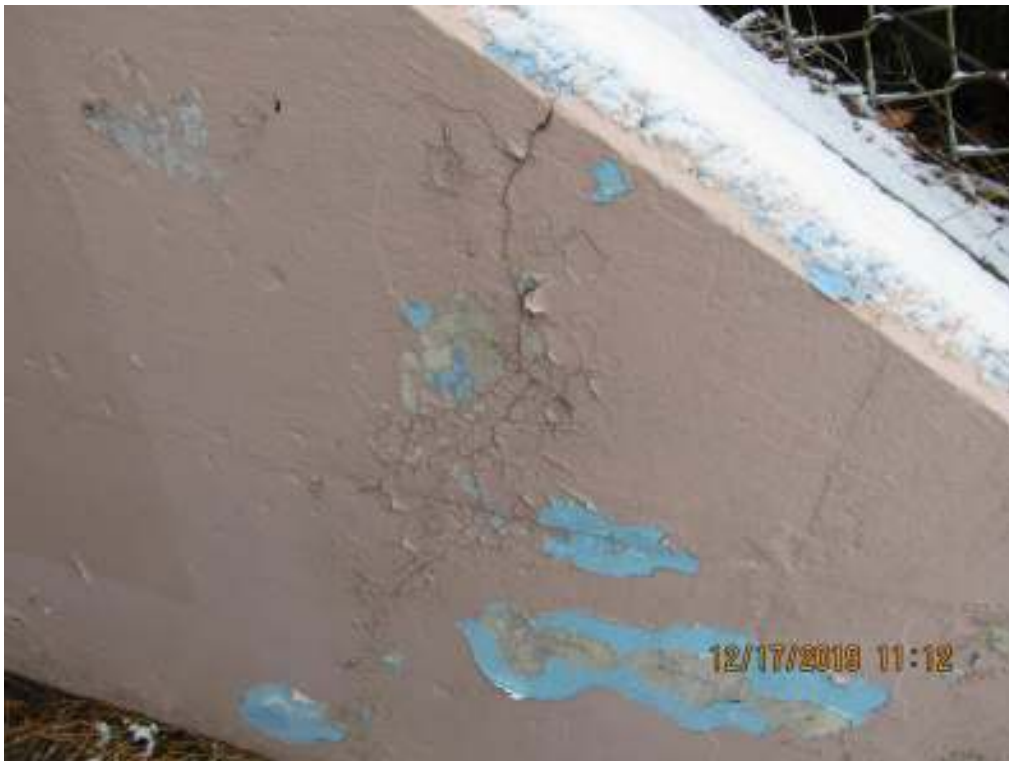
20 Vertical crack on south east retaining wall

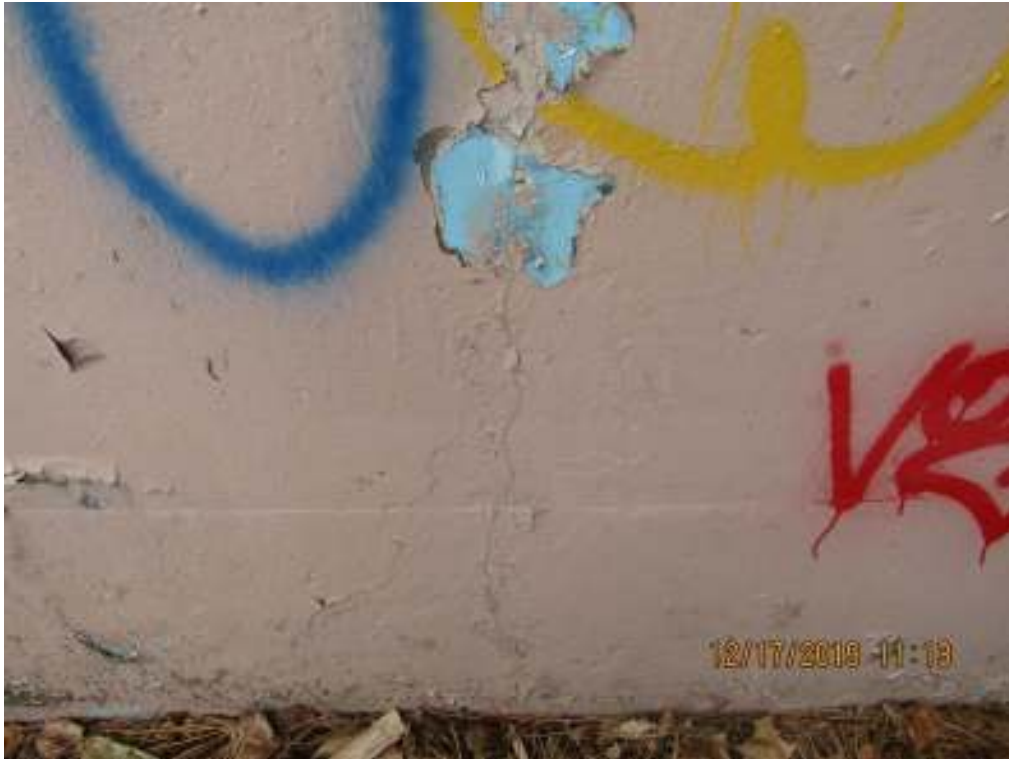
21 Vertical crack on south west retaining wall

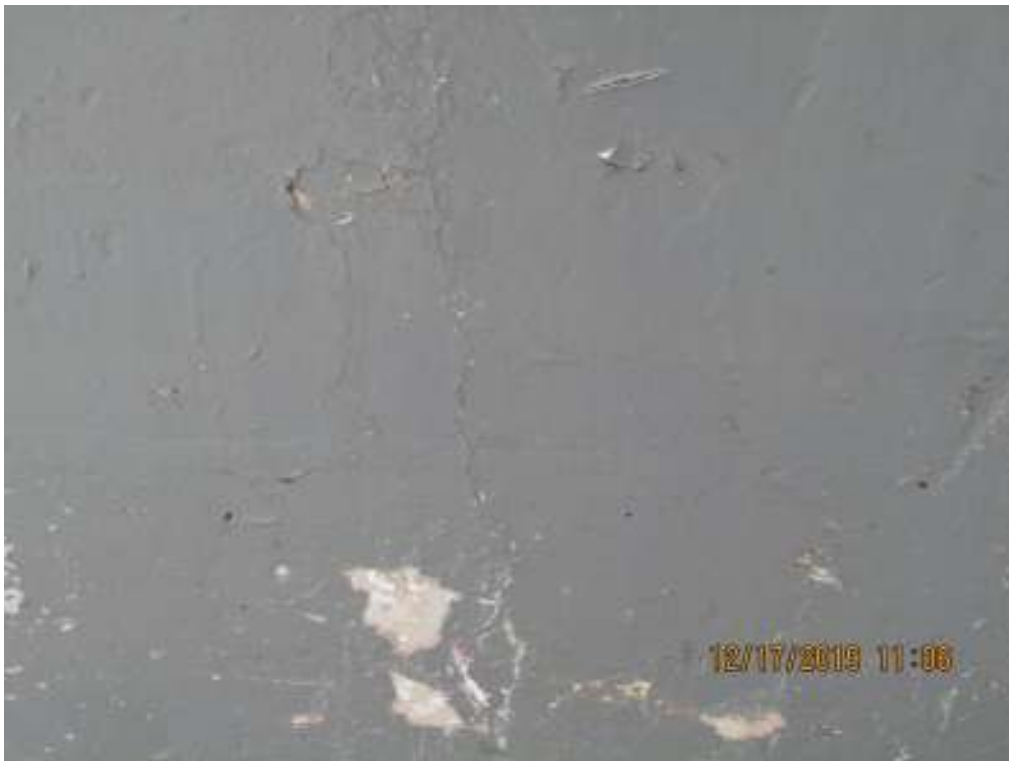
22 Narrow vertical crack on north west retaining wall

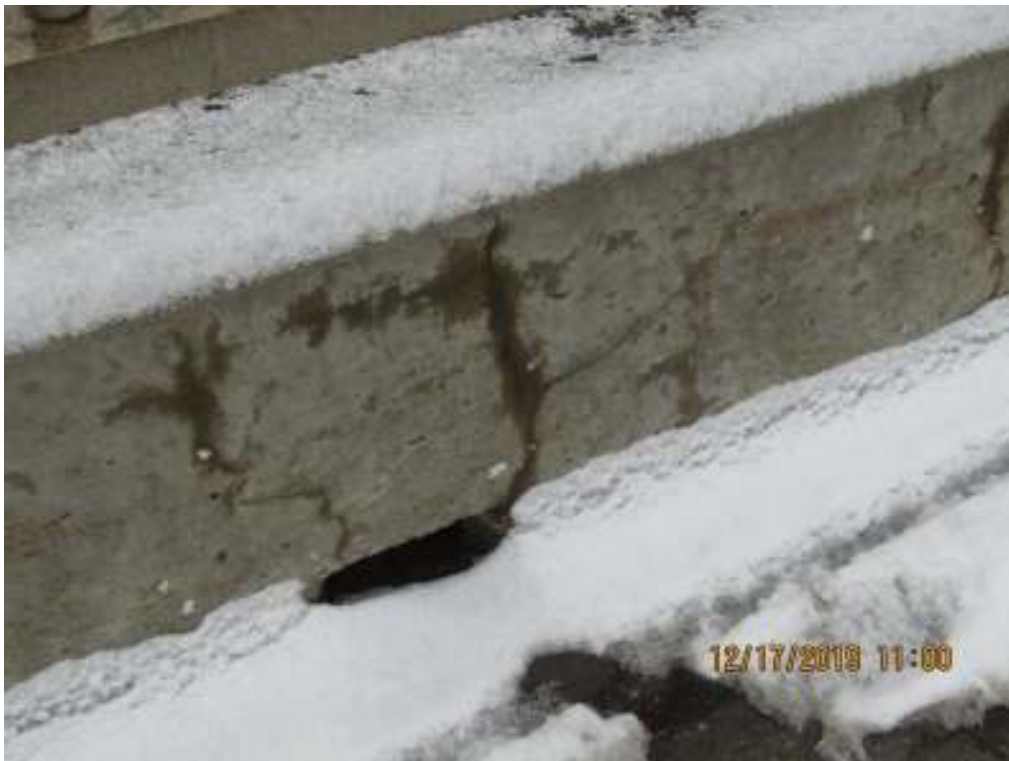
24 Typical narrow vertical cracks on north barrier wall

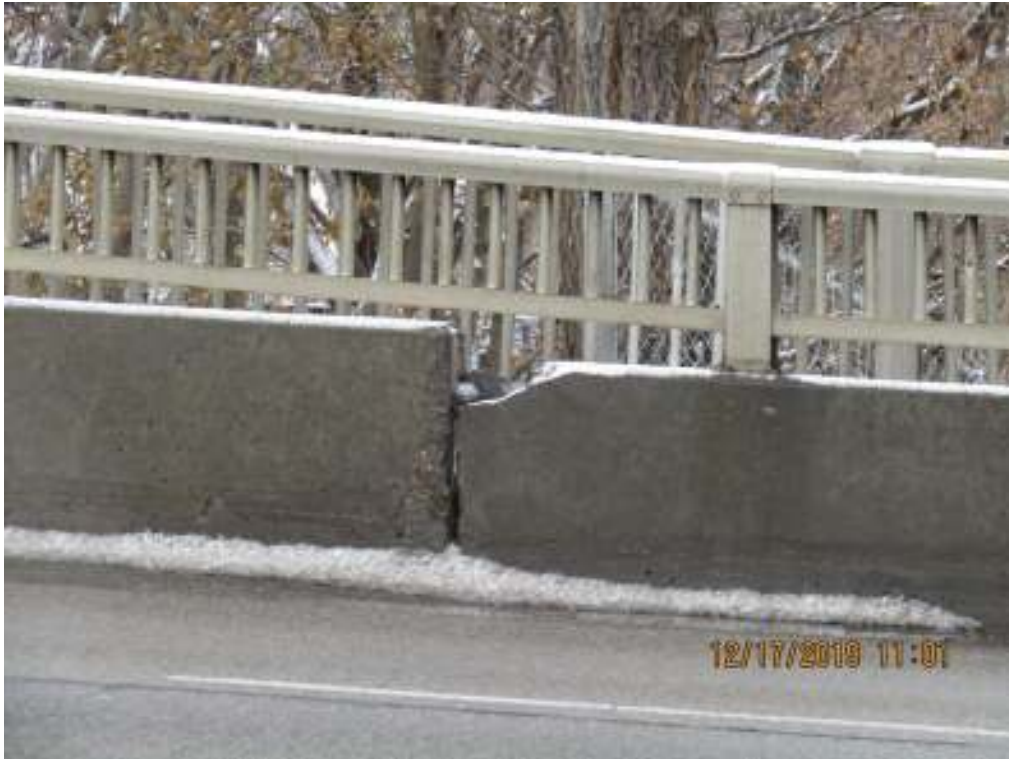
25 Spall on south barrier wall

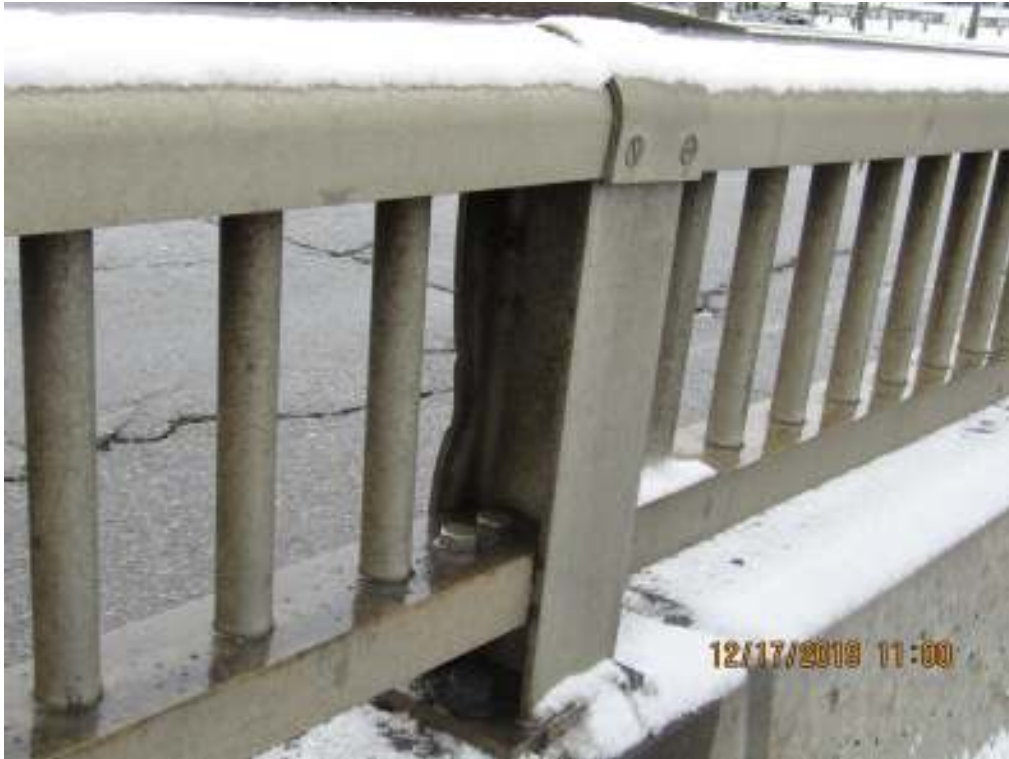
27 Impact damage on North barrier railing

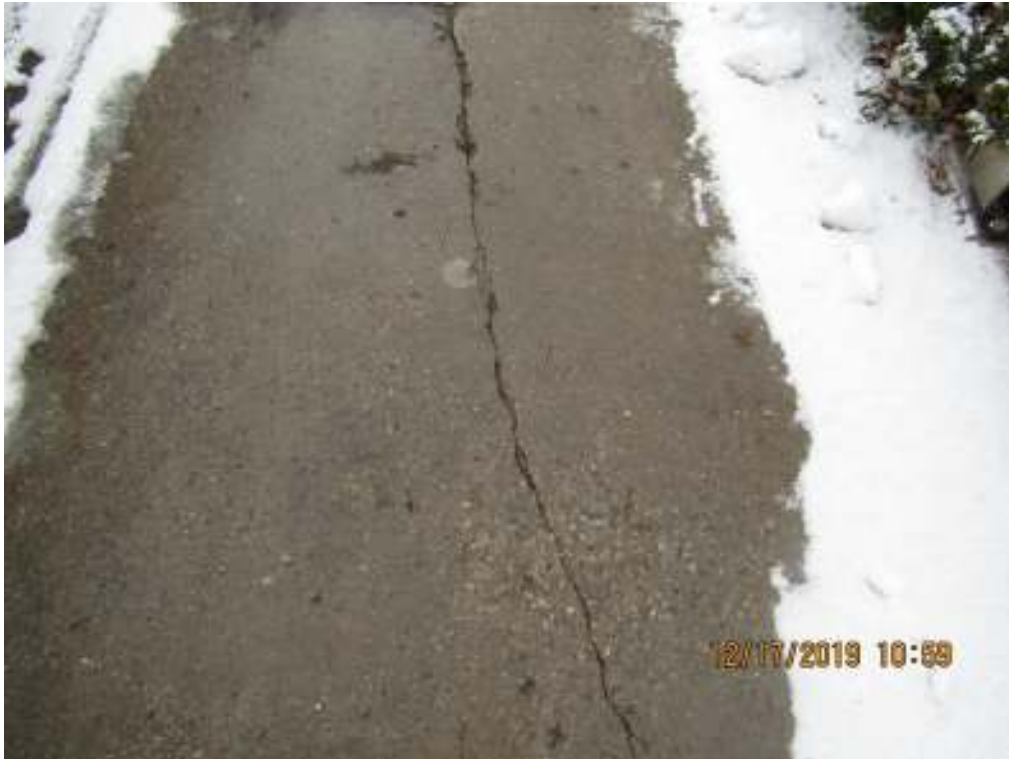
29 Large longitudinal crack on north sidewalk

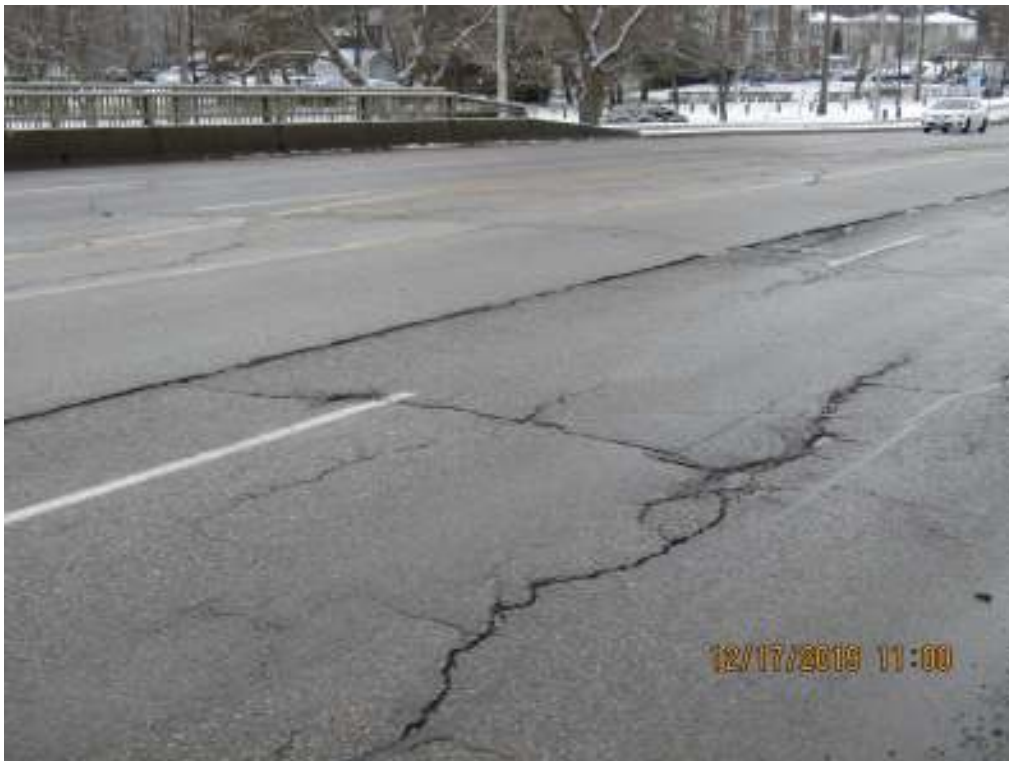
34 Potholes and cracks on west approach

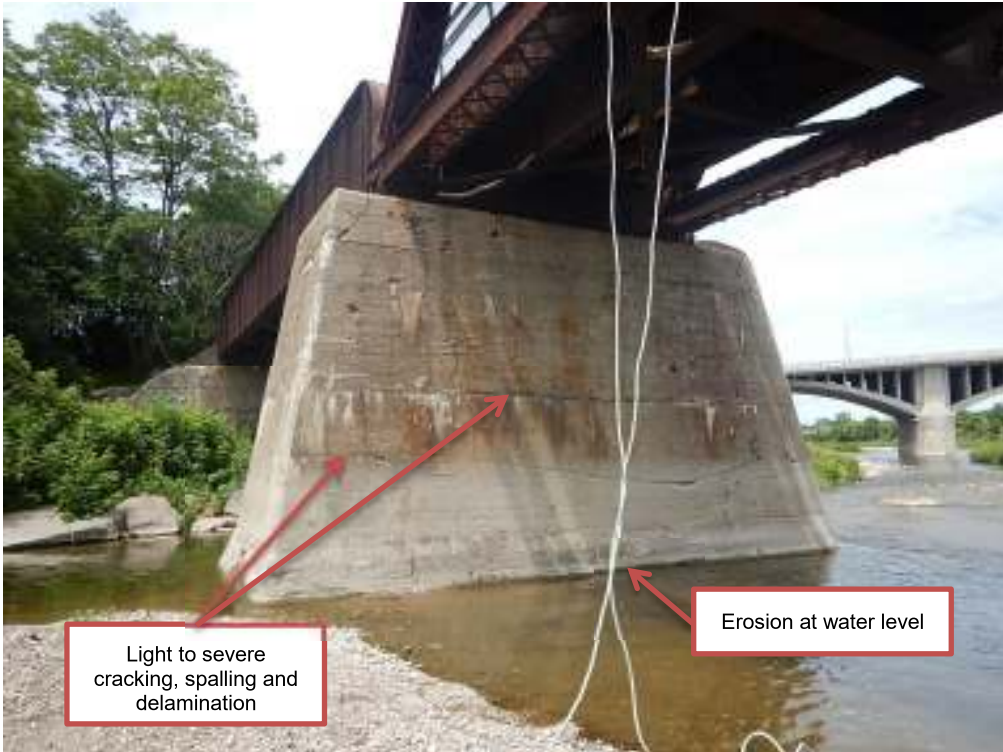
Light to severe  
cracking, spalling and  
delamination

Erosion at water level
