Colborne Street (East) Slope Stabilization Municipal Class Environmental Assessment Public Information Centre No. 2

Tuesday, March 12, 2019
Woodman Park Community Centre

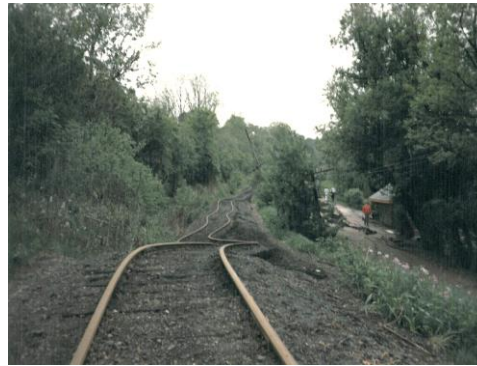
Railway along Beach Road after 1986 landslide

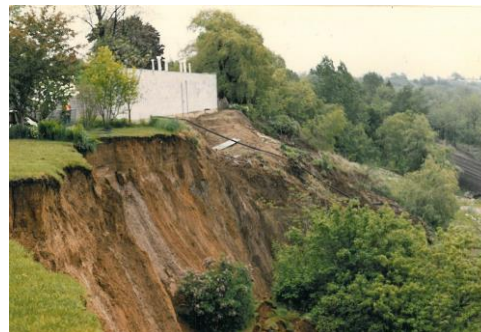
929 Colborne Street (East) after 1986 landslide

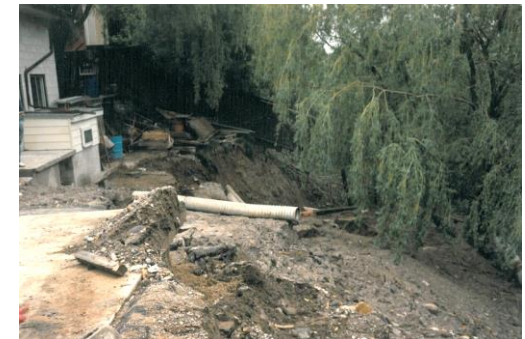
951 Colborne Street (East) after 1986 landslide

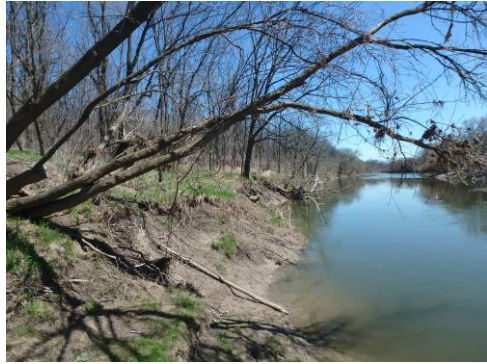
Evidence of toe erosion, including bare banks and fallen trees, April 2016

- Toe erosion from Grand River is a factor in slope instability.
- Slope toe movement tends to be greater in lower zones.
- Grand River width was reduced to half as a result of the 1986 slope failure. Since 2012 it has returned to its pre-failure width.

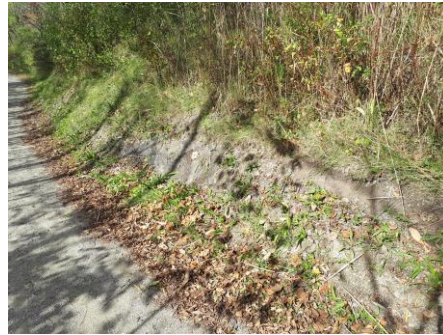
Slumping of the slope adjacent to the Rail Trail, October 2018

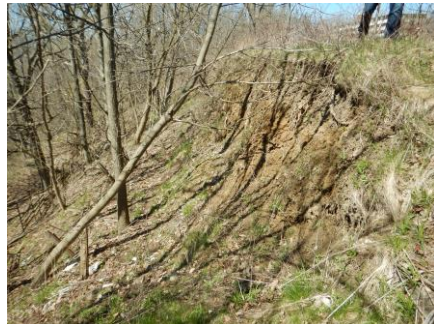
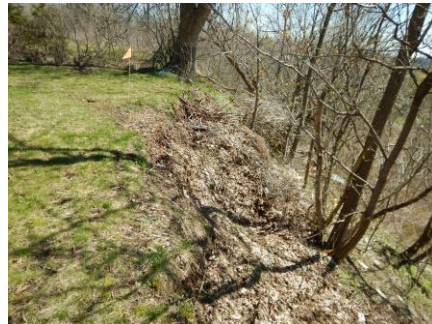
Slope monitoring in 2016, unstable slope evidence (left) and slumping near property line (right)
