Schedule B Class Environmental Assessment – Project File

Utility Access Route between Glenwood Drive and Peartree Court

A project file submitted by:
Aquafor Beech Ltd.

April 5, 2023

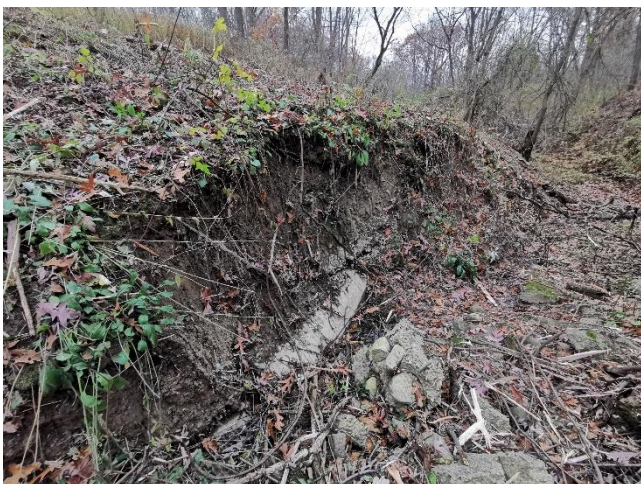
Figure 2-1: Exposed Sanitary Sewer Due to Channel Erosion (Pre-Repair, 2019)

As part of a previous City’s Utility Easement Assessment project, the sanitary sewer segment and manhole adjacent to the first crossing were found exposed due to channel erosion. The City in turn completed an emergency repair project in 2019, for which Aquafor was retained to complete the detailed design that diverted the channel away from the manhole and installed bed and bank stabilization measures, providing cover to the exposed sewer. Due to the absence of a formal access road, significant efforts were required to perform the emergency repairs including removal of dense vegetation and mature trees within the easement and restoration of manicured sods. These efforts proved the need for a permanent route to provide the City with easy access to the infrastructure with the study area, lessening the impact and cost in the long term. The pre and post repair conditions of the sanitary sewer are shown in **Figure 2-1** and **Figure 2-2** respectively.

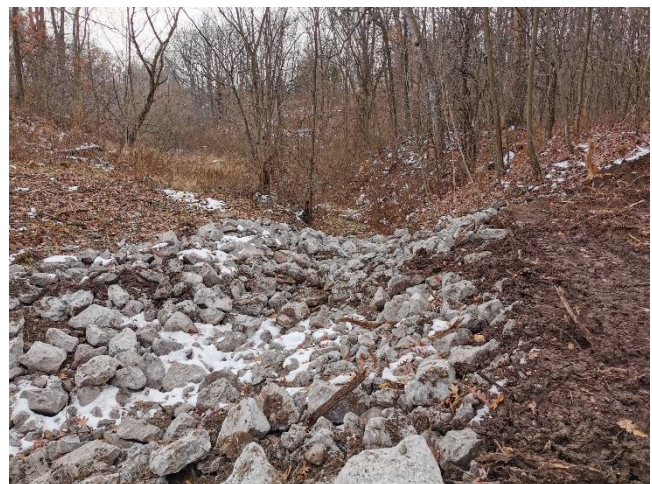
Figure 2-2: Sanitary Sewer Protect with Riprap Cover (Post-Repair, 2019)

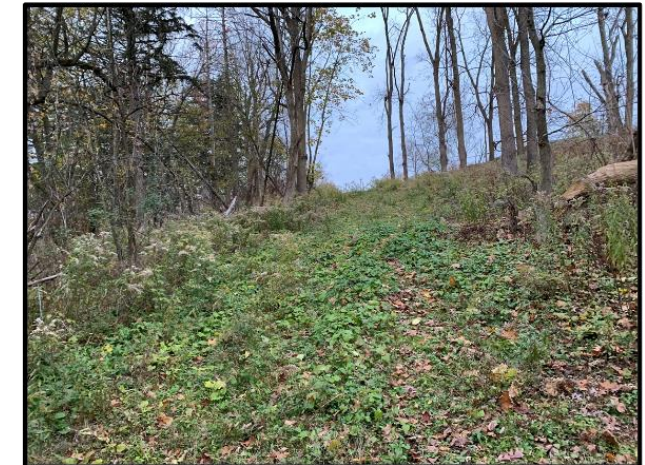
B. Steep Grade Change Along Easement Entrance to Wooded Valley

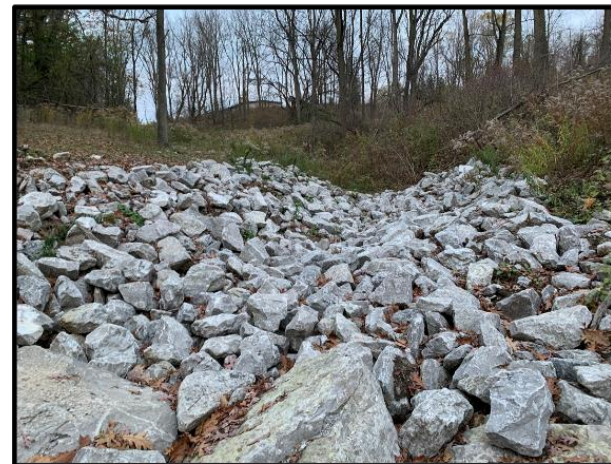
C. Emergency Back Stabilization Measures to Protect Exposed Sanitary Sewer (2019)

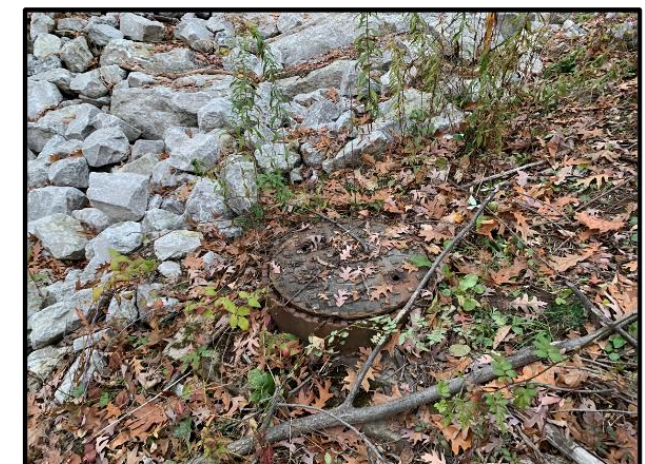
D. Emergency Bank Stabilization Measures to Protect At-Risk Manhole 11

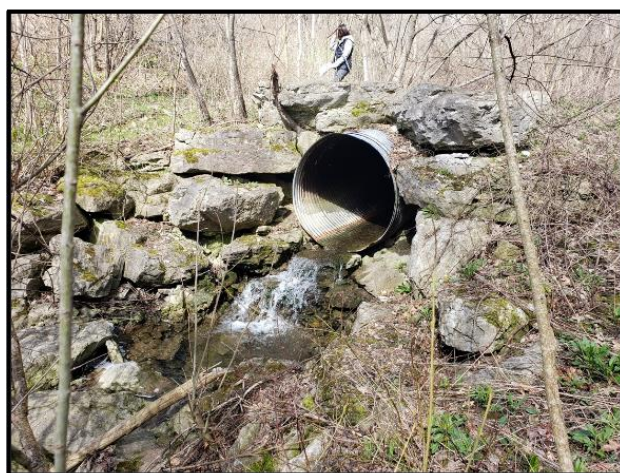
E. Existing Crossing over Combined Storm Outfall Channel

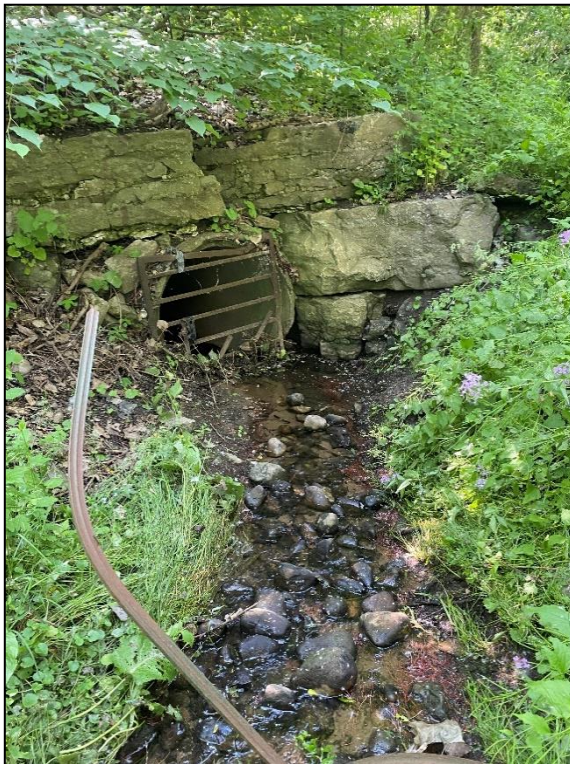
Figure 3-10: Culvert at Downstream Extent.

Aquafor confirmed a small mapped tributary flowing from west to east through the study area, ultimately entering a small corrugated steel pipe culvert and passing below Beach Road, discharging into the Grand River approximately 100 m downstream. Aquatic habitat was noted during terrestrial ecology field investigations, with background information for the surrounding area used to provide insight into potential fish communities. However, fish community and aquatic habitat have not previously been reported on within the tributary directly impacted by the proposed works. As such, a fish habitat assessment was completed on June 10, 2021 using the Rapid Assessment Methodology for Channel Structure of OSAP (Section 4: Module 1, Stanfield, 2017). The site used for the OSAP assessment extended from the Beach Road culvert, upstream approximately 300 m to a confluence between two small tributaries. The site then extended up the north tributary to where it terminated south of St. Peter School. In general, the site followed the proposed layout of the proposed works. This site was selected to provide a representative view of the study area, providing insight into existing habitat conditions associated with the proposed works. Habitat assessment field sheets are in **Appendix B**.

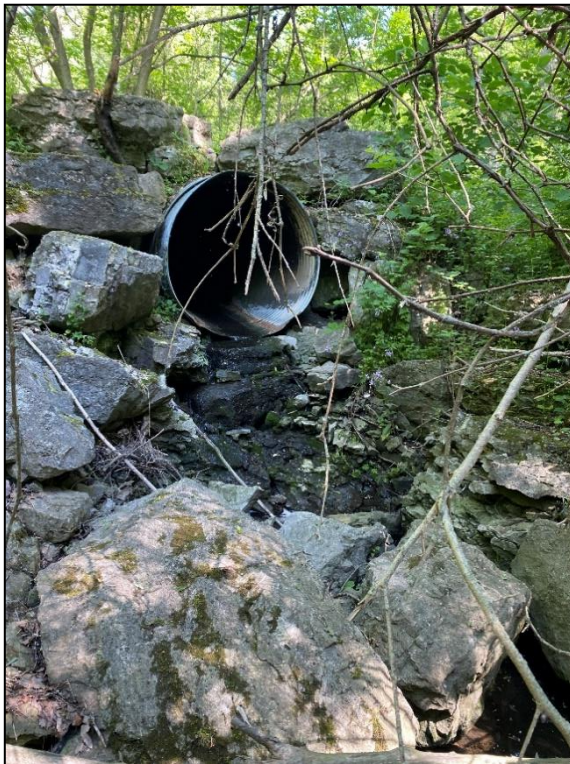
Figure 3-14: Perched CSP Culvert.

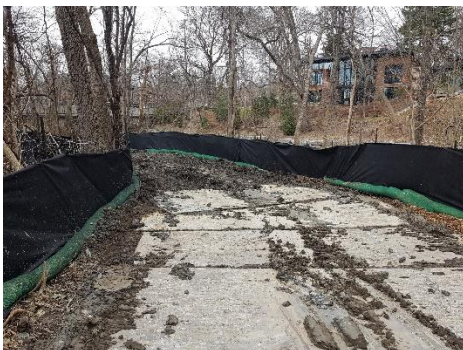
Figure 4-2: Example of Temporary Wood Matting with ESC Fencing.

Examples of the proposed access route materials are shown in **Figure 4-2** to **Figure 4-5**, and a preliminary design plan form of Alternative 2 is illustrated in **Figure 4-6**. The preliminary construction cost estimate for Alternative 2 is set out in **Table 4-2**.

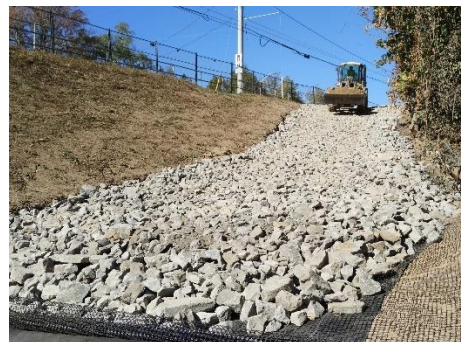
Figure 4-3: Example of Rock Geogrid Access Route.

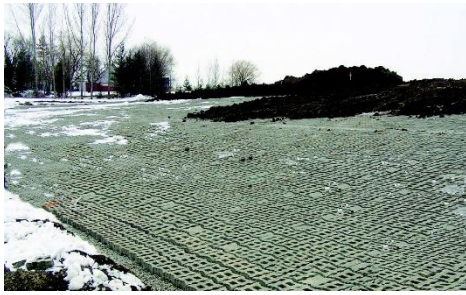
Figure 4-4: Example of Vegetated Concrete Block Installation (Nilex, 2022).

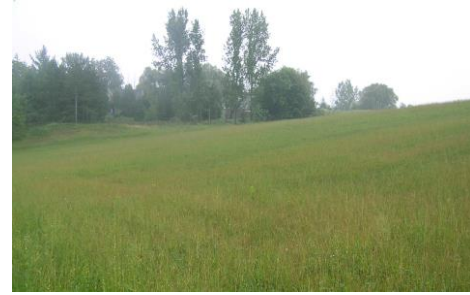
Figure 4-5: Example of Established Vegetated Concrete Blocks (Nilex, 2022).
