# Water, Wastewater and Stormwater Master Servicing Plan Update – 2051 Amendment

November 2021

## Volume V – Stormwater Master Plan

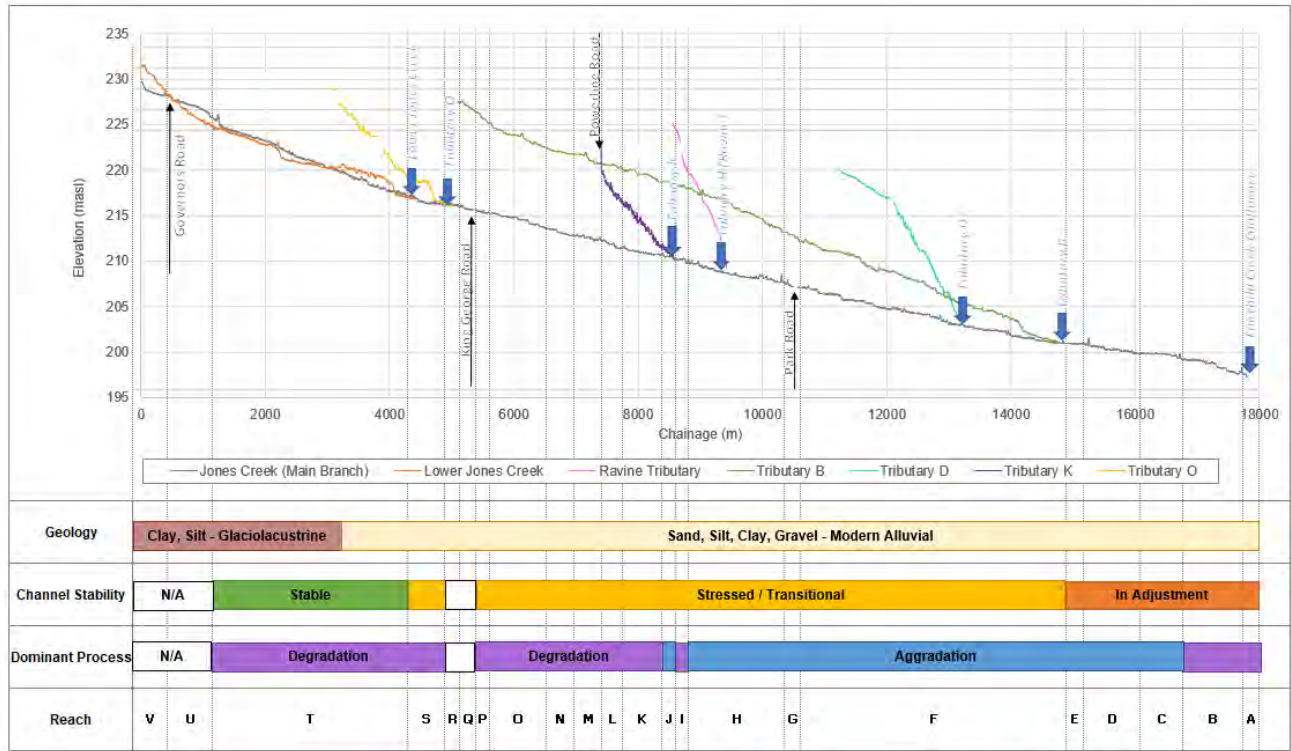
Figure 2-38: Annotated Jones Creek and Drainage Network Profile

An annotated profile has been developed that provides a spatial representation of existing conditions (Figure 2-38). Review of this profile enables linkages to be made between different aspects of the fluvial geomorphic assessment. For example, the channel stability bar graph, in reference to the profile, demonstrates a general downstream decline in channel stability; this may reflect a downstream cumulative impact and response to changes in sediment loading and/or hydrology from contributing tributaries. The annotated profile also demonstrates a shift from overall channel bed lowering/degradation processes to a more dominant aggradational process; the aggradation/deposition may reflect inputs from tributaries and deposition of upstream derived sediment.

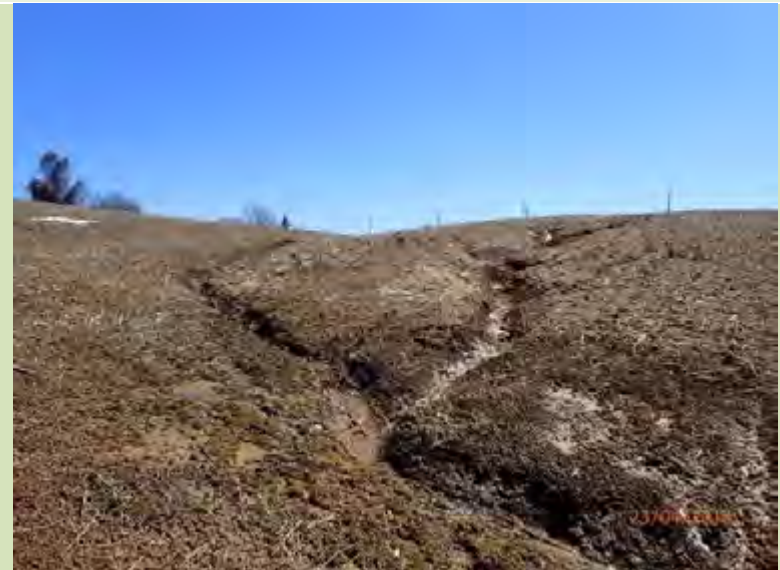
<b>Gully</b>	<p>Relatively permanent water courses, steep sides, low width depth ratios and stepped profiles with characteristically headcut at the upslope end (Knighton, 1998).</p> <p>Gullies are typically considered to have a depth greater than 0.6 m.</p>

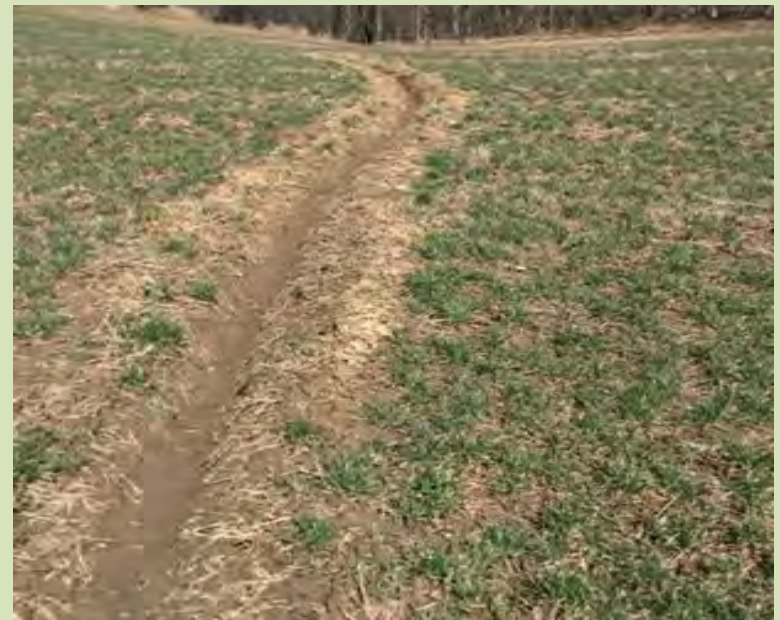
**Wetland (Linear)** Feature with sustained water storage function. Abundant water has caused the formation of hydric soils and has favoured the dominance of either hydrophytic plants or water tolerant plants (CVC and TRCA, 2014).

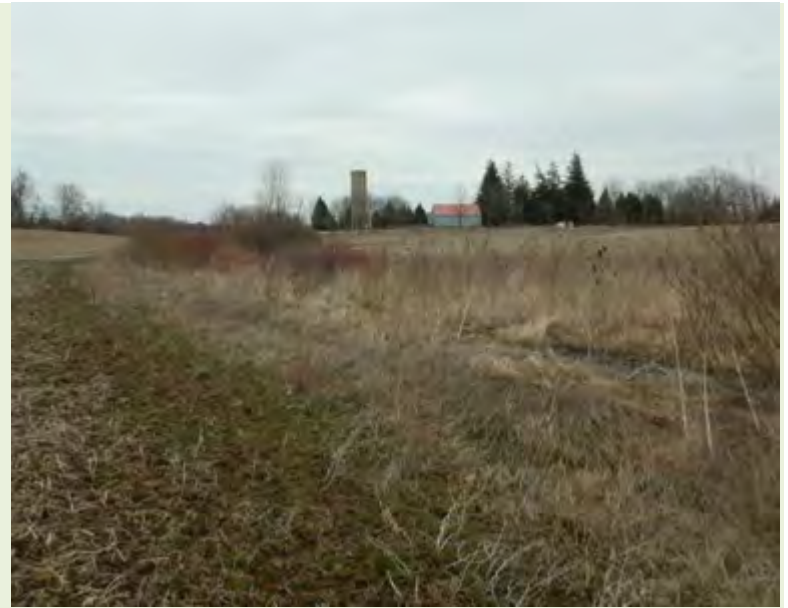
**No Defined Feature** No identifiable depression to convey water – water transport through overland or sheet flow (Stanfield, 2017).

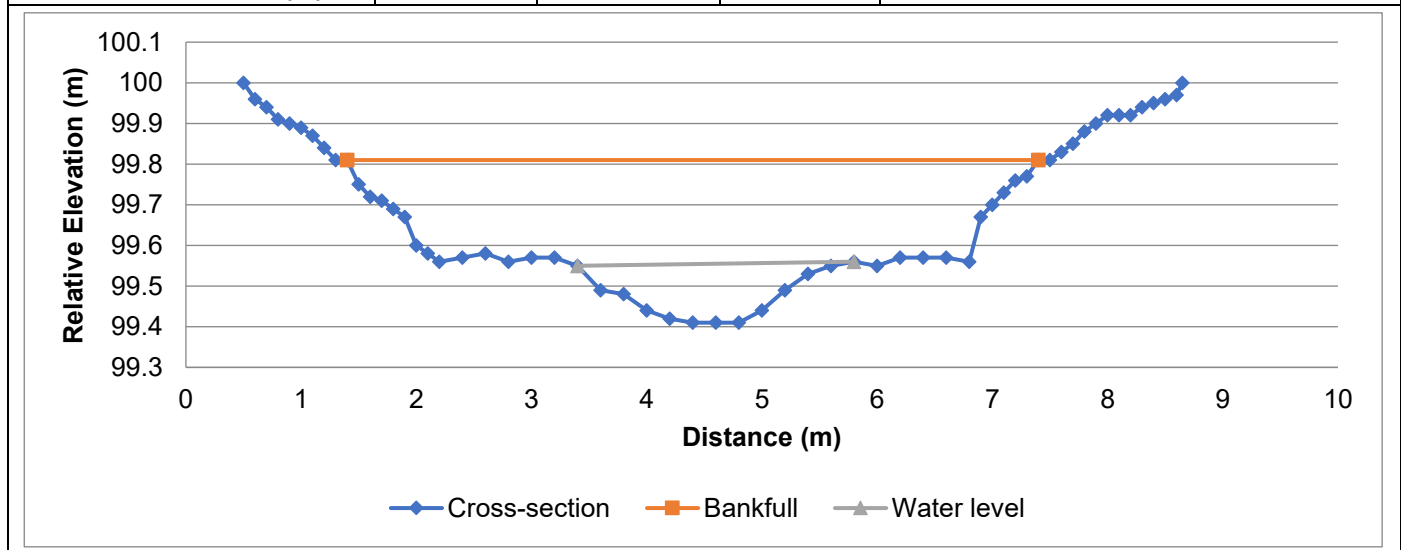
Hydrogeomorphology – Upstream			
Measured Low Flow Discharge (cms)	-	Total Stream Power (W/m <sup>2</sup> )	21.66
Corresponding Average Velocity (m/s)	-	Unit Stream Power (W/m)	3.6
		Maximum Shear Stress (N/m <sup>2</sup> )	9.94
Calculated Average Bankfull Discharge (cms)	0.85	Average Shear Stress (N/m <sup>2</sup> )	6.38
Calculated Average Bankfull Velocity (m/s)	0.98	Mannings <i>n</i>	0.05
