Cultural Heritage Evaluation Report

Three Grand River Crossings Schedule B Municipal Class Environmental Assessment, City of Brantford, Ontario

19128292-2000-R01-Rev1

December 6, 2021

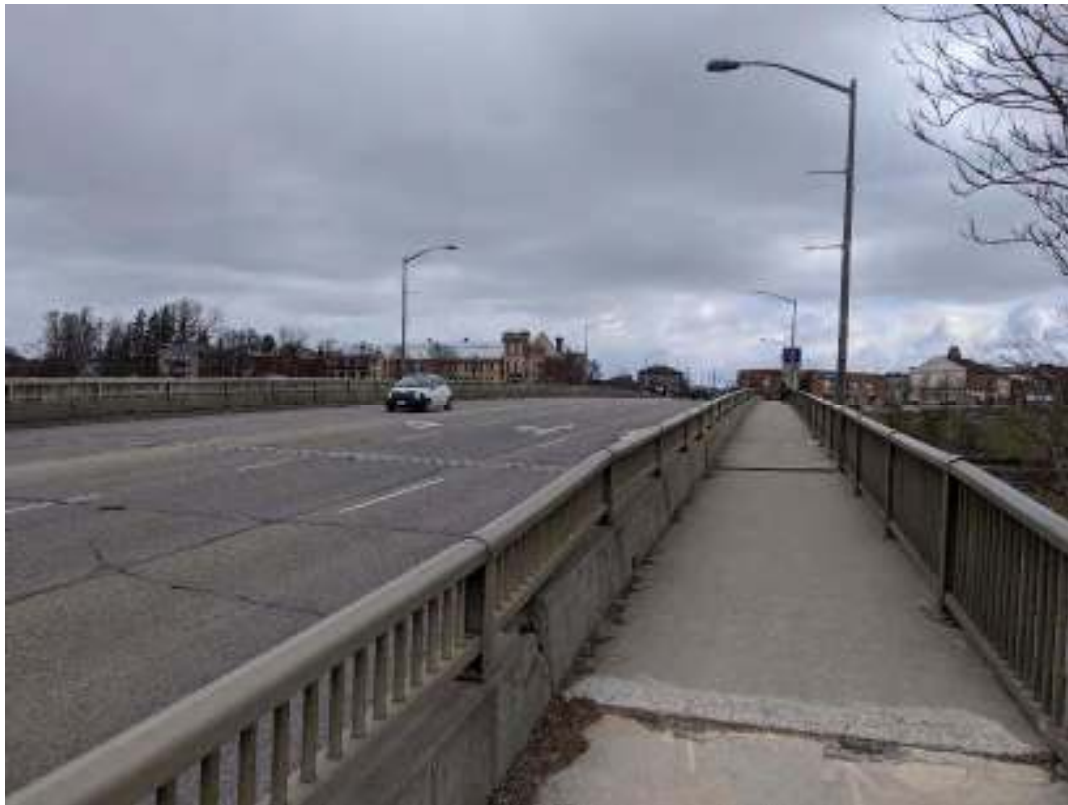
Figure 50: View east from near the centre of the bridge of the deck camber from the east and west, low cast-in-place concrete parapet walls with single railings either side of the asphalt wearing surface, and cast-in-place concrete sidewalk with aluminium post and panel railings

The superstructure over the arched spans of the Lorne Bridge and the Lorne Bridge Girder Span is a solid and thin concrete slab deck with a chamfered soffit and a slight rise in the centre that cambers to the east and west (Figure 49). Either side of the asphalt wearing surface are low cast-in-place concrete parapet walls with single railings, which are either aluminium post and panel or hot dip galvanized. Another aluminium post and panel railings runs along the outside edges of the deck, and there is a cast-in-place concrete sidewalk between the railing and parapet wall on both the north and south (Figure 50). Expansion joints are at either end of the girder span, and over the east and west abutments.

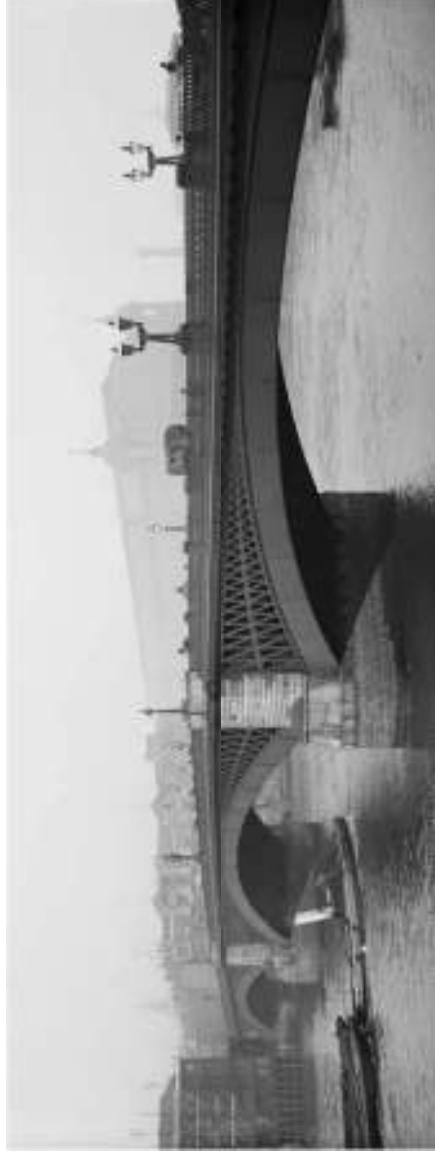
Figure 67: The Old Southwark Bridge spanning the Thames in London England, built in 1819 and replaced in 1921 (Historic England). Note the shallow arch spans, mouldings at the top of the sharp-nosed piers, and prominent parapet posts over the piers that match those of the Lorne Bridge (see Figure 68)

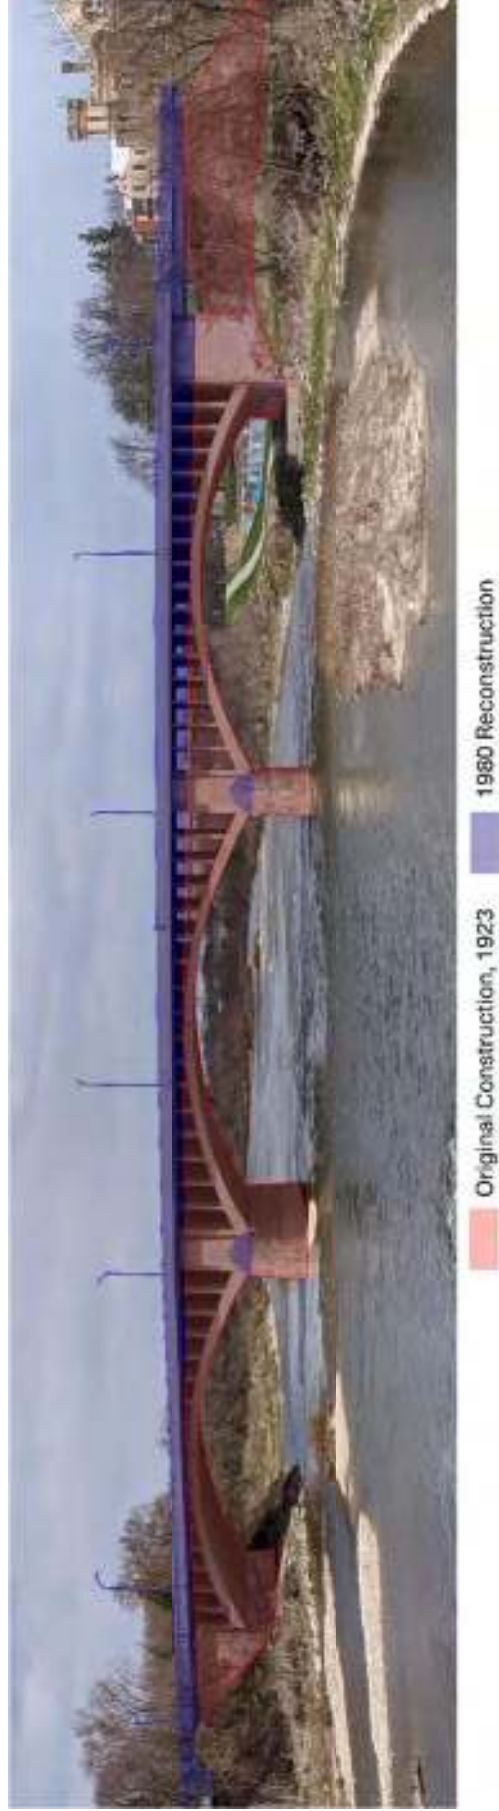
Figure 77: Visual integrity analysis of the Lorne Bridge

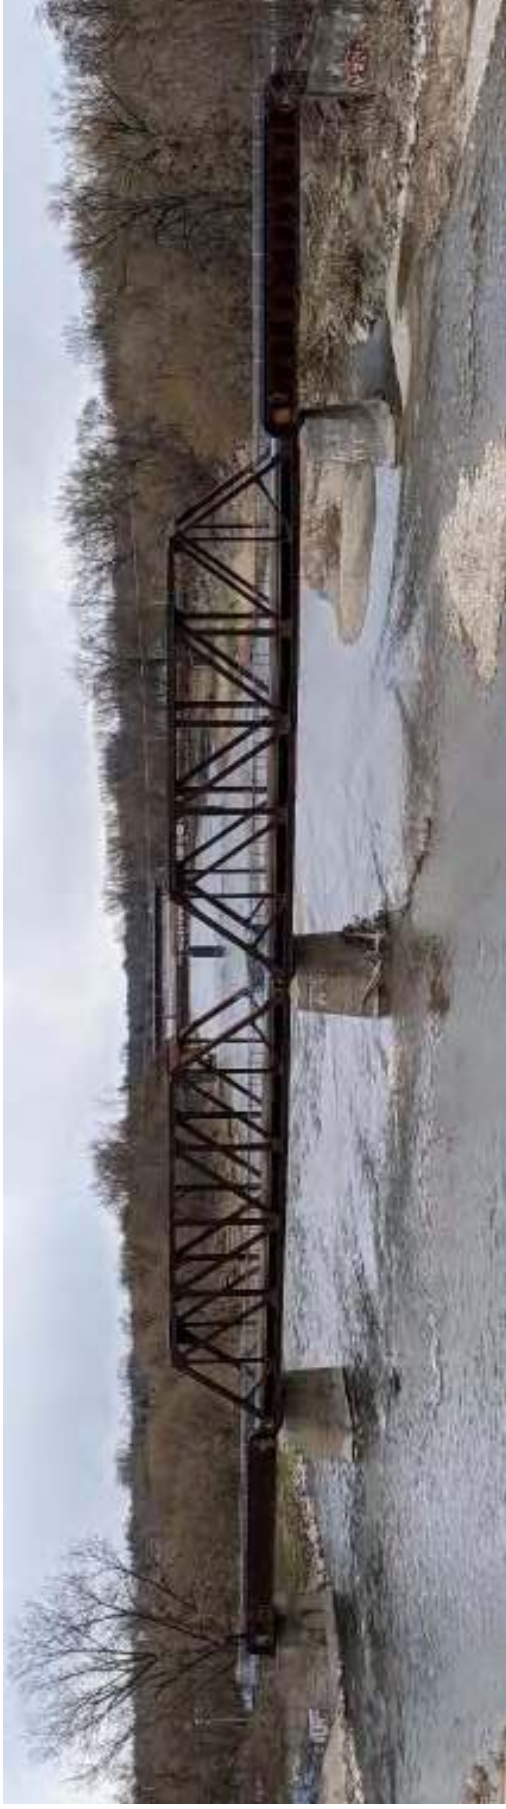
Figure 86: North elevation of the Brant's Crossing Bridge

There are three piers each approximately 9.5 m wide, 3 m thick, and standing 7 m high. They are solid shaft cast-in-place concrete, with curved ends and moderate batter on the upstream side, and flat face with minor batter on the downstream side (Figure 89 and Figure 90); an exception is the west pier (No. 3), which has a steeper batter than the others on the downstream side (Figure 91). The pier foundations stand on exposed bedrock in the riverbed.

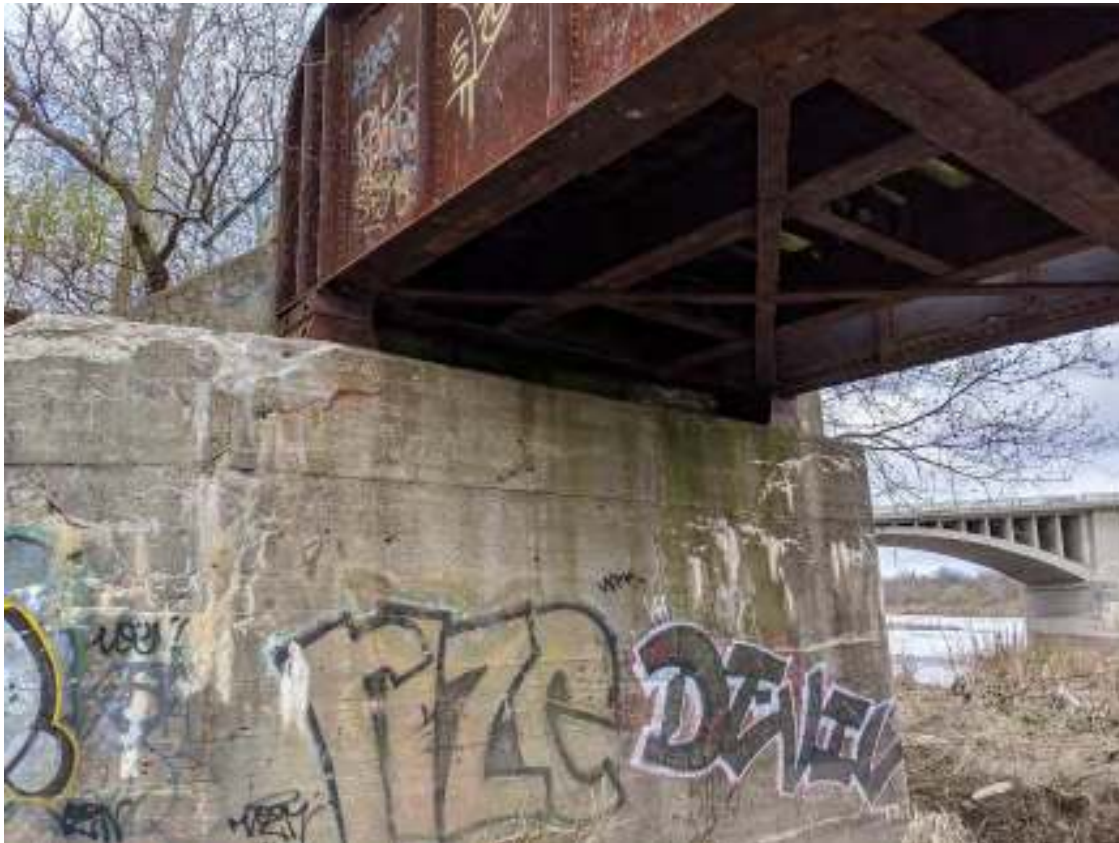
Figure 88: Front wall and ballast wall of the west abutment

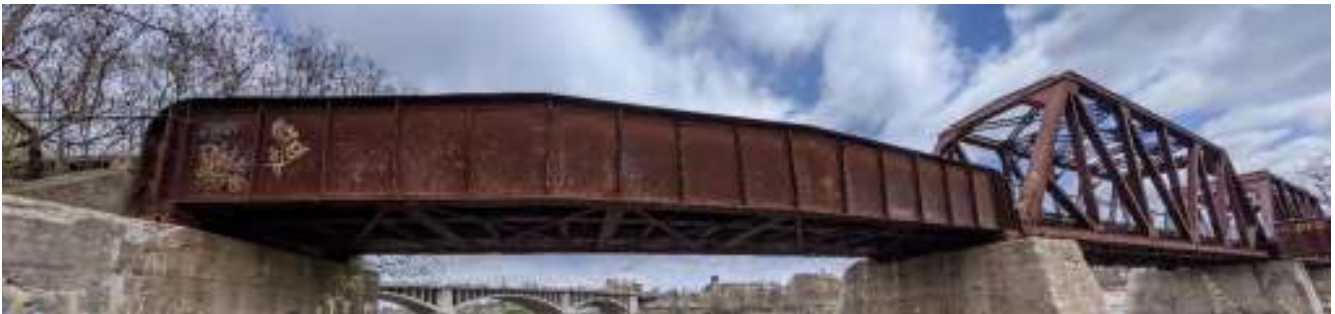
Figure 92: West approach girder span (includes some camera distortion).

The deck is closely spaced wood ties, over which are the track sections, corrugated pipe utility corridor, and the planked walkway with aluminium stringers and aluminium post and chain-link balustrade. On the upriver sides of both approach spans are large perforated plates that appear to prevent access to the corrugated pipe utility corridor (Lance Brown 2020: pers. comm; Ken Chrysler 2020: pers. comm.) (Figure 104). Between the spans on the downriver side is a triangular platform formed with two lateral members and on either side are four-panel webs with vertical web stiffeners. This has been made into a viewing platform for the pedestrian walkway.

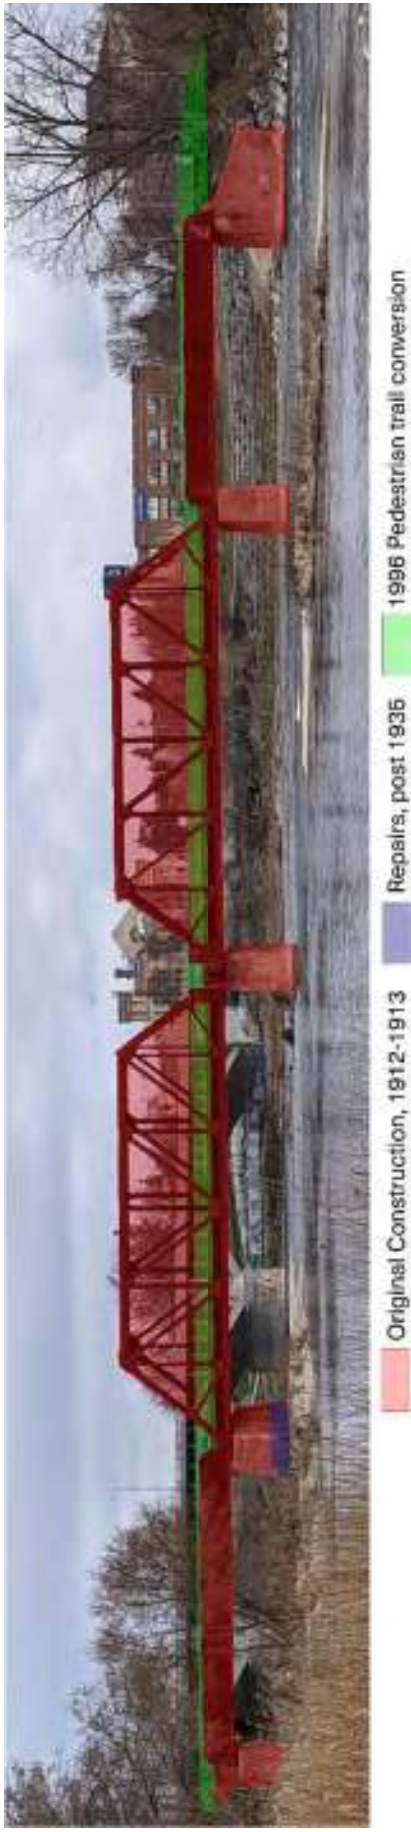
Figure 115: Visual integrity analysis of Brant's Crossing Bridge

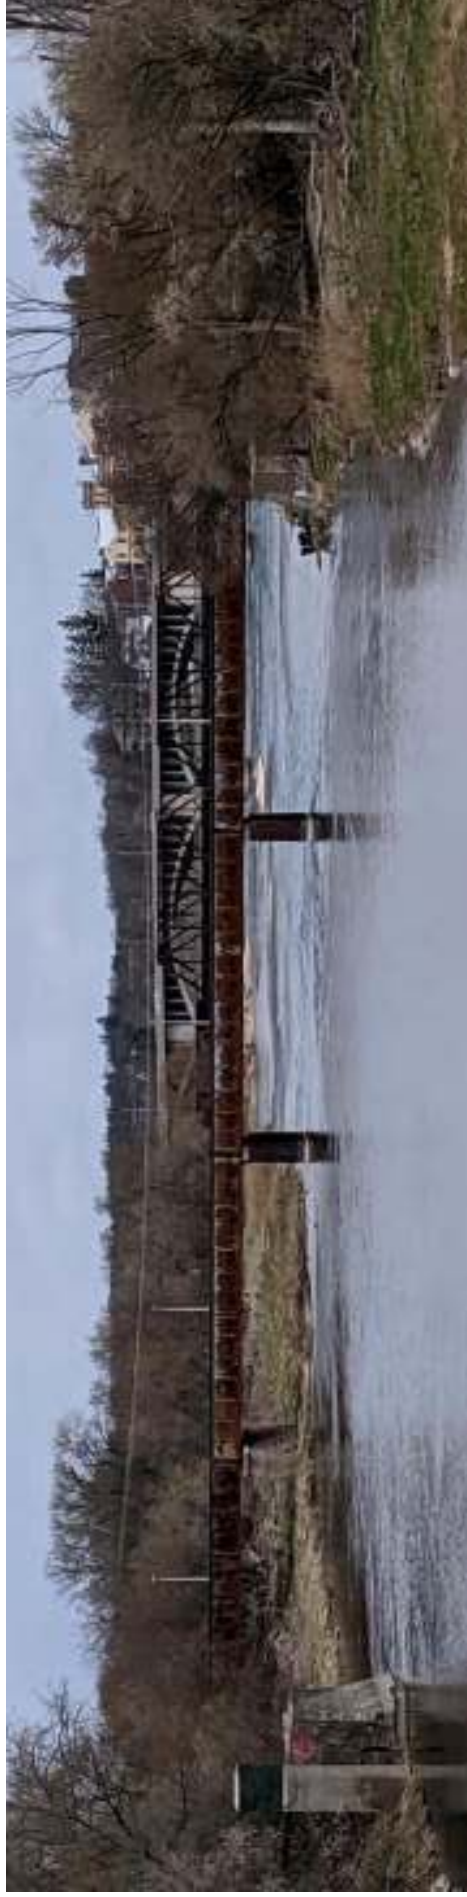
Figure 123: South elevation of the TH&B Crossing Bridge

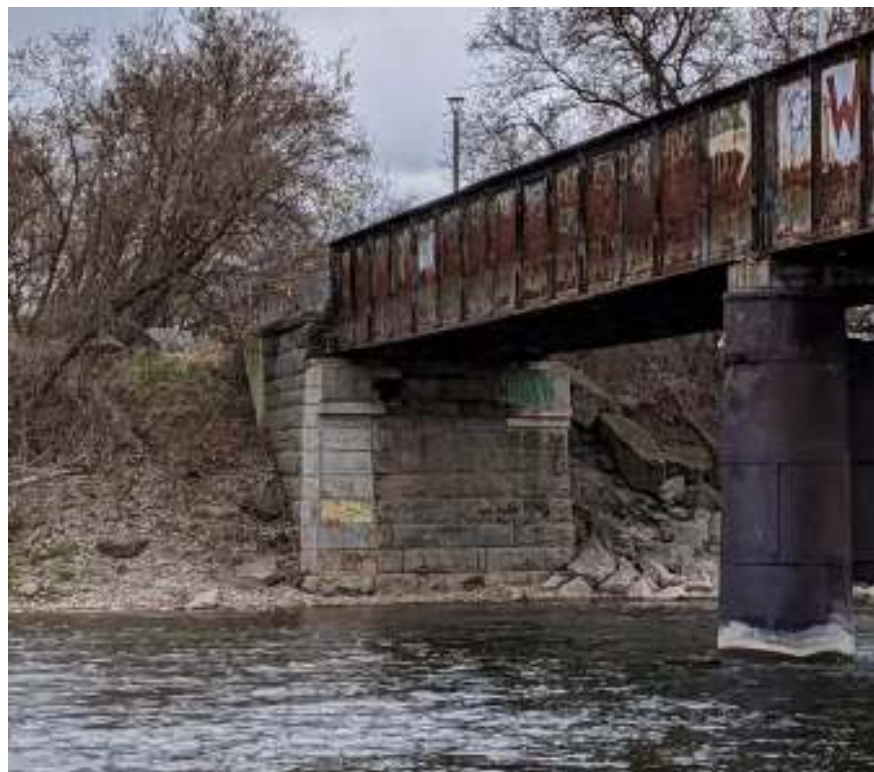
Figure 128: View facing southeast of the east abutment with ashlar construction and concrete repairs

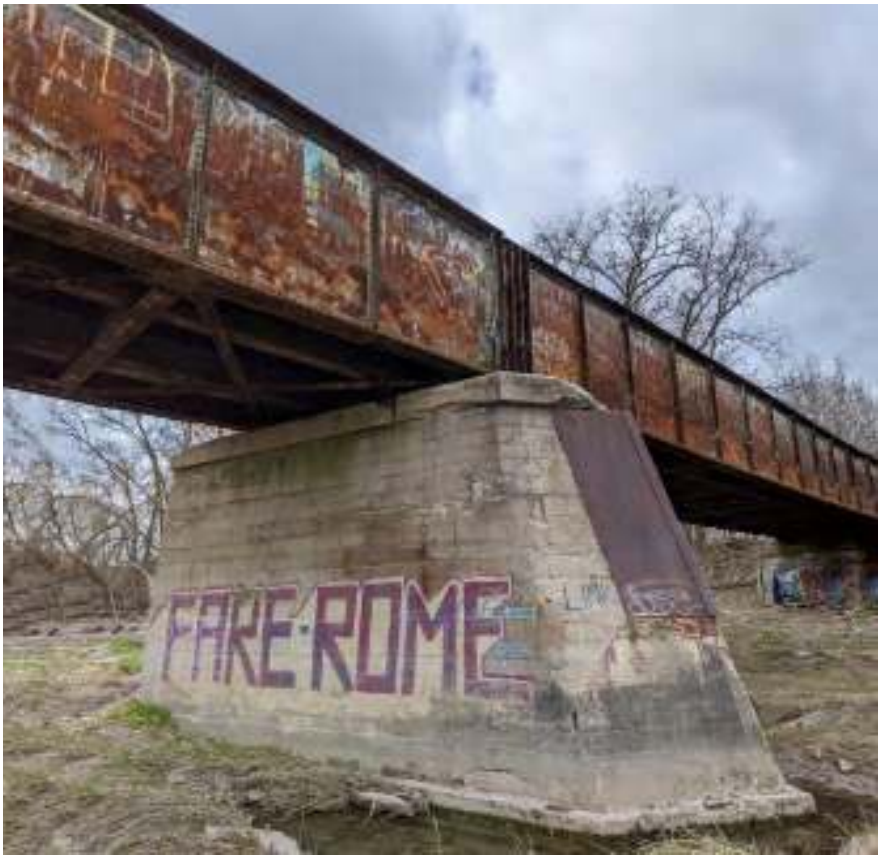
Figure 129: View facing south of the concrete pier

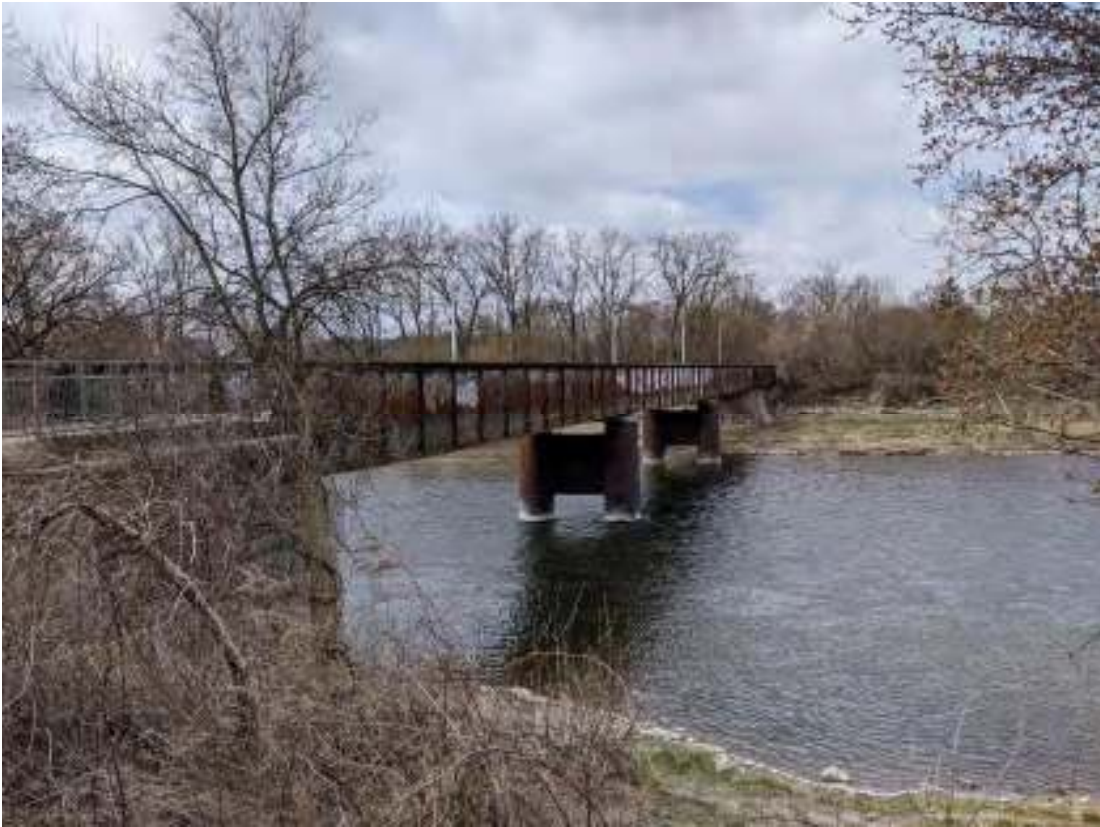
Figure 133: View facing west of the girder spans

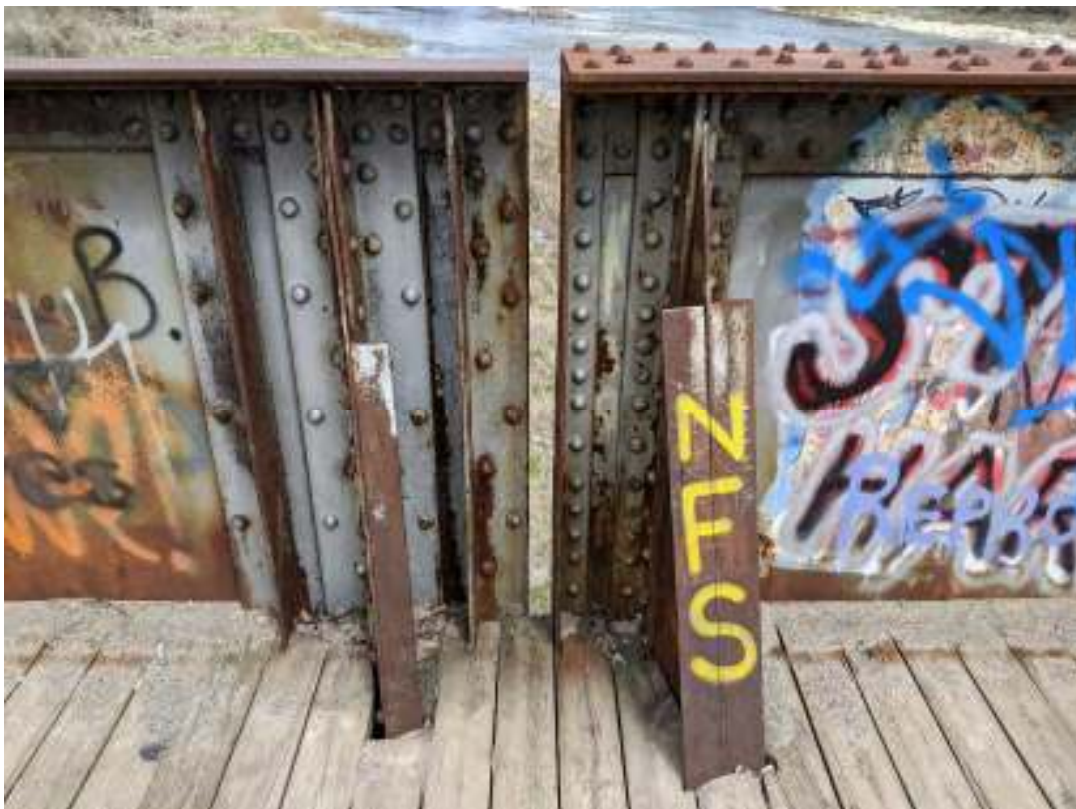
Figure 136: Joint between the west approach span and centre west span showing varying construction

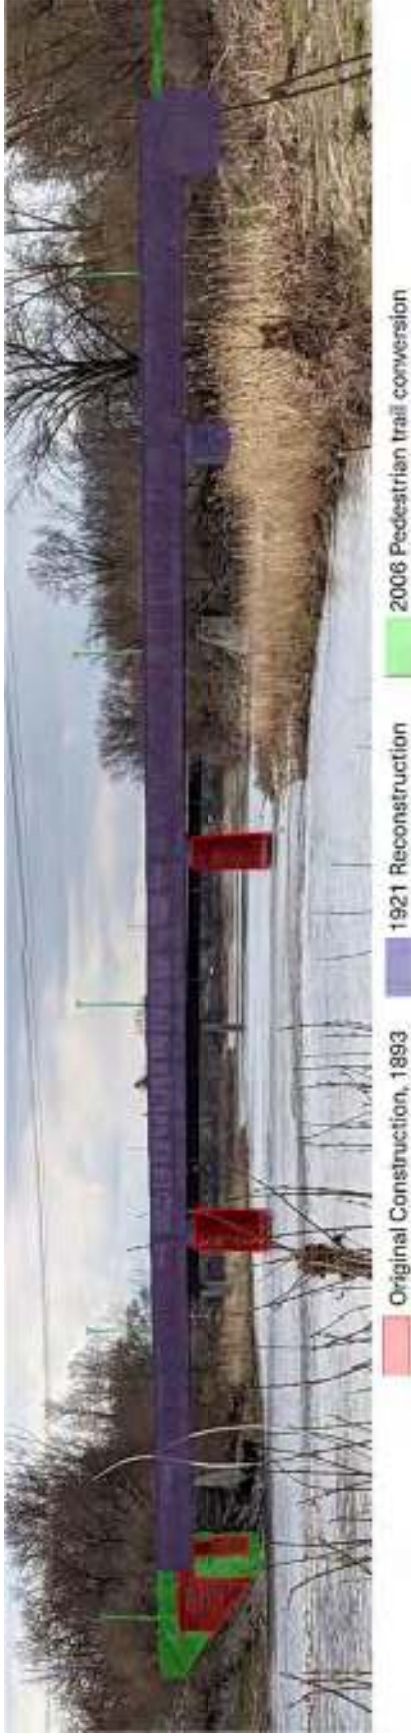
Figure 145: Visual integrity analysis of the TH&B Crossing Bridge
