City of Brantford

# Lorne Bridge (Structures 117, 131, 132) Structural Evaluation Report

**GMBP File: 119104**  
**May 2021**

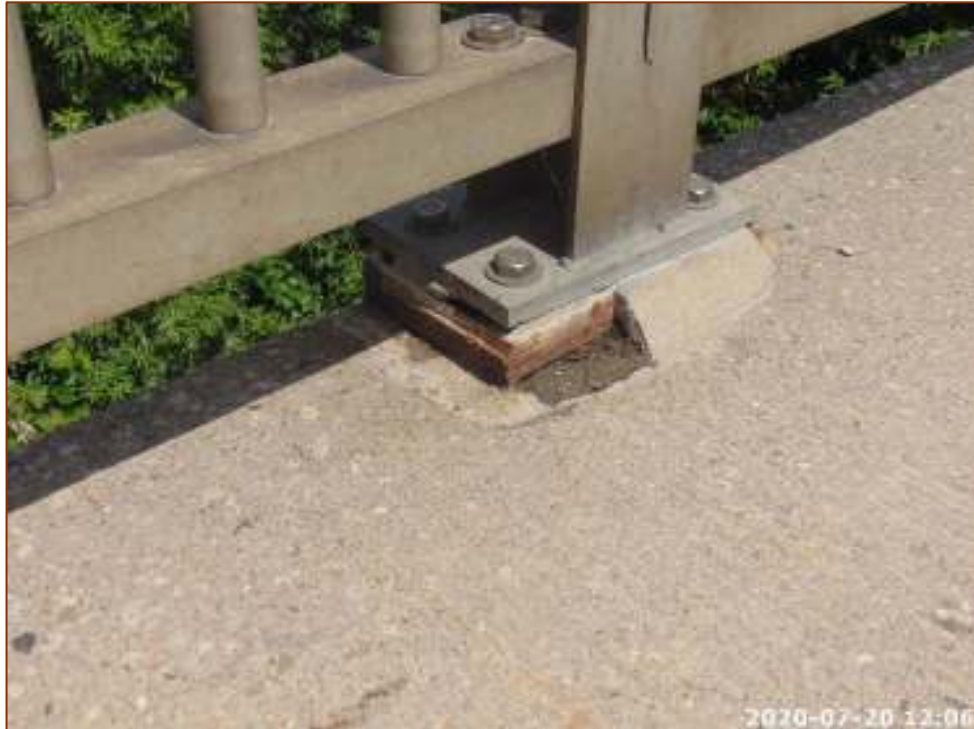
*Photo 11 – Exterior Barrier Wall, Spall on Pedestal (Typ)*

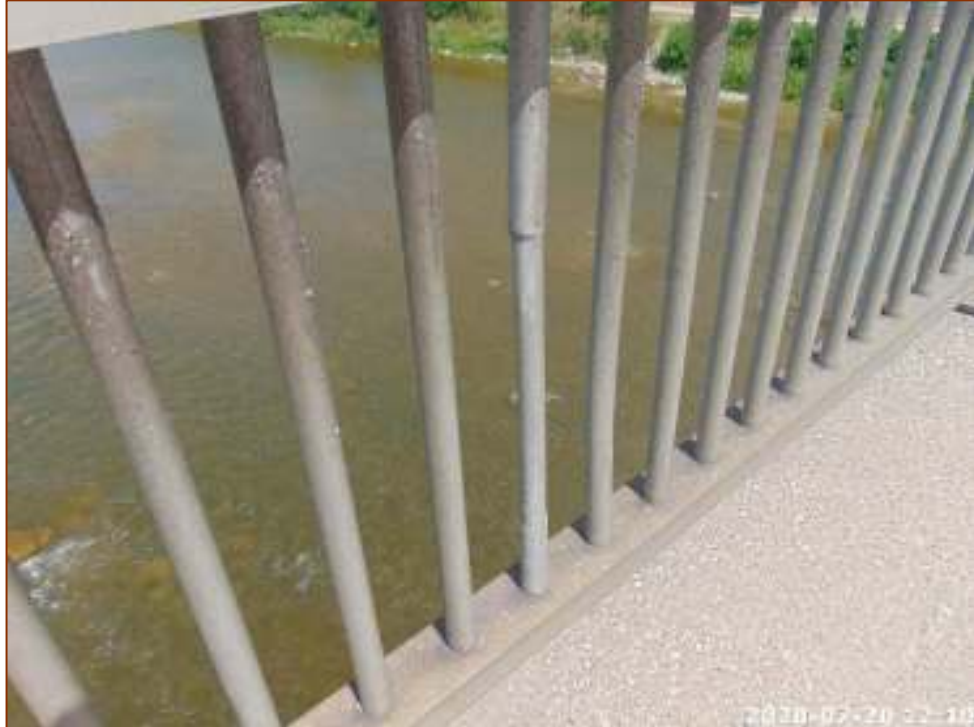
*Photo 13 – North Exterior Railing, Typical Spindle Repair*

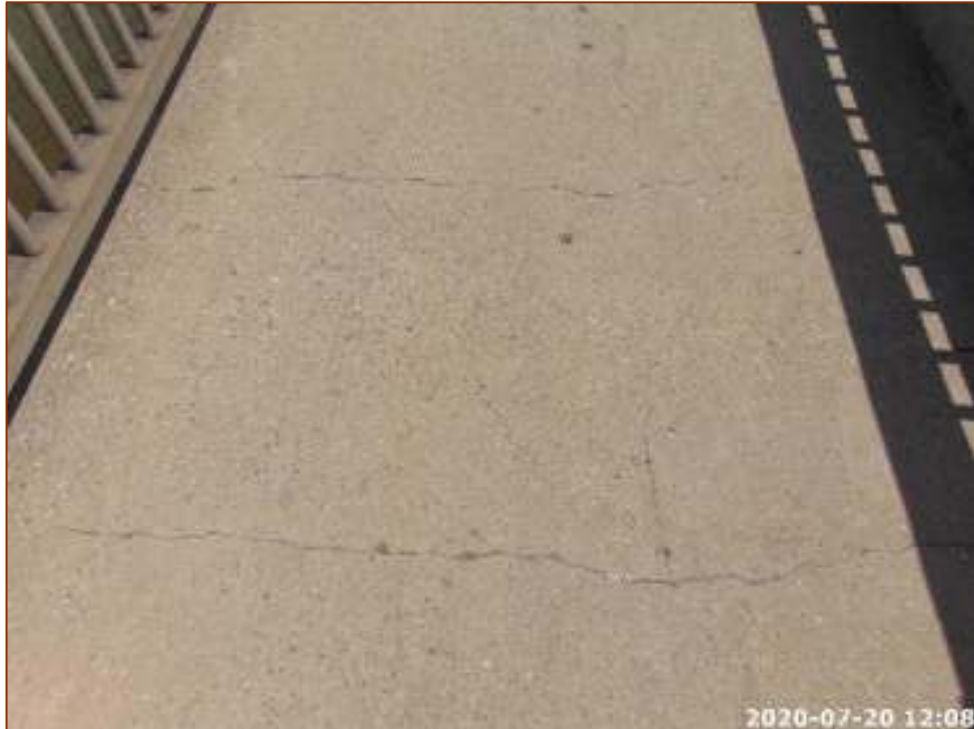
*Photo 15 – North Sidewalk, Wide Transverse Cracks(Typ)*

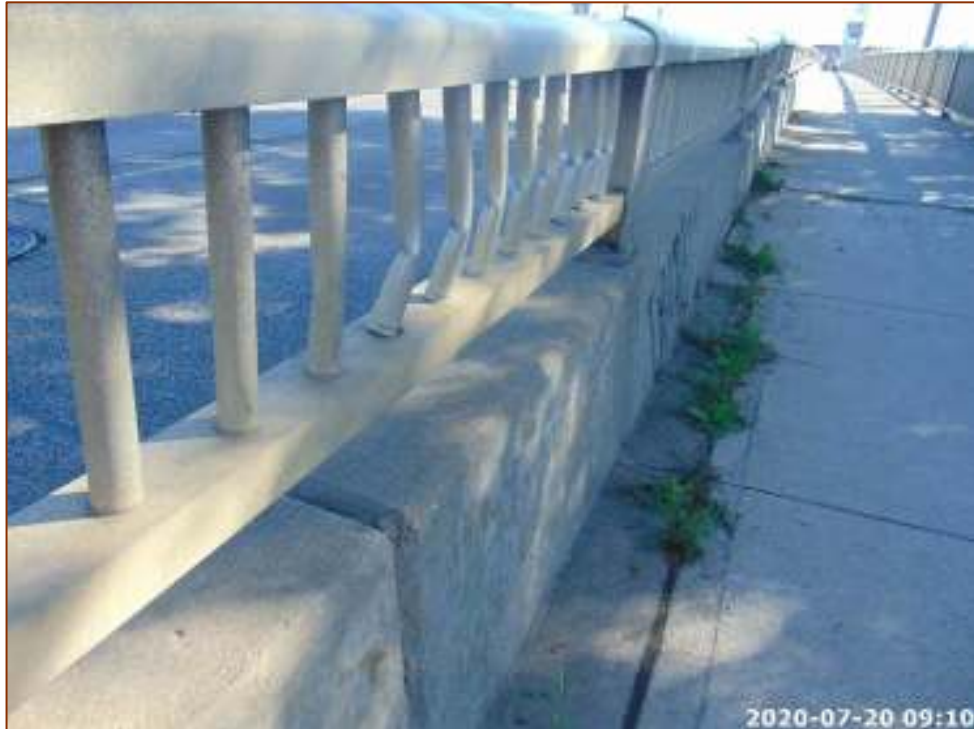
*Photo 17 – Interior Barrier Wall Railing, SW Approach, Impact Damage*

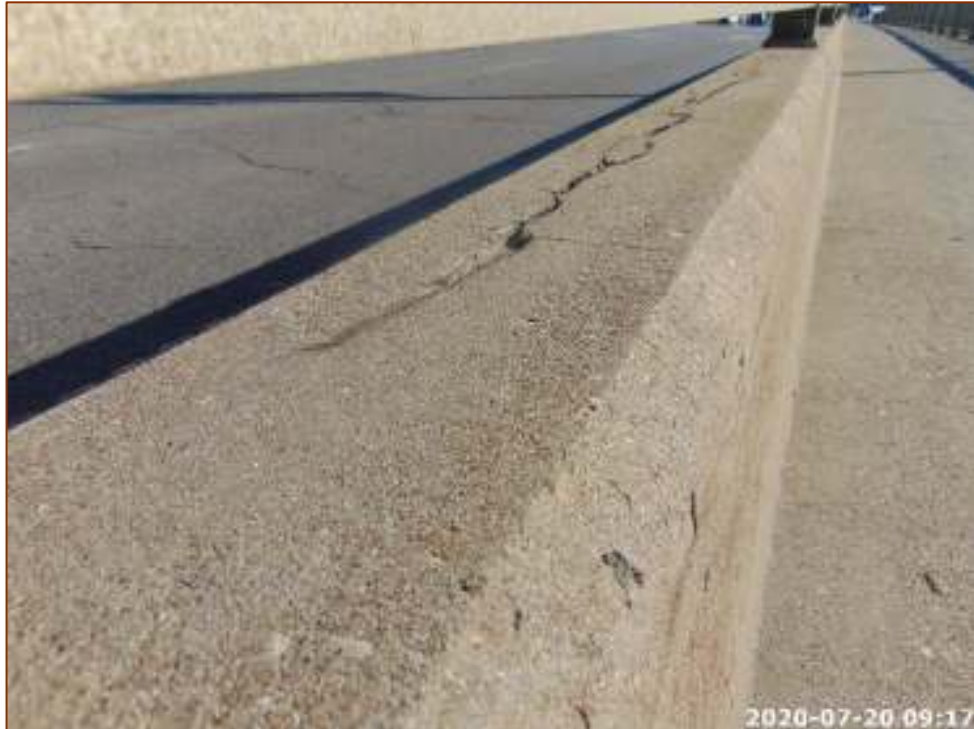
*Photo 19 – South Interior Barrier Wall, Wide Horizontal & Vertical Stained Cracks, Delaminations and Spalls*

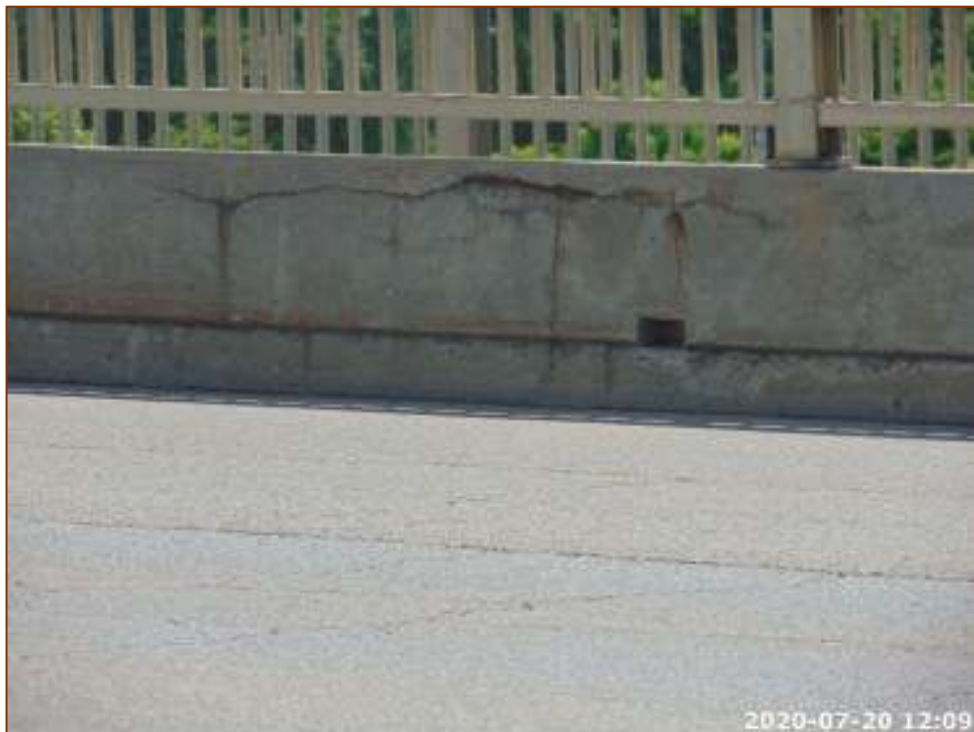
*Photo 20 – South Interior Barrier Wall, Inter Face, Wide Horizontal & Vertical Stained Cracks, Delaminations and Spalls*

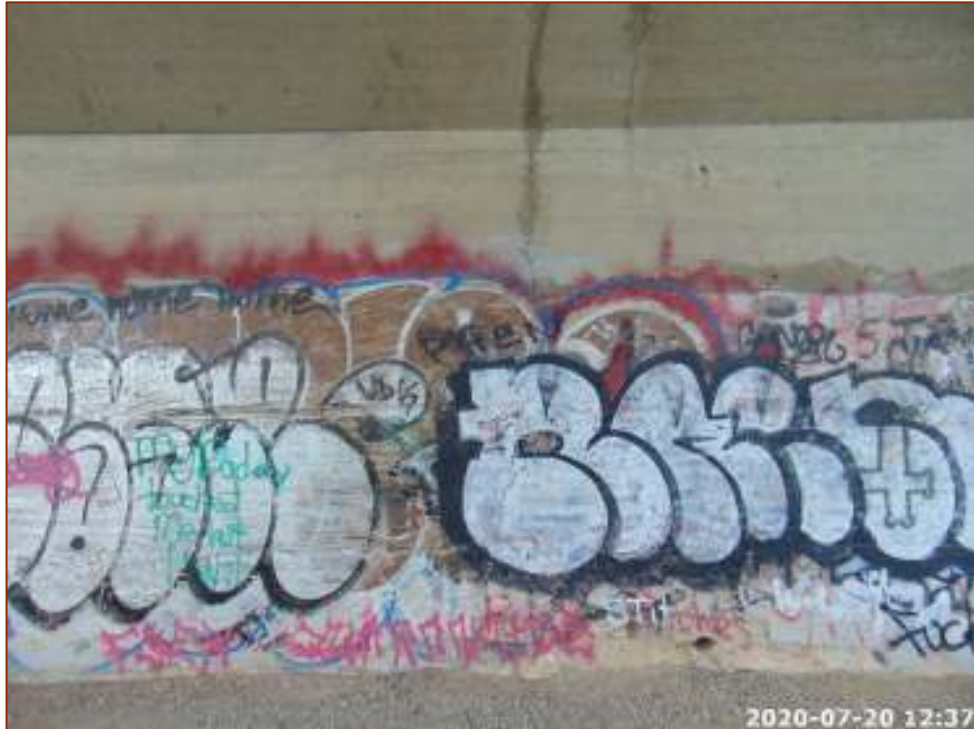
*Photo 23 - East Abutment, Wide Vertical Crack, Full Height*

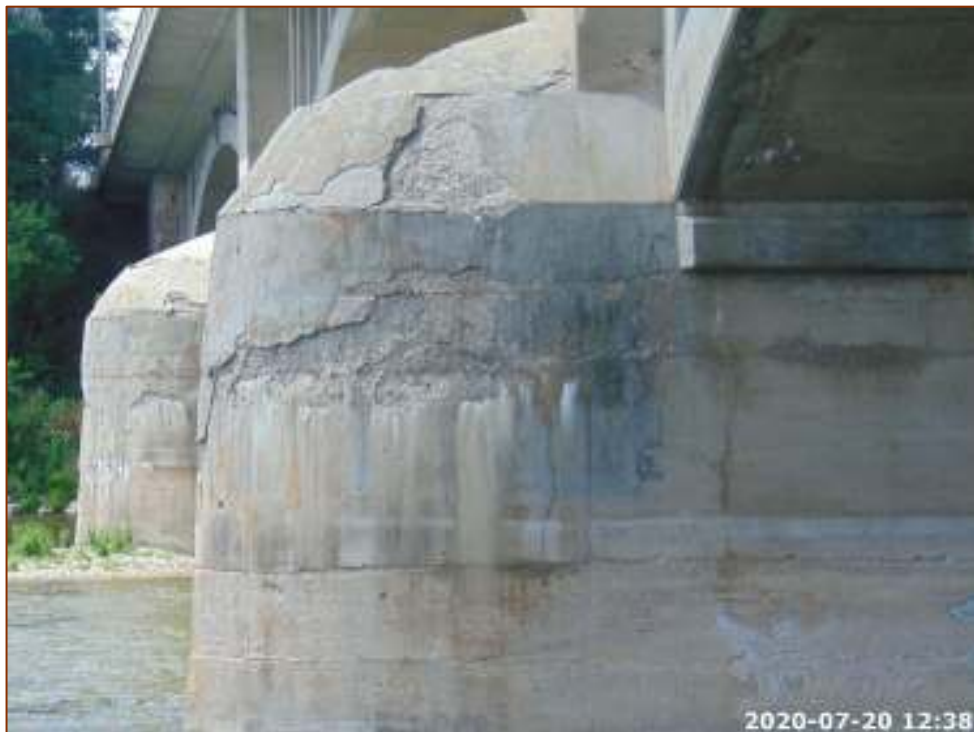
*Photo 24 - East Pier, Severe Scaling & Erosion, Cracks with Efflorescence*

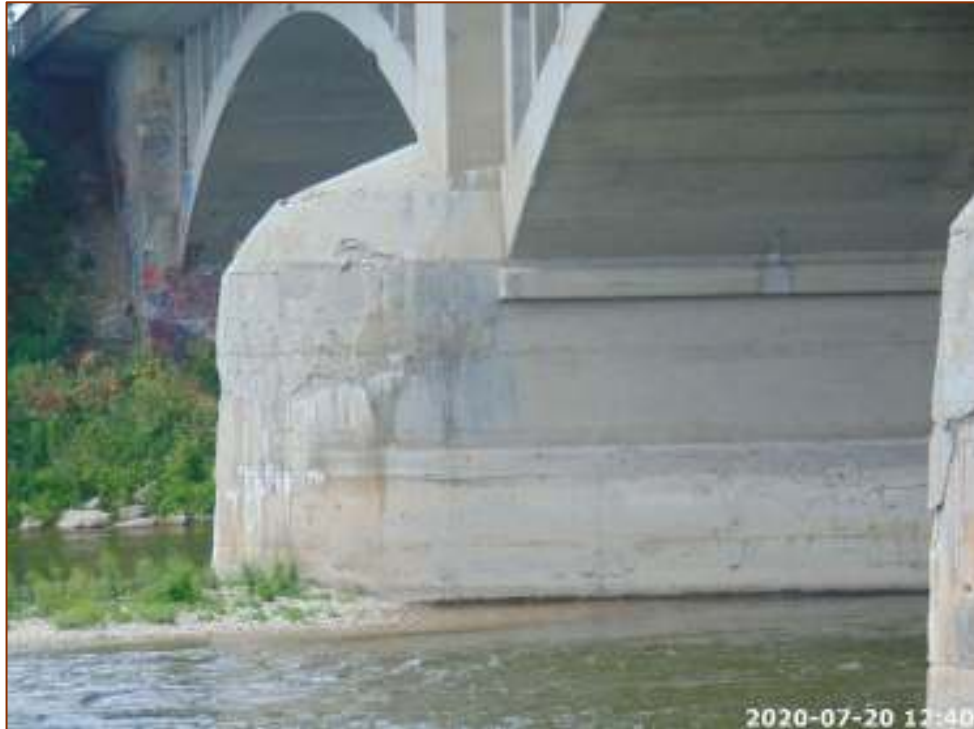
*Photo 25 - West Pier, Severe Scaling & Erosion, Cracks with Efflorescence*

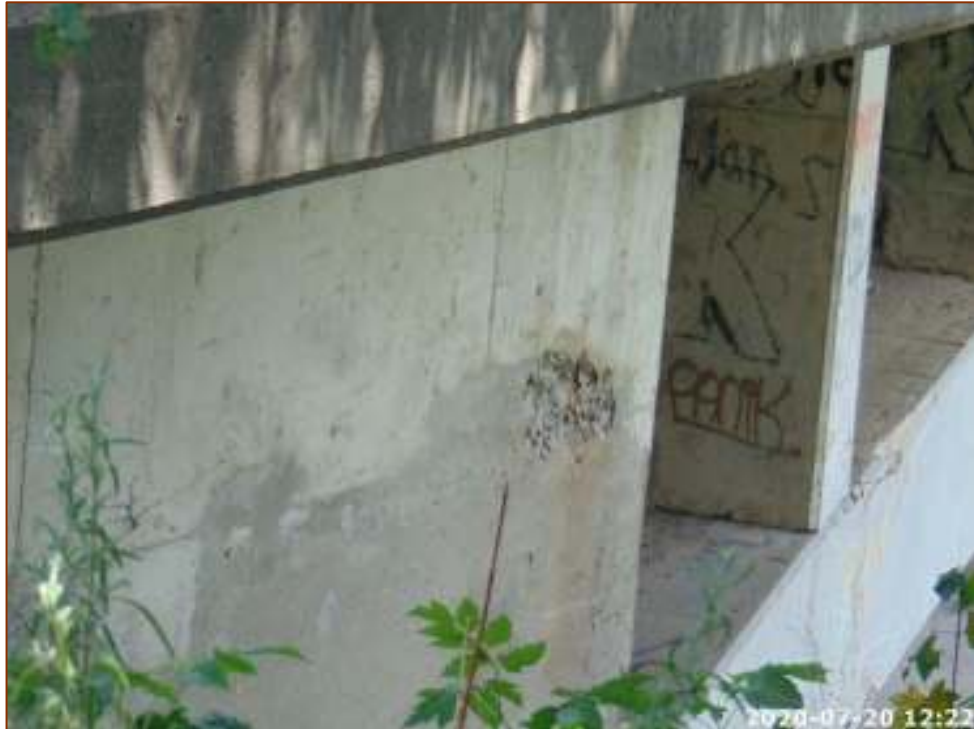
*Photo 27 - 27. SW Wingwall, Spall with Exposed Rebar*

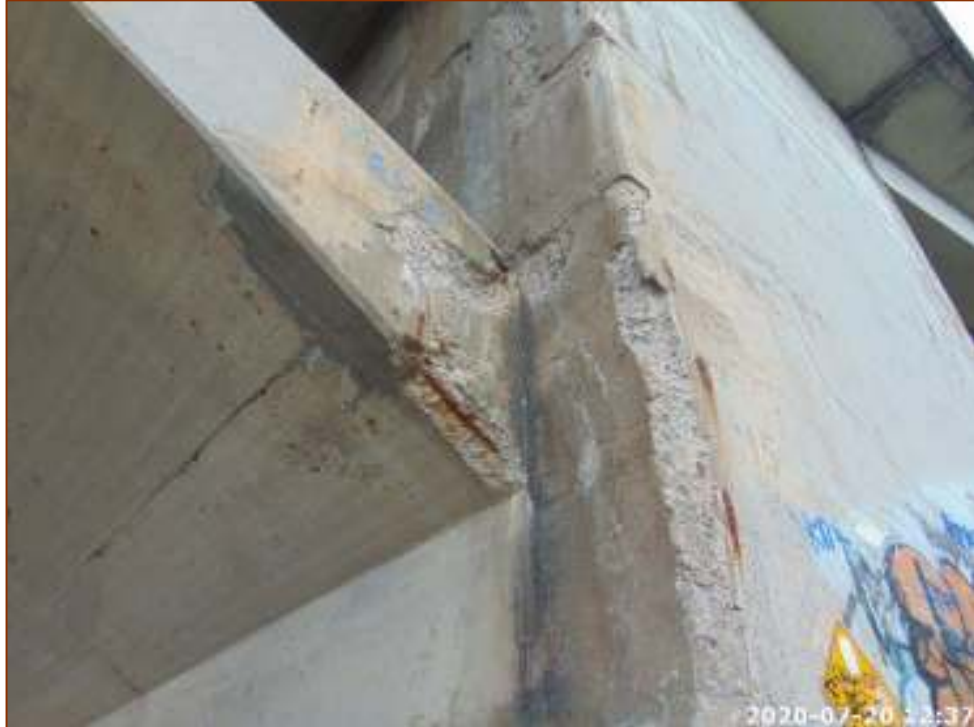
*Photo 29 - Arch Rib, Bottom Face, & East Abutment, SE Corner, Spalls*

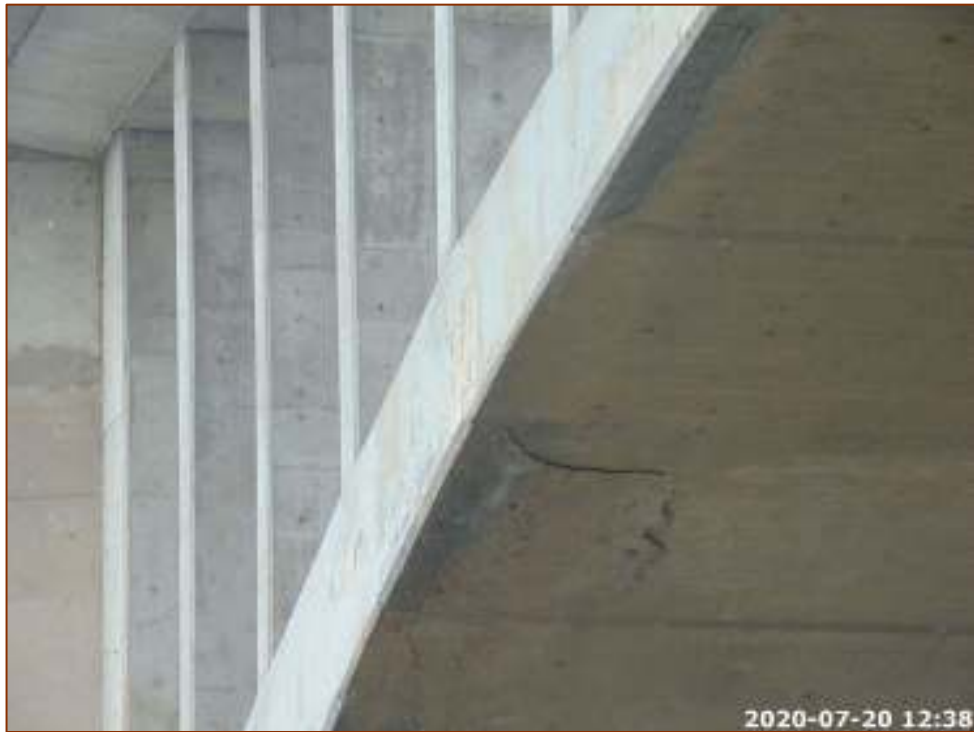
*Photo 30 - Arch Rib, Bottom Face, Middle Span, Delaminations*

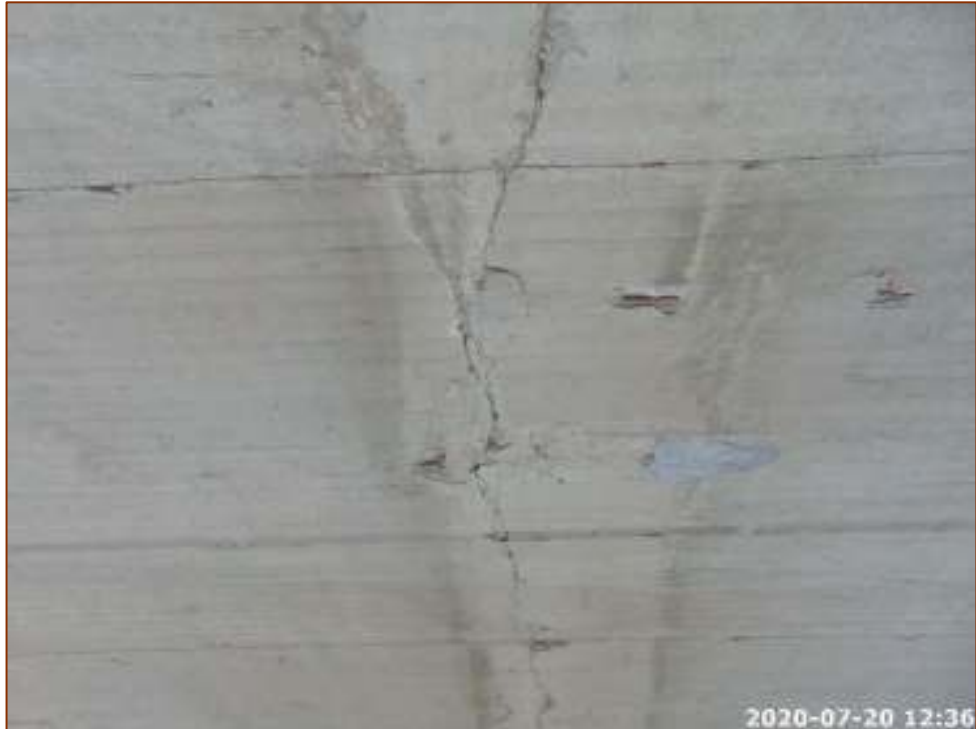
*Photo 31 - Arch Rib, Bottom Face, East Span, Wide Longitudinal Crack*

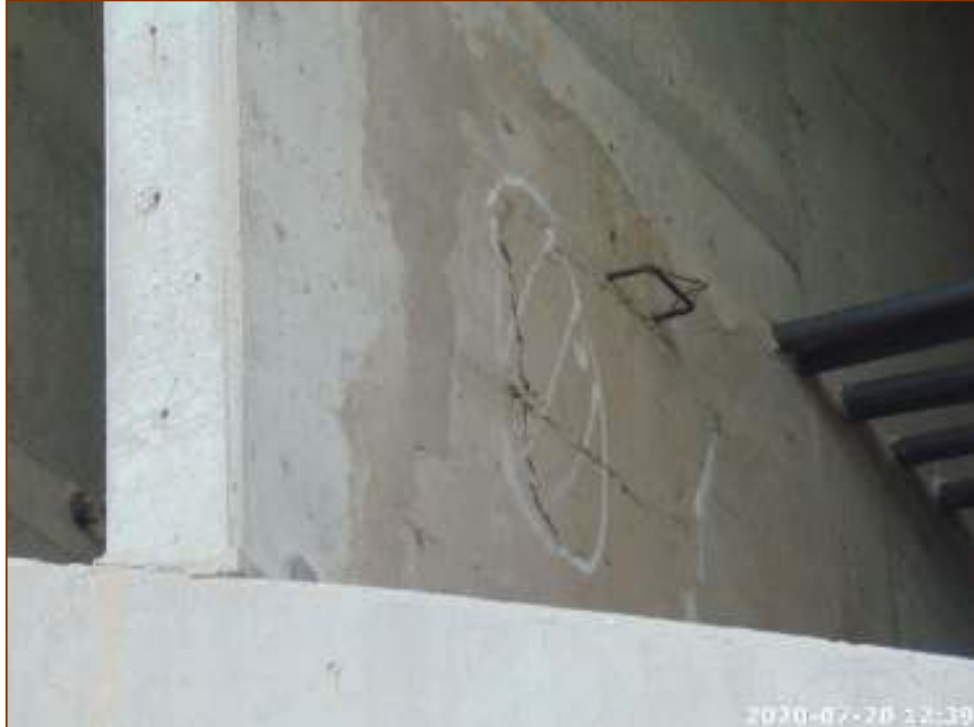
*Photo 33 - Spandrel Column, 2nd from East, SE Corner, Delamination*

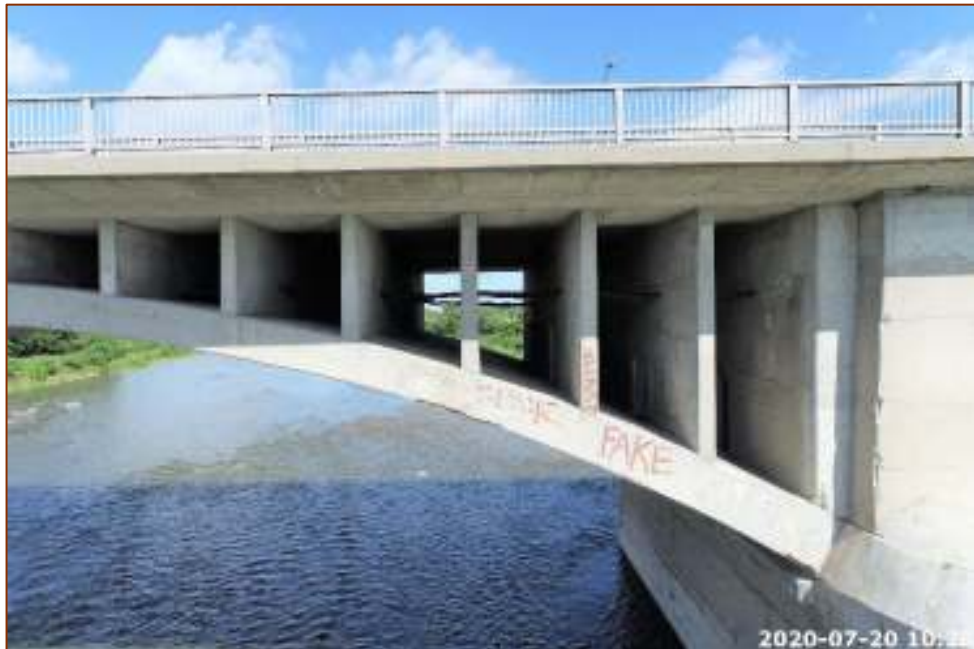
*Photo 34 - Centre Span, South Face of Bottom Chord, Spalls & Delaminations*

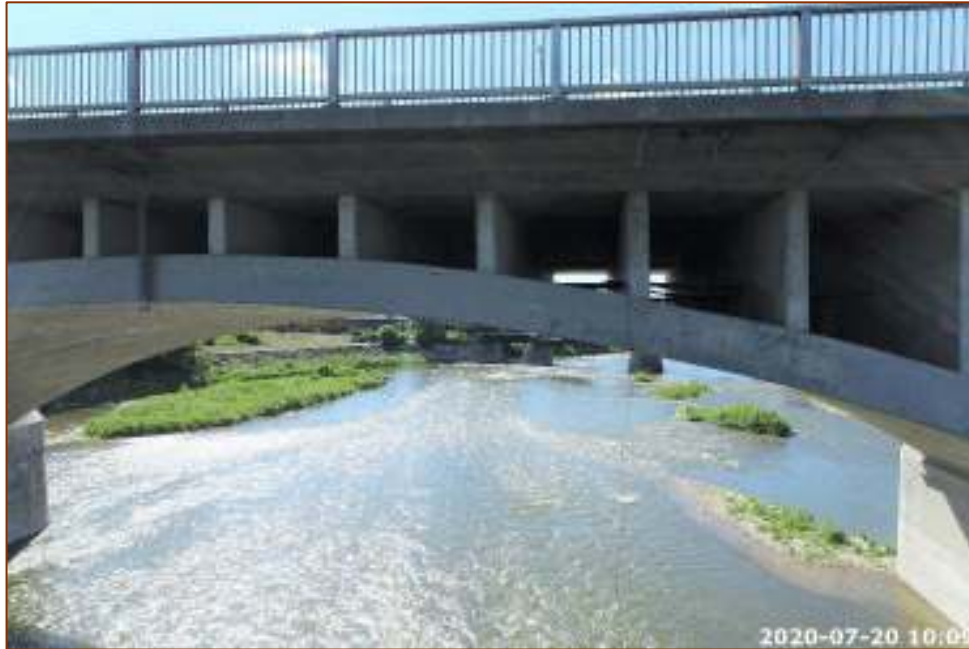
*Photo 35 - Centre Span, Wide Cracks & Suspected Delamination of Bottom Chord, Top & North Face*

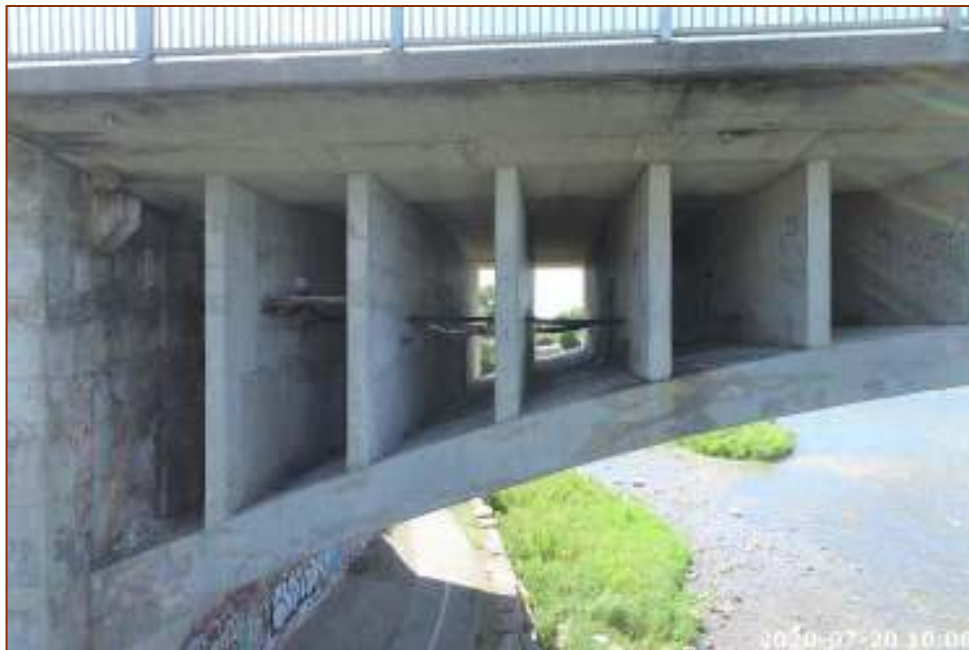
*Photo 36 - East Span, Delamination on West Face of 1st Spandrel, Spalls on West Face of 2nd Spandrel*

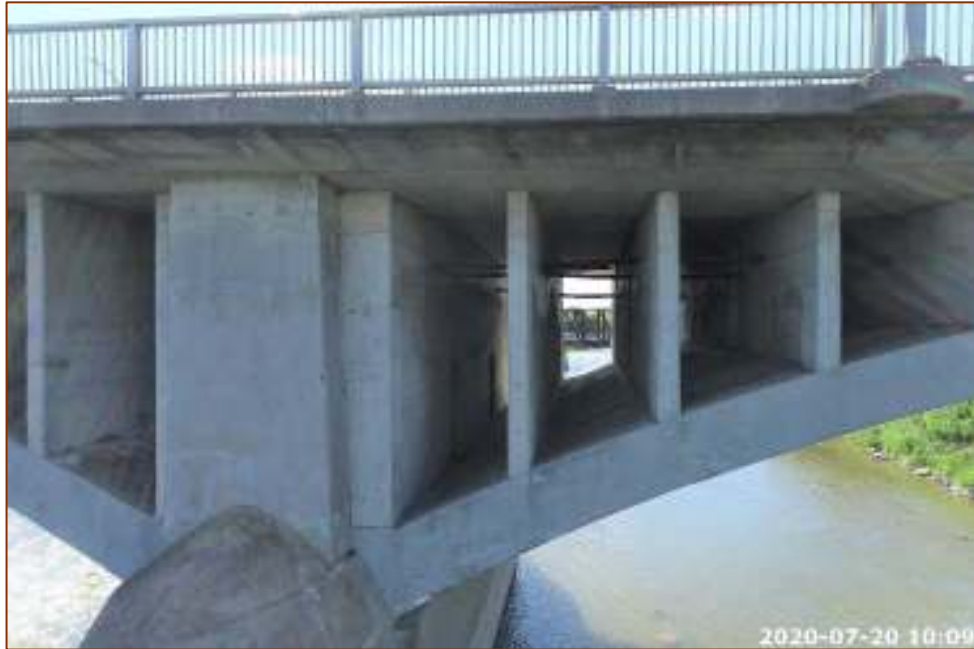
*Photo 37 - West Span, Cracks & Suspected Delamination of Bottom Chord, North Face*

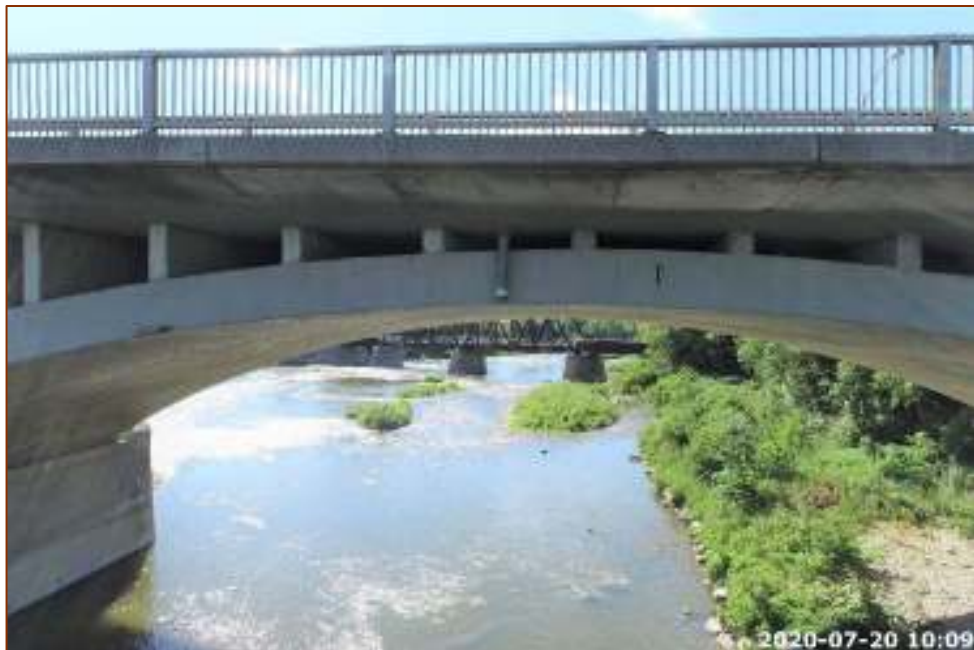
*Photo 38 - West Span, Delamination on North Face of Bottom Chord & North Face of Centre Spandrel*

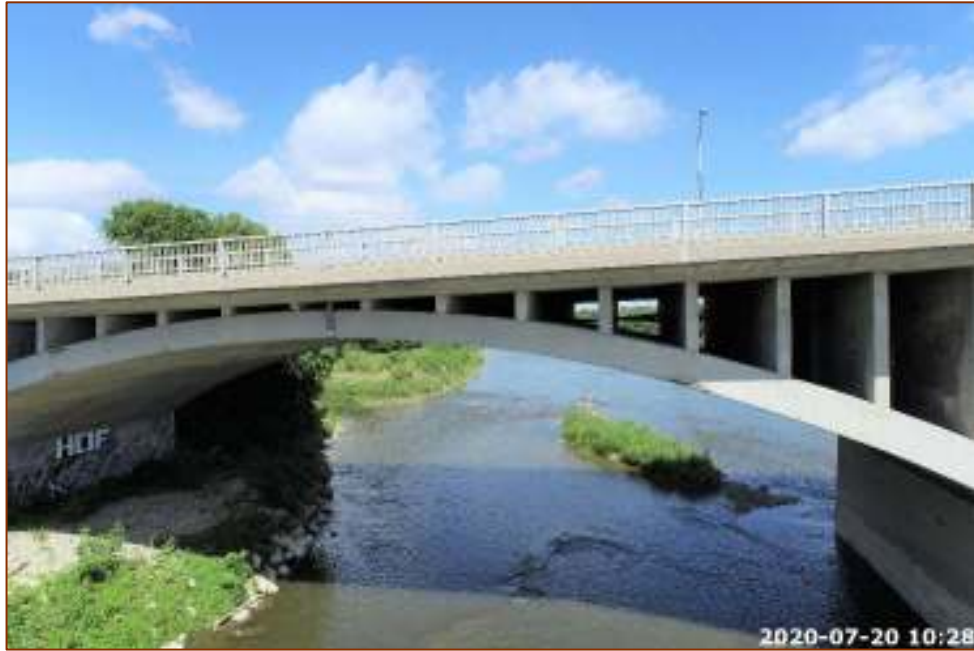
*Photo 39 - West Span, Spalls with Exposed Rebar & Delamination of Bottom Chord, S Face, & Centre 3 Spandrels*

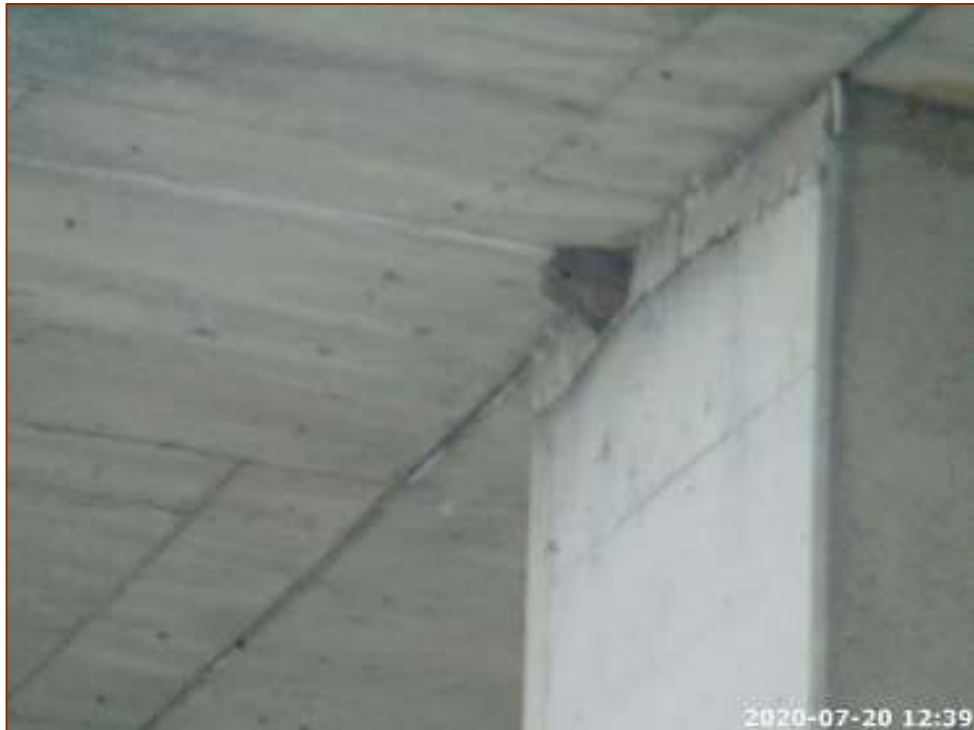
*Photo 40 - Bird Nest, East Pier, South Face*

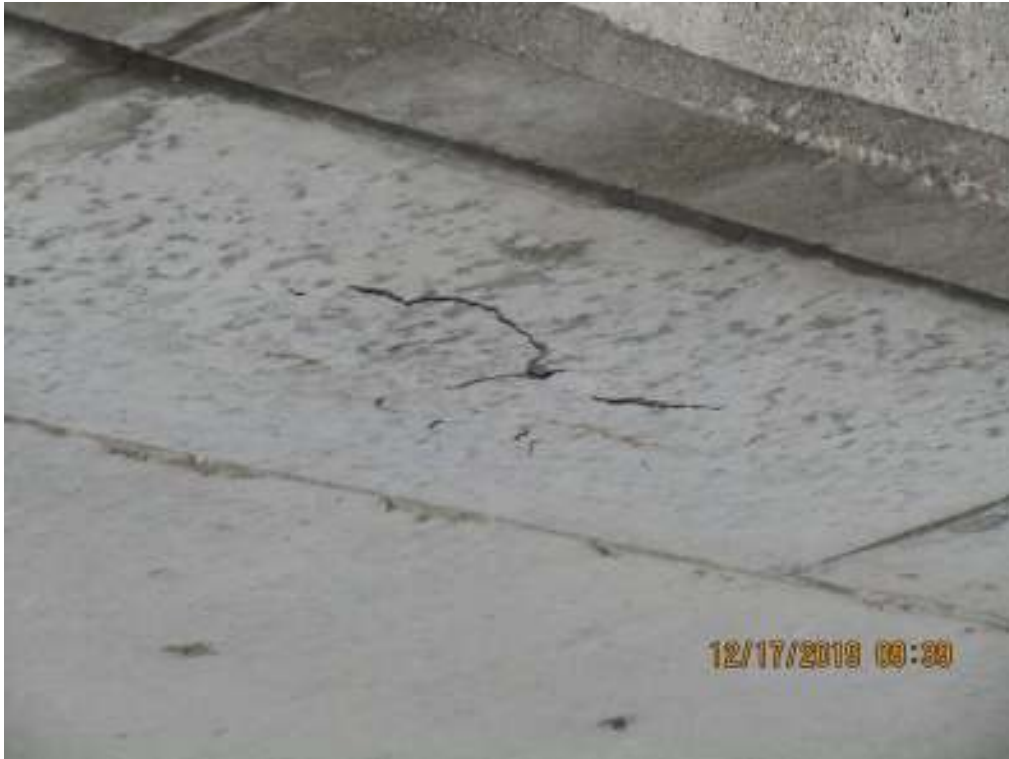
19 Delamination on north exterior soffit

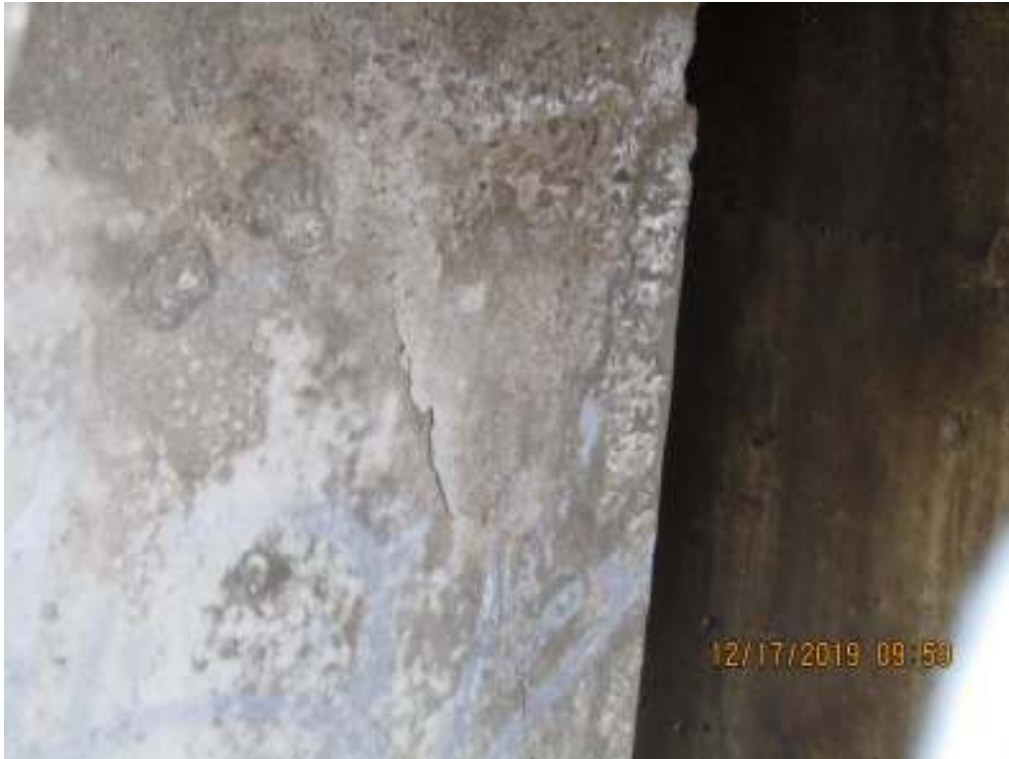
25 Delamination on south exterior girder end

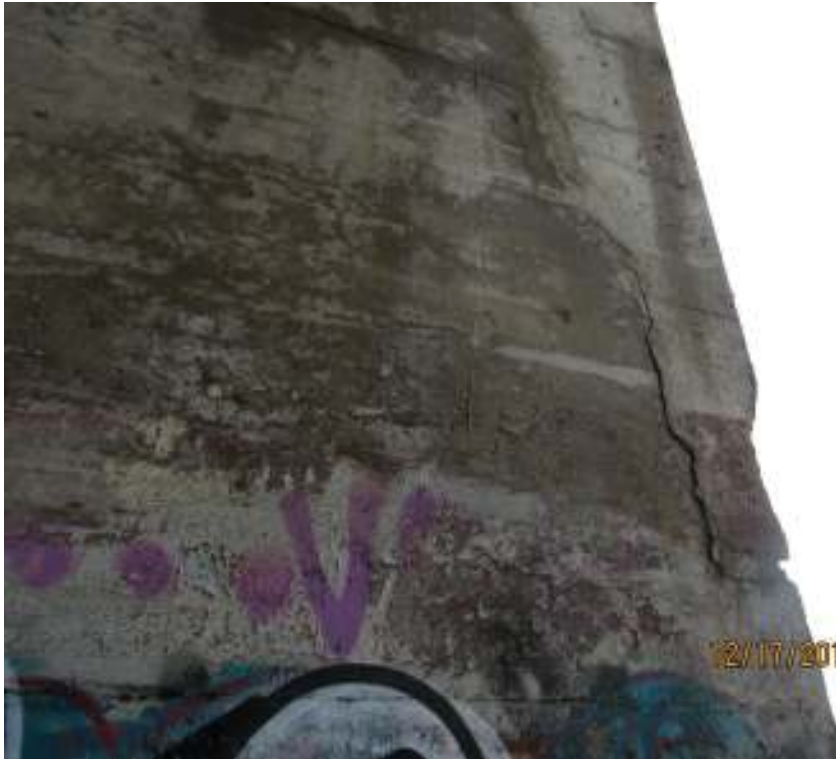
35 Delamination on west abutment at north side

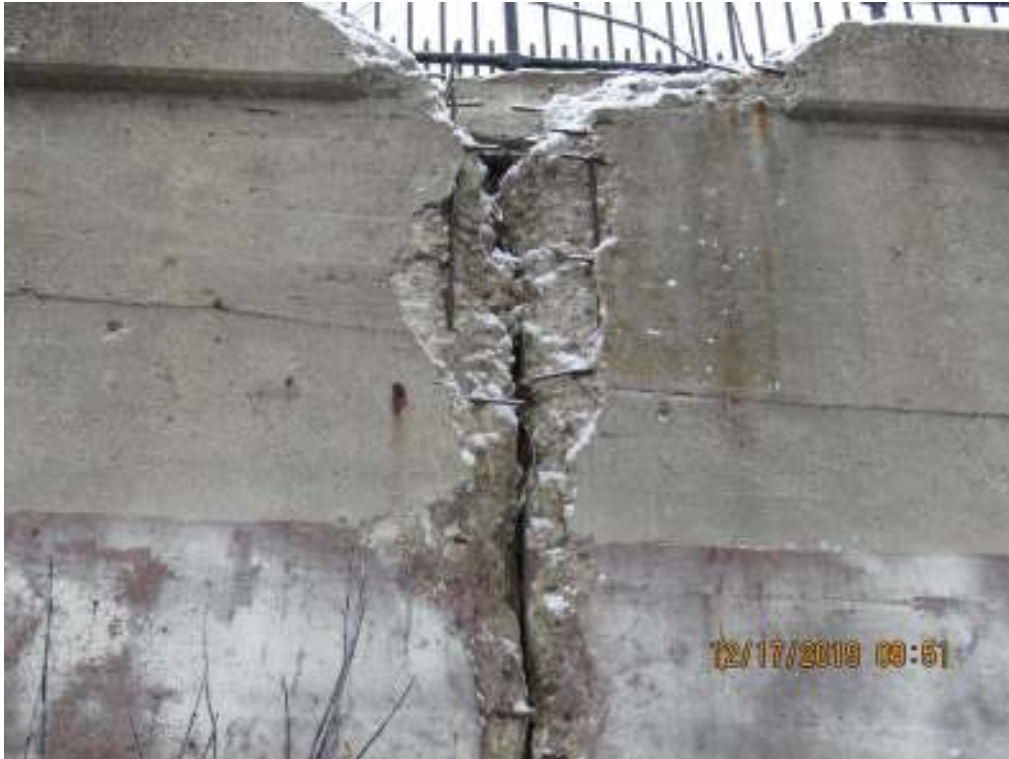
47 Typical section loss with exposed rebar on east retaining wall

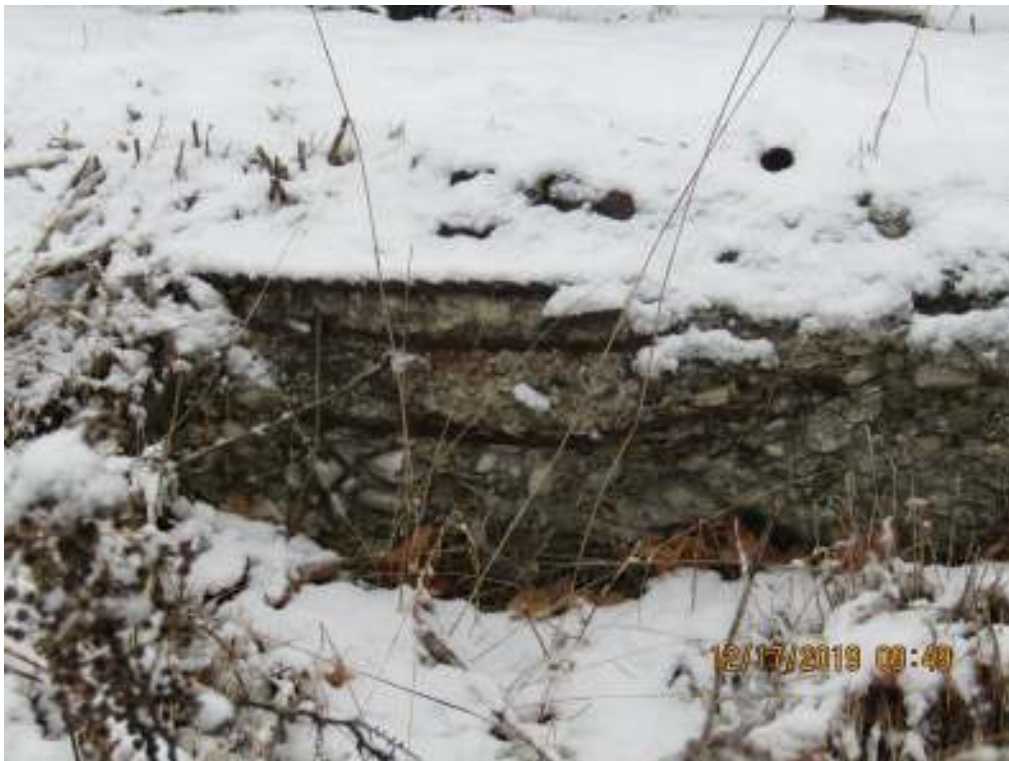
48 Typical section loss with exposed rebar on east retaining wall

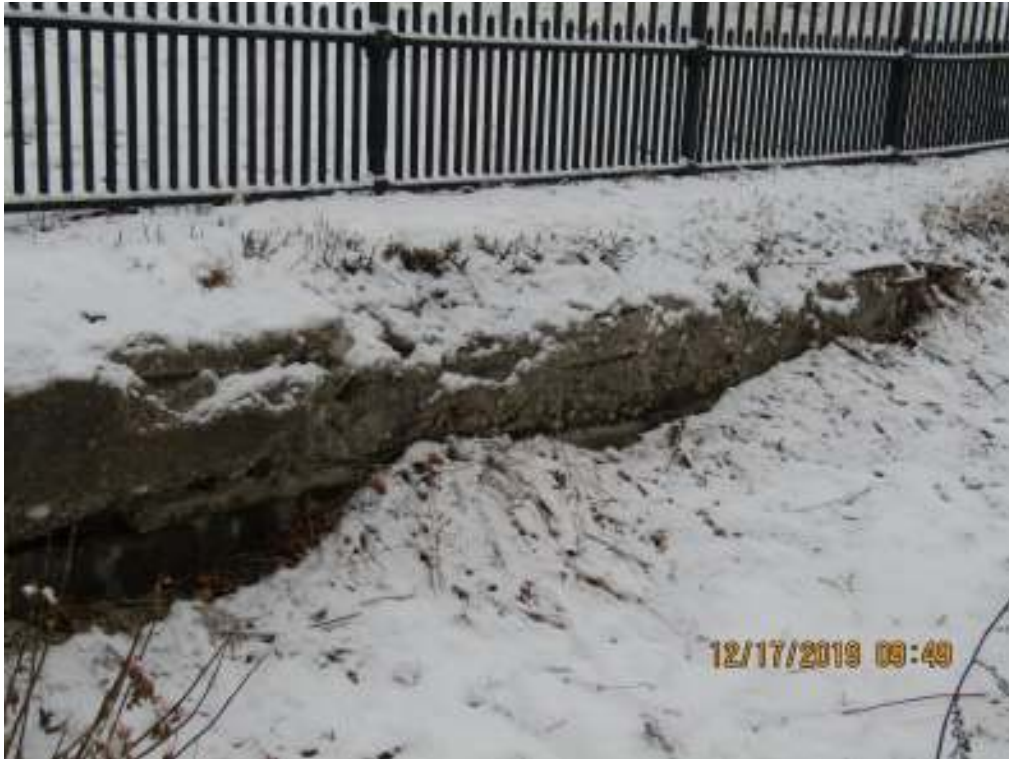
49 Typical section loss with exposed rebar on east retaining wall

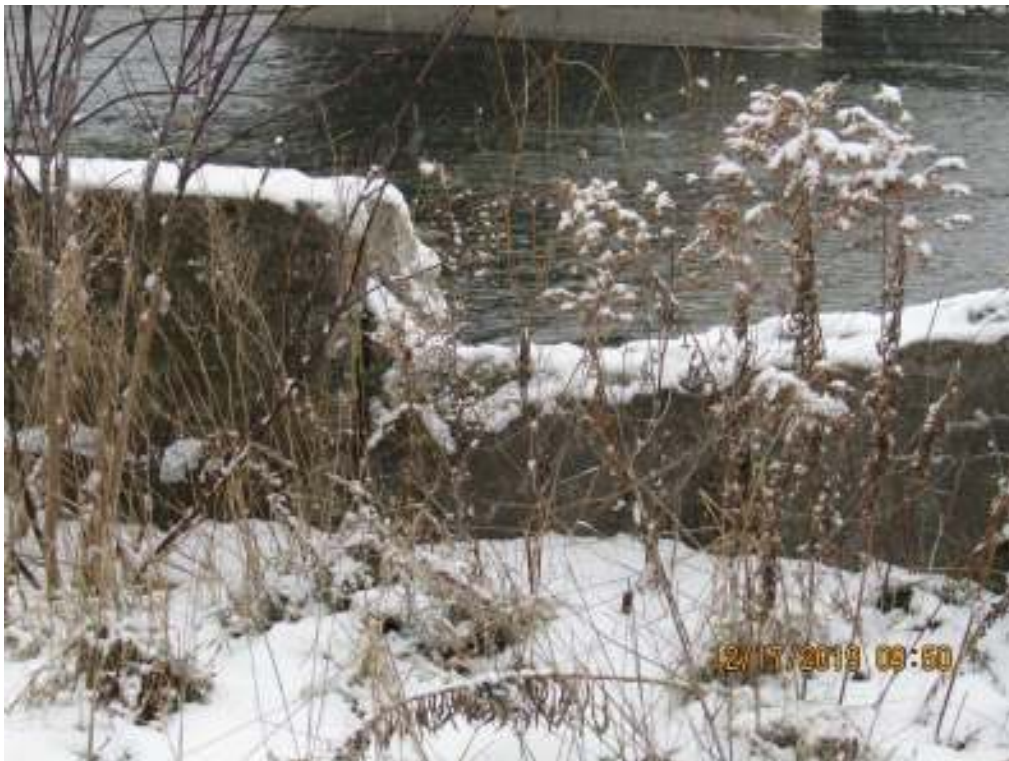
50 Typical section loss with exposed rebar on west retaining wall

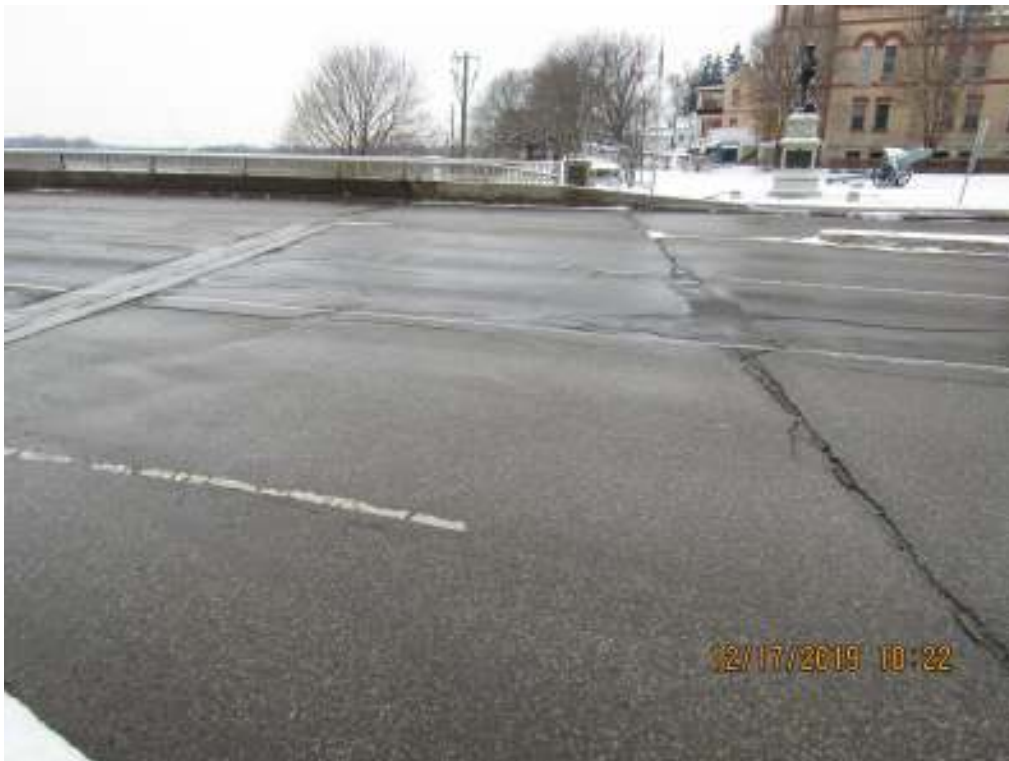
66 East approach slab

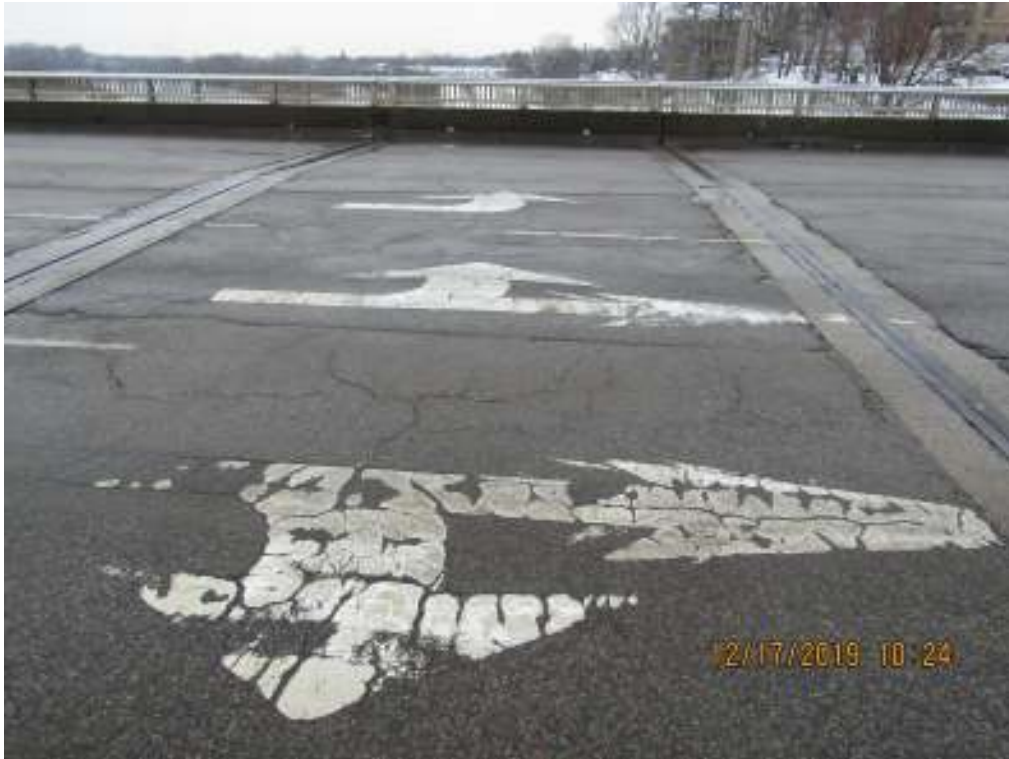
67 West approach slab

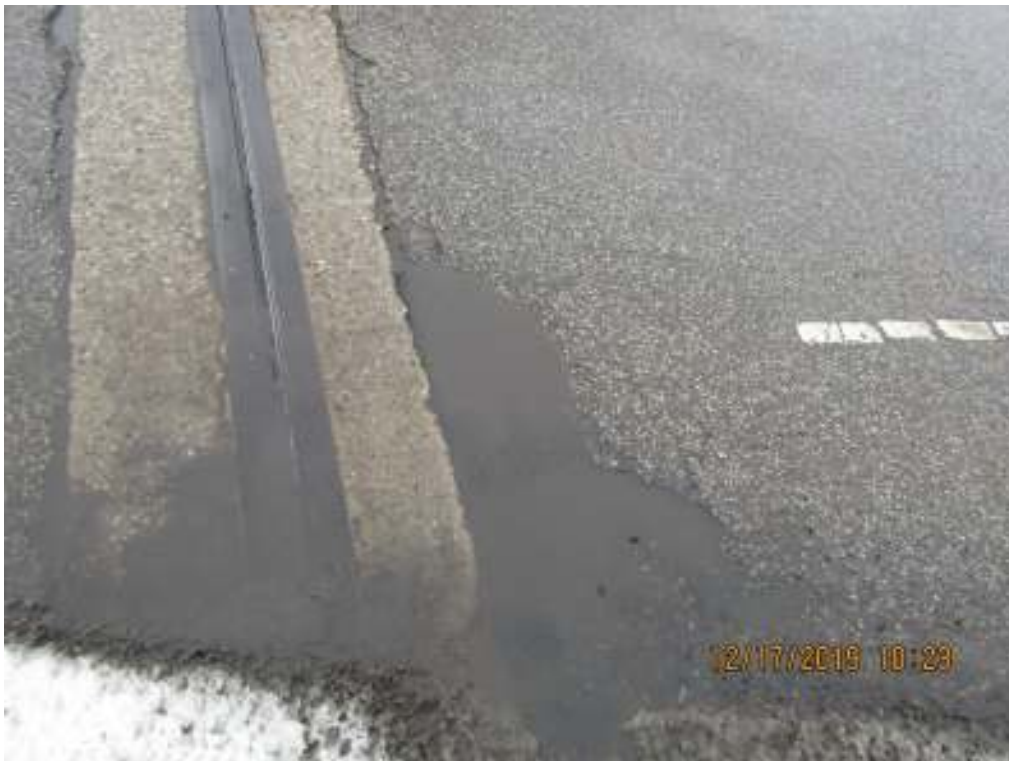
70 Pothole on east approach slab next to expansion joint

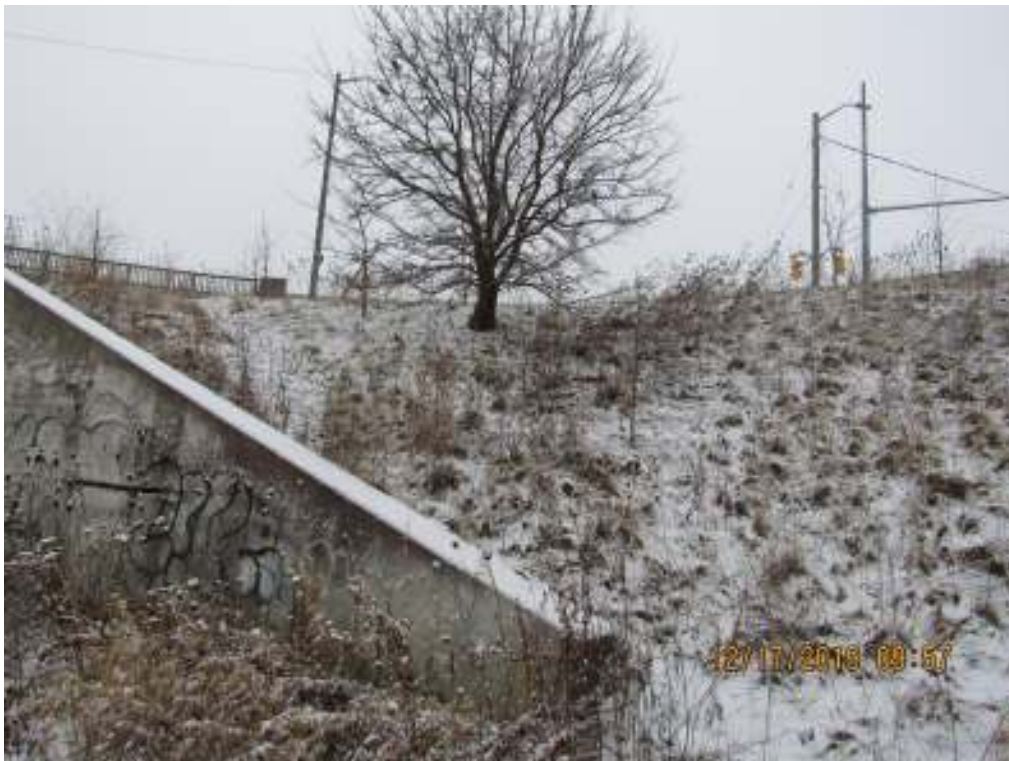
74 South east embankment
