City of Brantford

# Lorne Bridge (Structures 117, 131, 132) Structural Evaluation Report

**GMBP File: 119104**  
**May 2021**

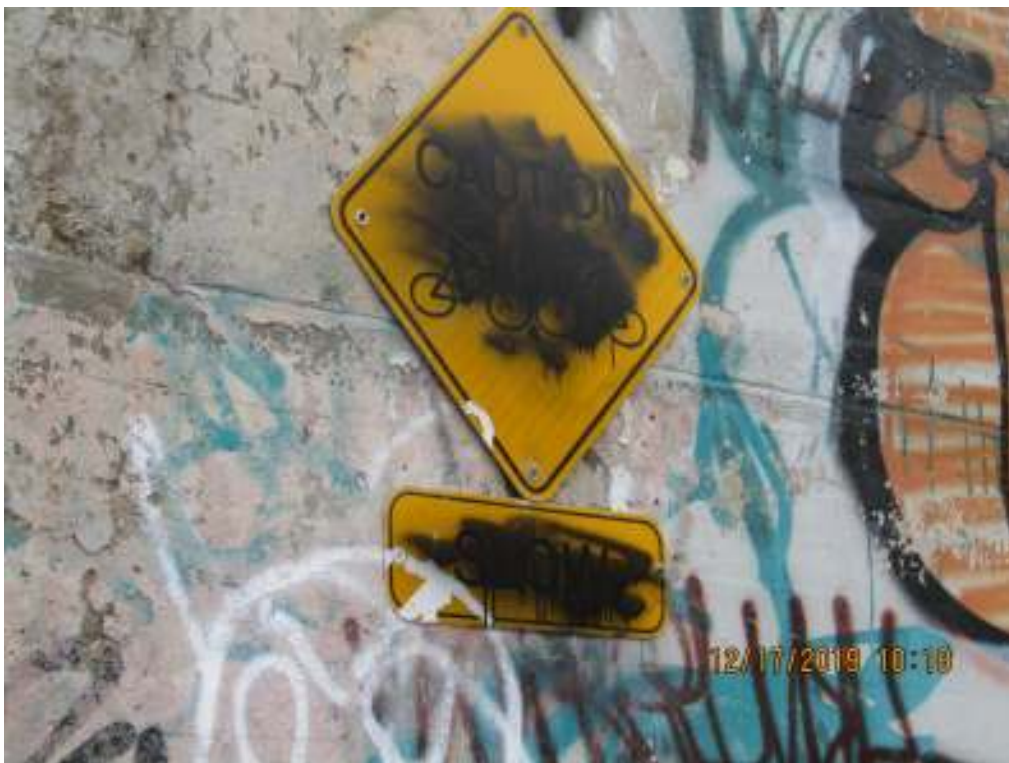
76 Sign on bridge

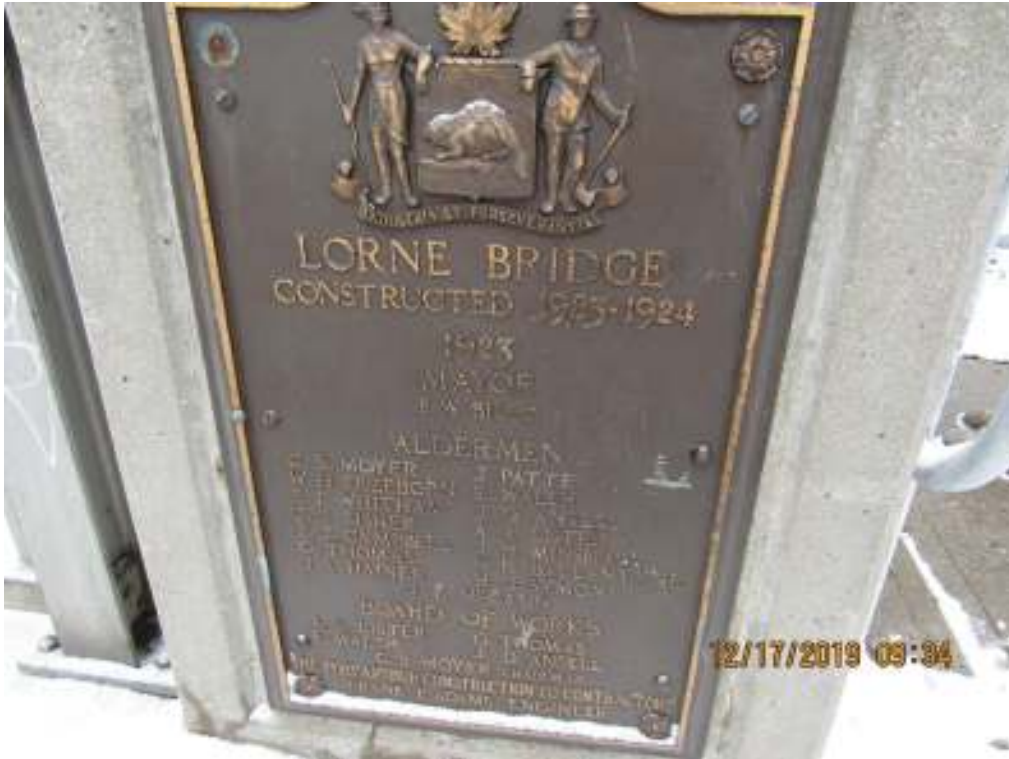
77 Plaque on Bridge

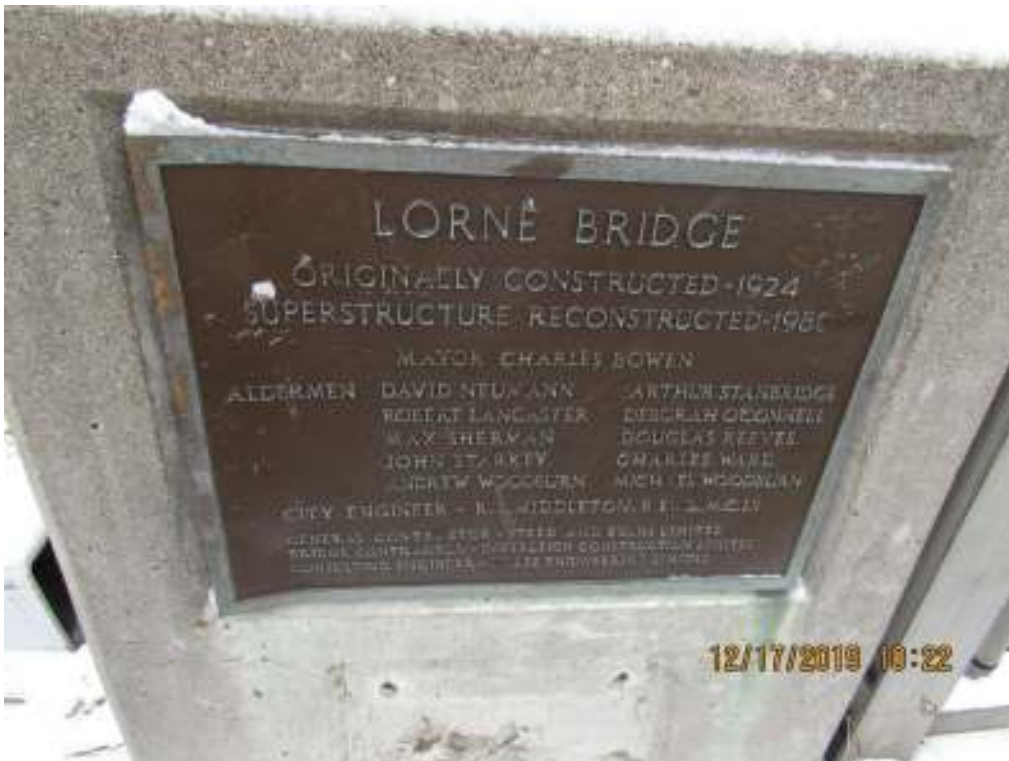
78 Plaque on bridge

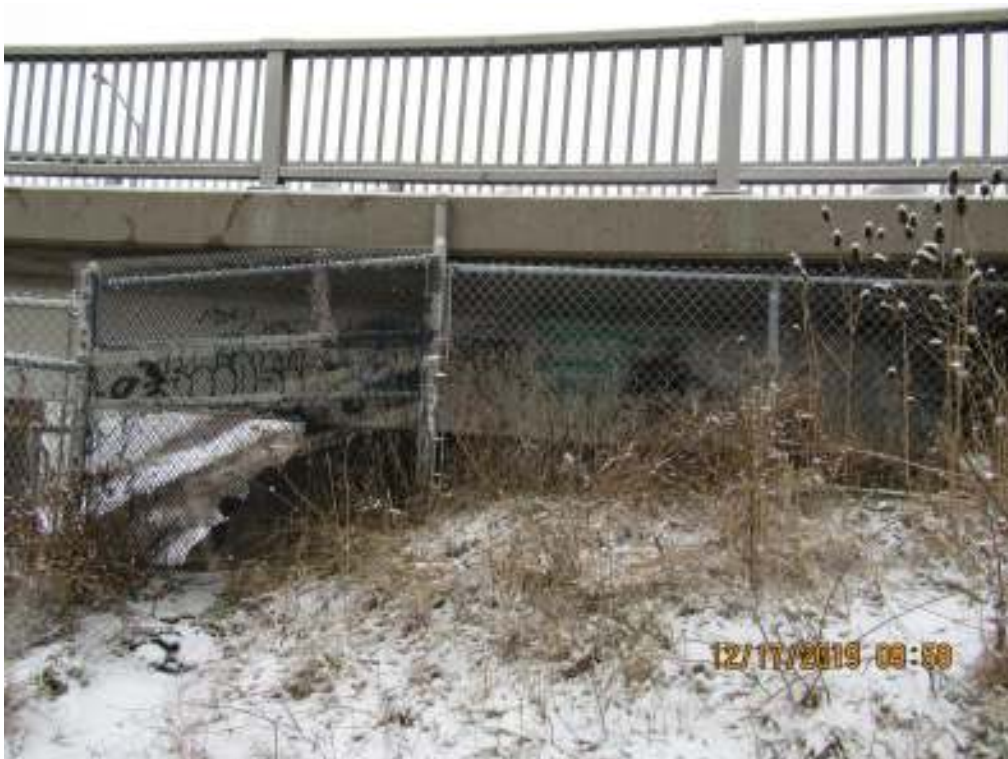
80 Chain link fence at south side

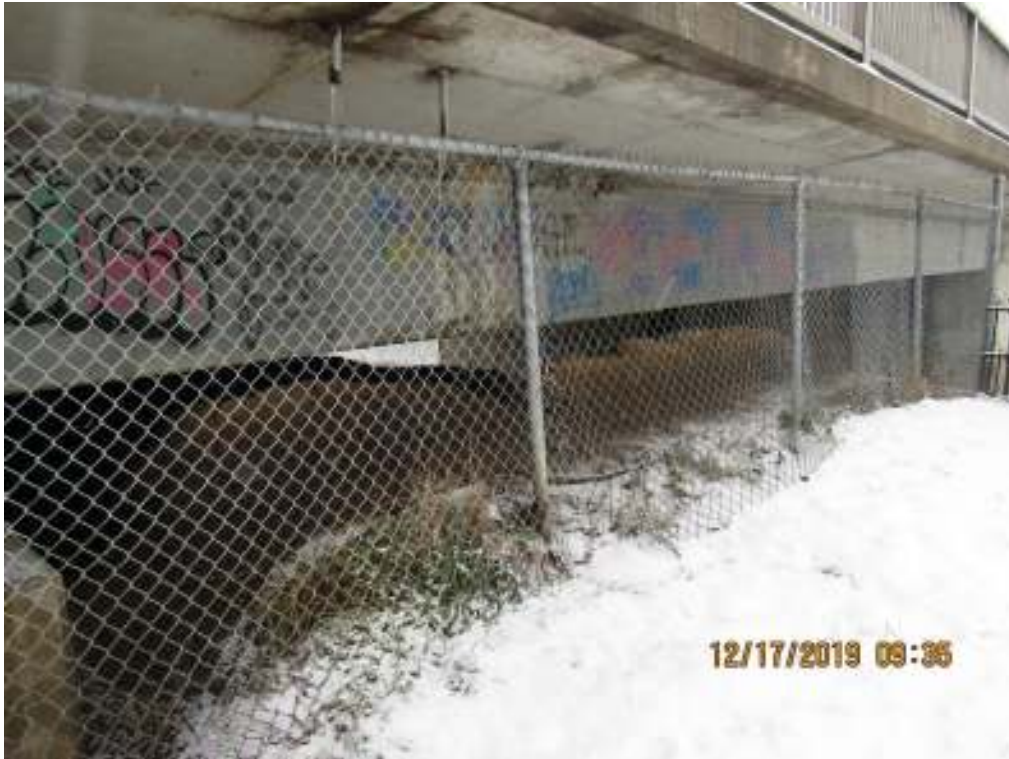
81 Chain link fence at north east end

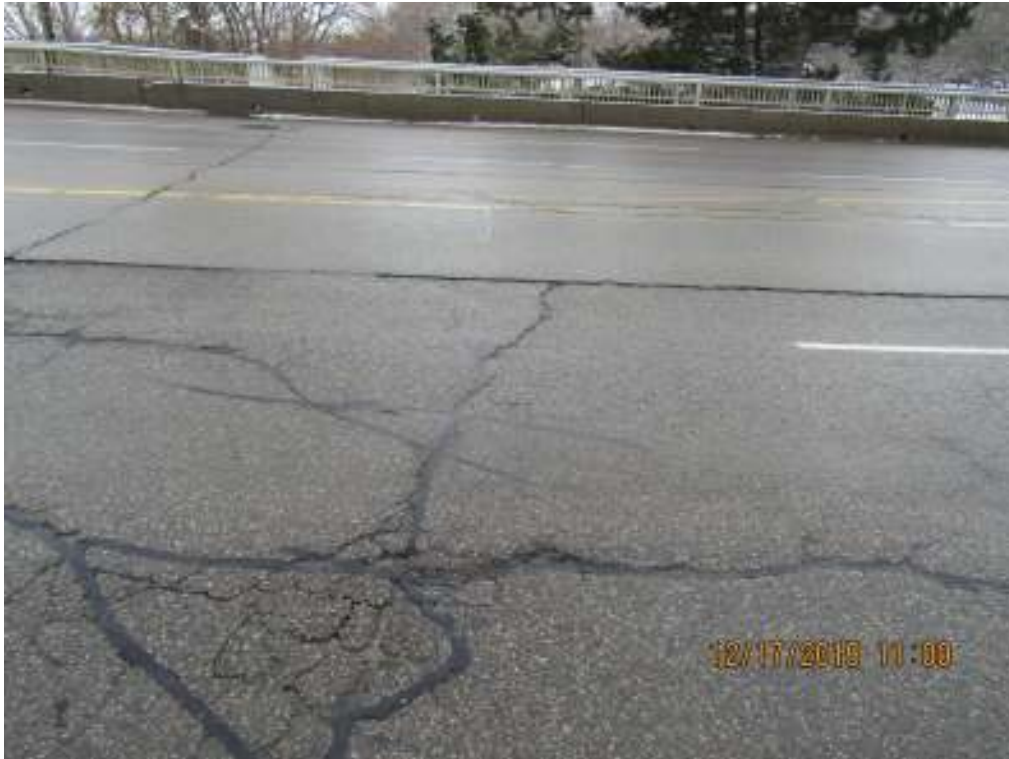
03 Roadway at top of culvert looking south

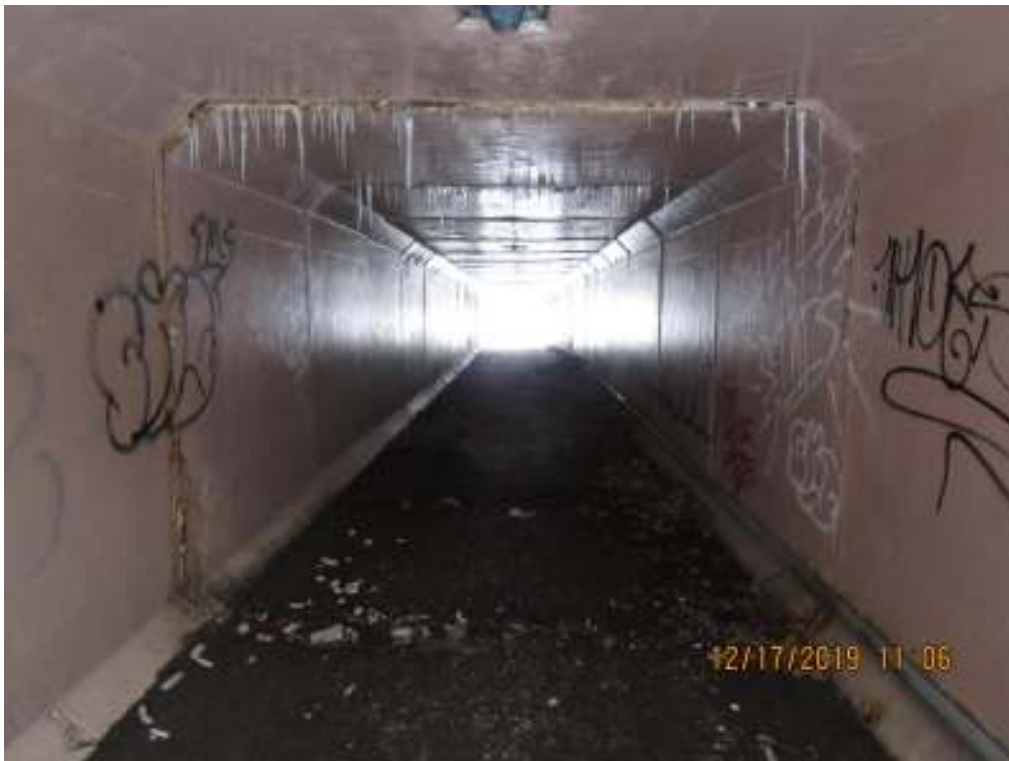
06 Barrel, looking south

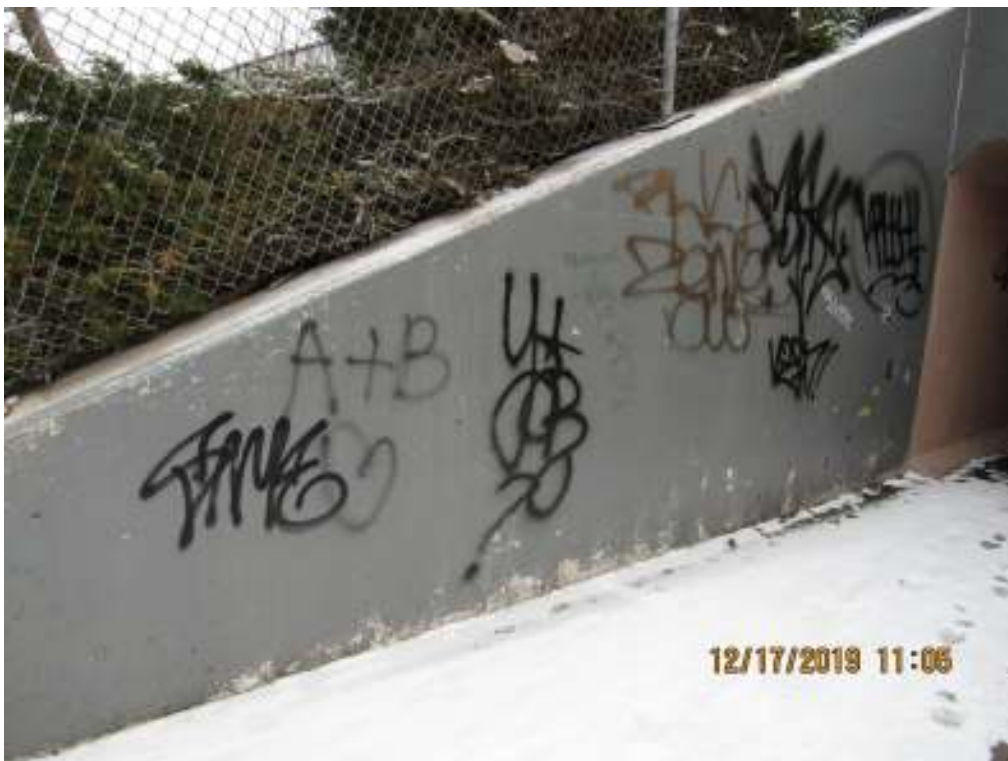
16 North east retaining wall

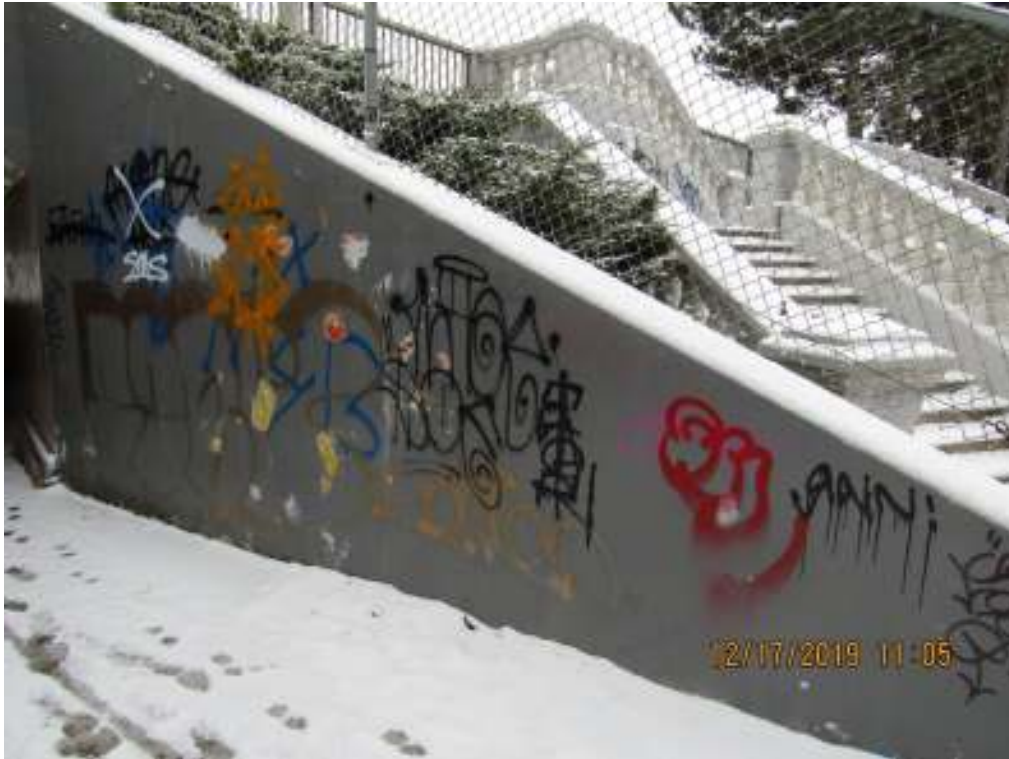
17 North west retaining wall

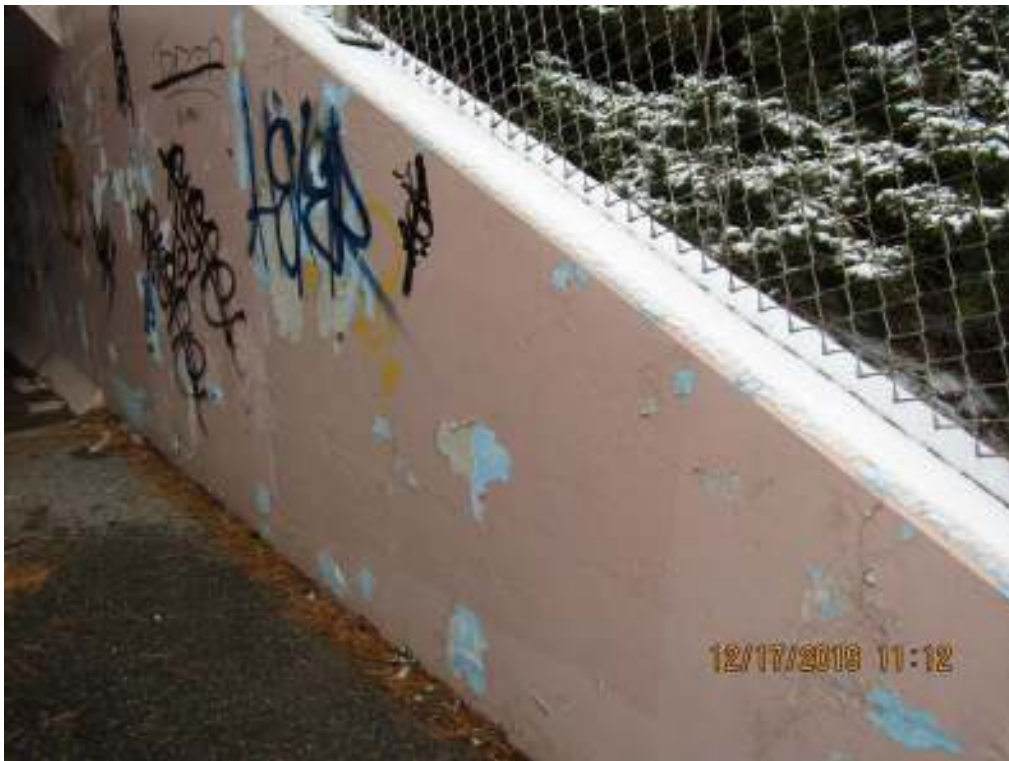
18 South east retaining wall

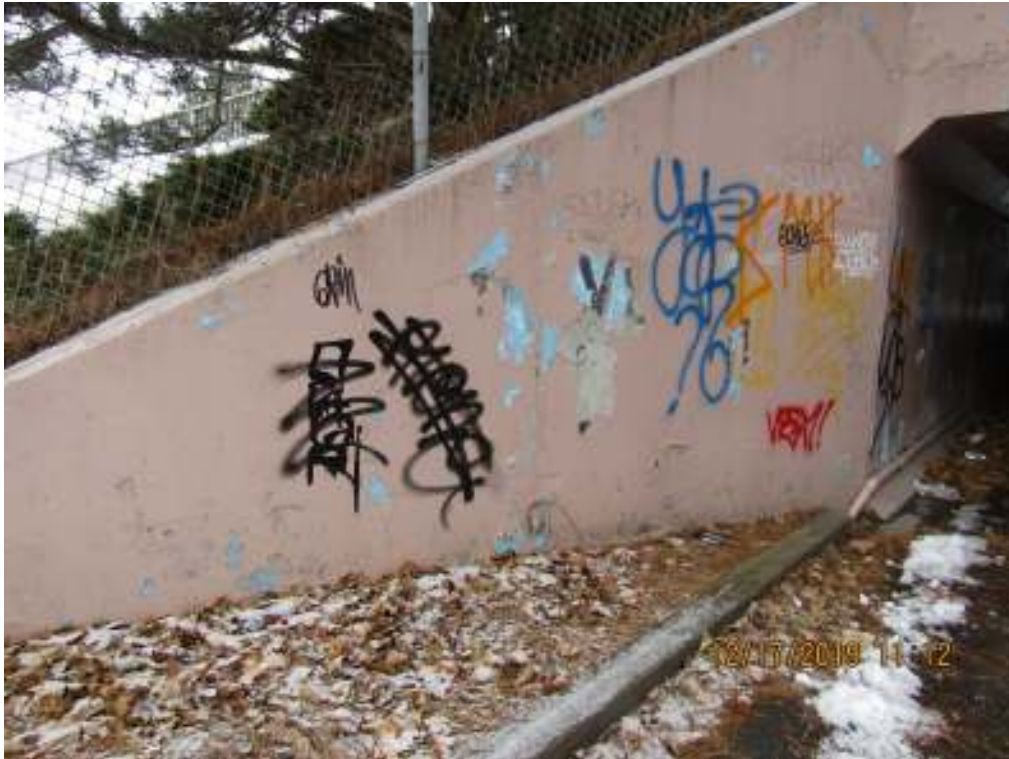
19 South west retaining wall

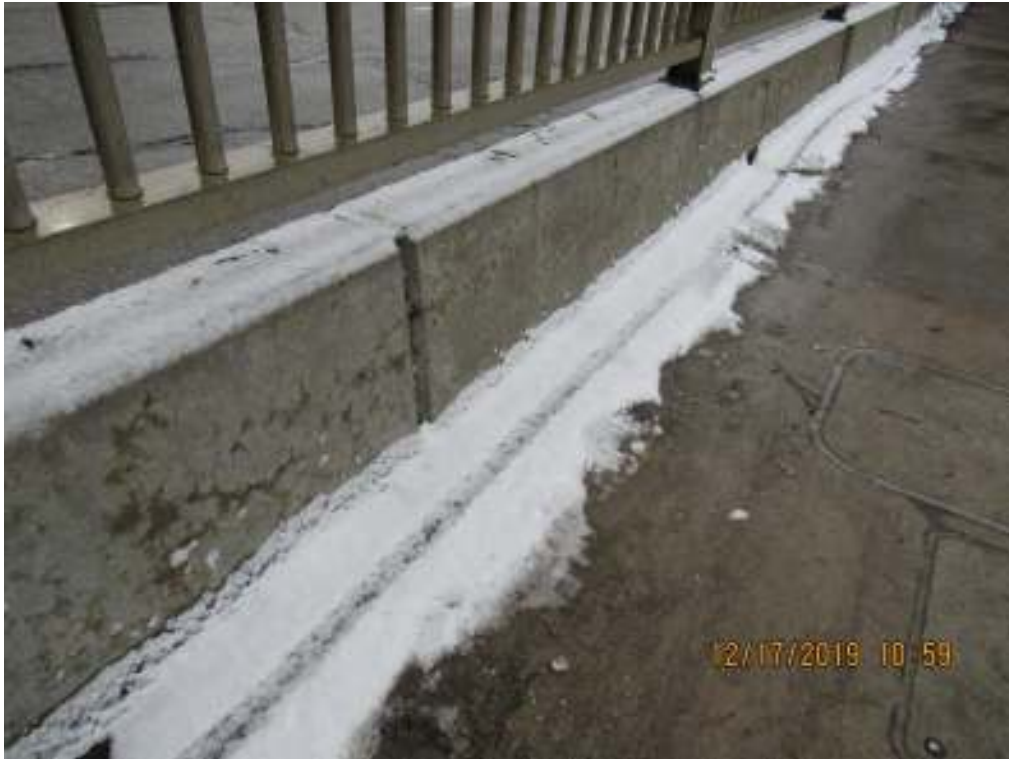
23 North barrier wall

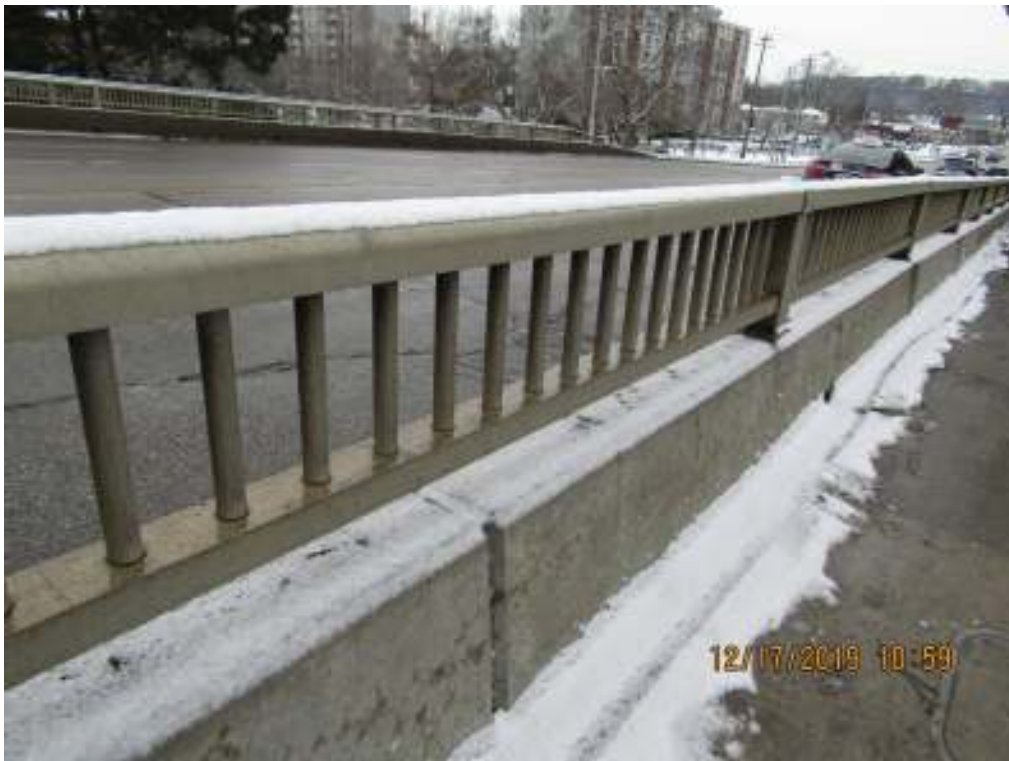
26 North barrier railing

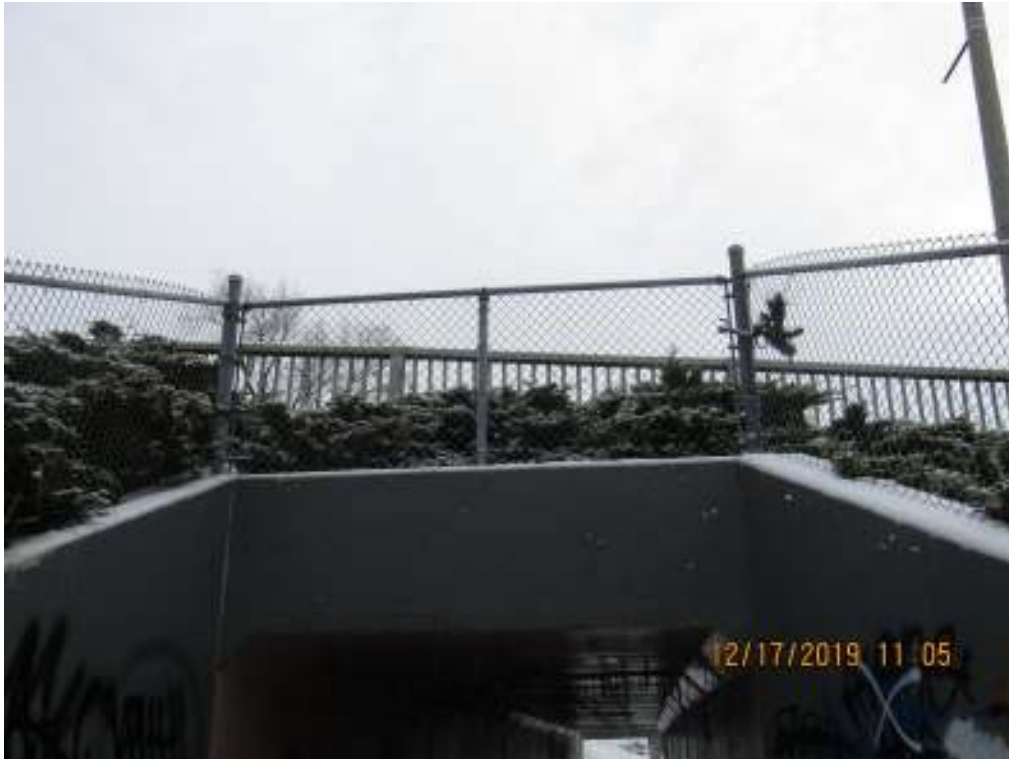
31 Chain link fence on north face

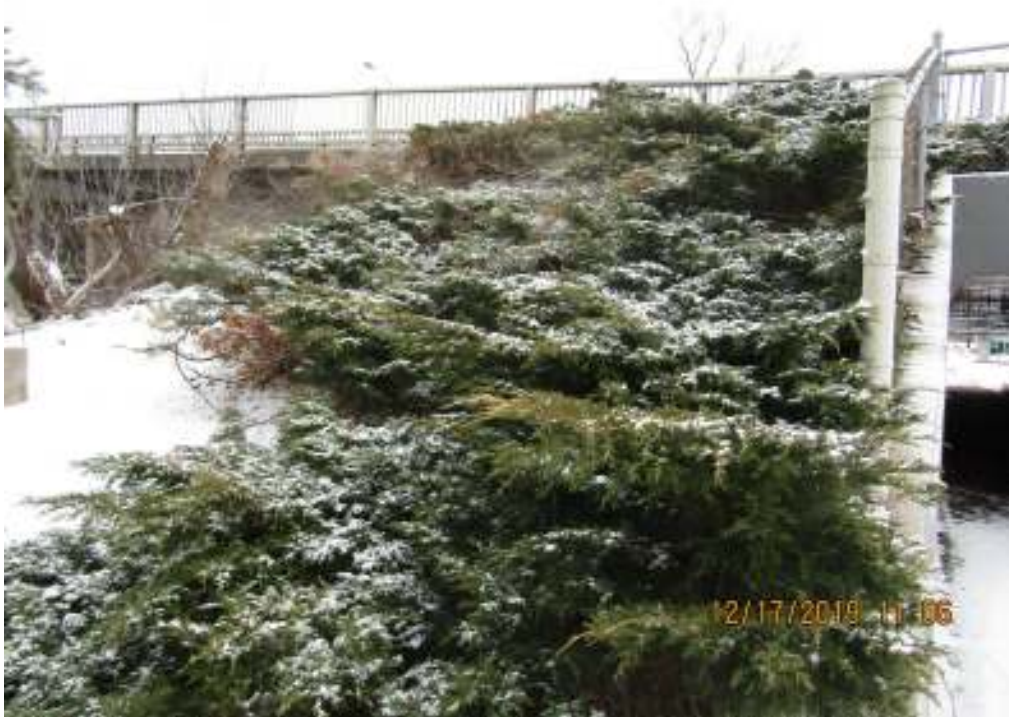
35 North east embankment

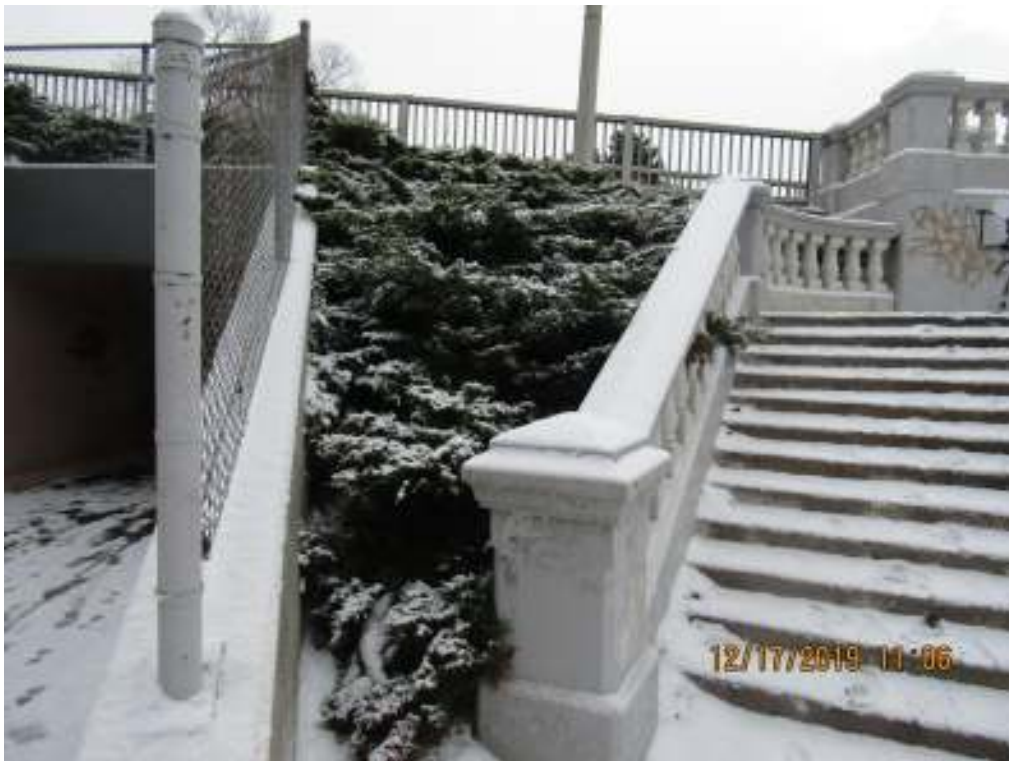
36 North west embankment

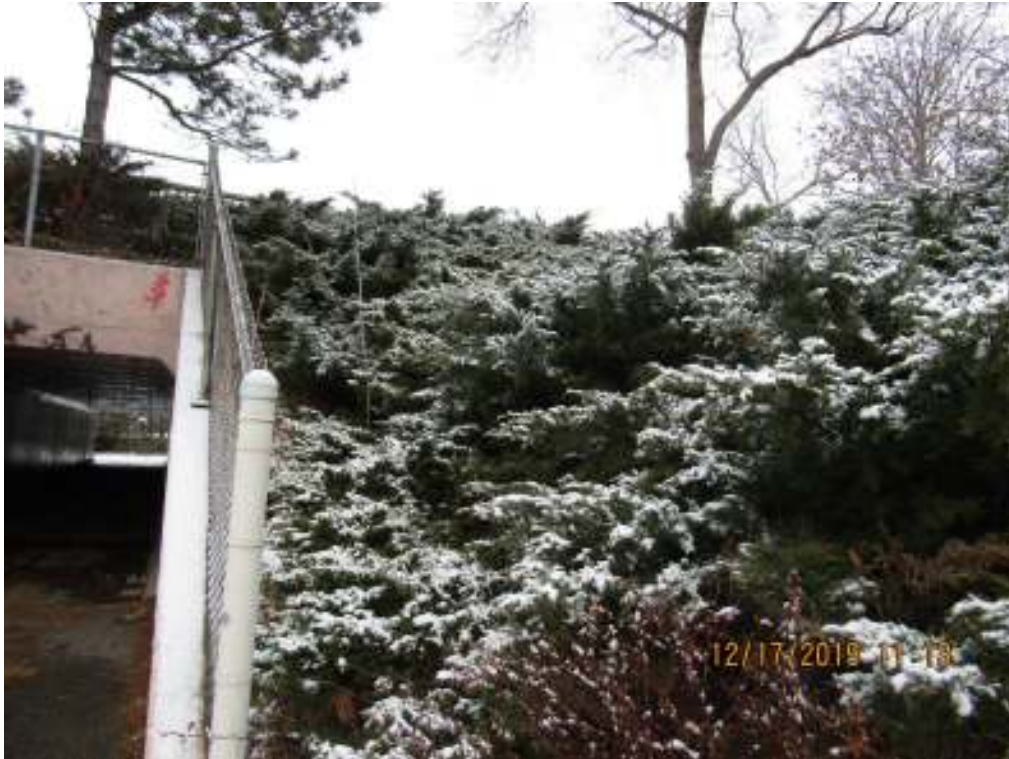
37 South east embankment

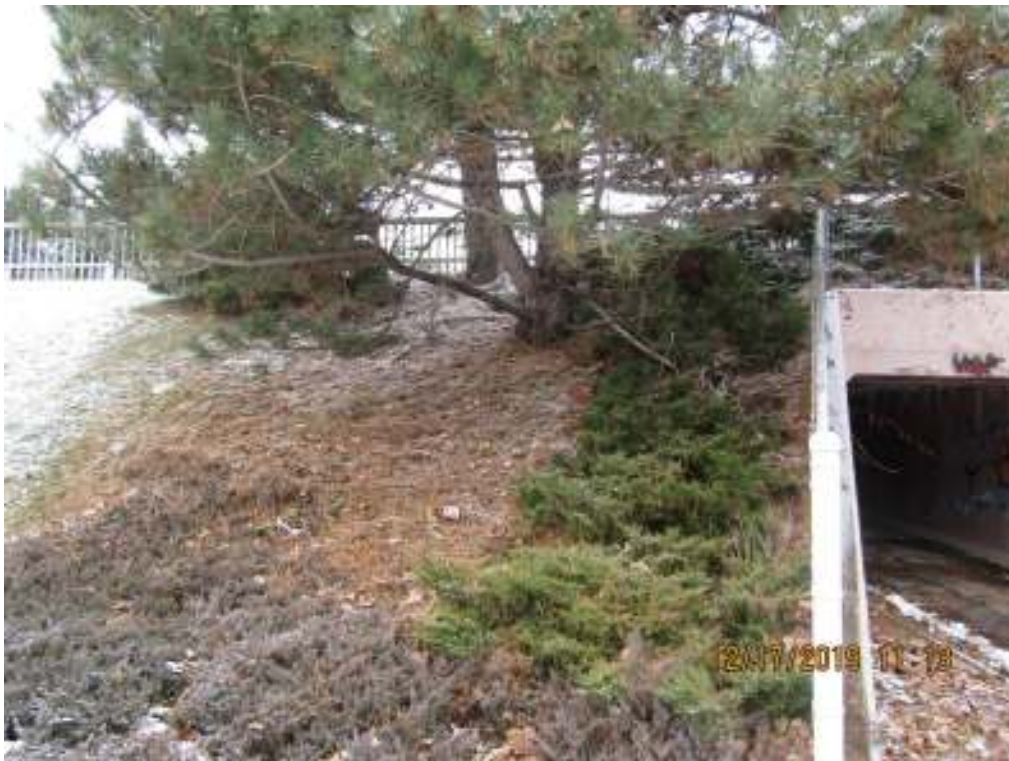
38 South west embankment

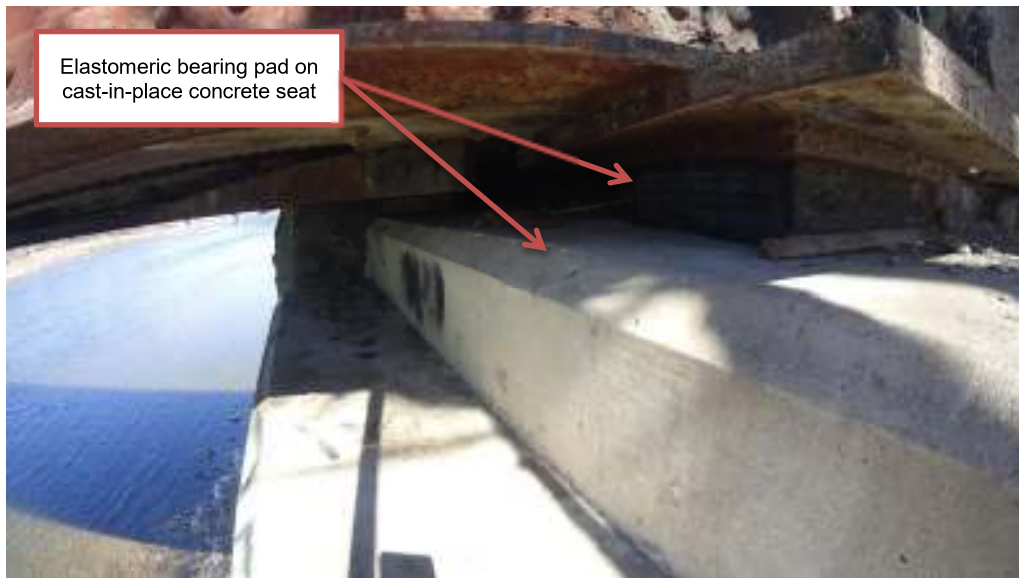
**Figure 2: Replaced abutment bearing on Bridge 143**

Bearings would likely be replaced with elastomeric bearings similar to Structure 143 (TH&B Pedestrian Crossing) downstream of Structure 104. As shown in the photo below, a cast-in-place concrete bearing seat may be required to compensate for the difference in height of the new bearings. A hydraulic assessment could be considered to determine whether the superstructure should be raised to increase hydraulic capacity. The costs to complete a hydraulic assessment, raise the bridge, potential modifications to the abutment walls and wingwalls, and potential modifications to the approach pathways have not been included in the cost estimate provided in **Appendix D**. We estimate that raising the existing superstructure would greatly increase the complexity and cost of rehabilitation.

same deck elevation. Therefore, the bearing elevation would need to increase just to maintain the existing deck elevation. This could be accomplished using similar construction details to those provided in **Figure 2** above. If the hydraulic assessment determines that the deck elevation is to be raised above the current elevations, additional modifications to the abutment walls, wingwalls, and the approach pathways would be required. The costs of these additional modifications have not been included in the pre-engineering cost estimate provided in **Appendix D**.

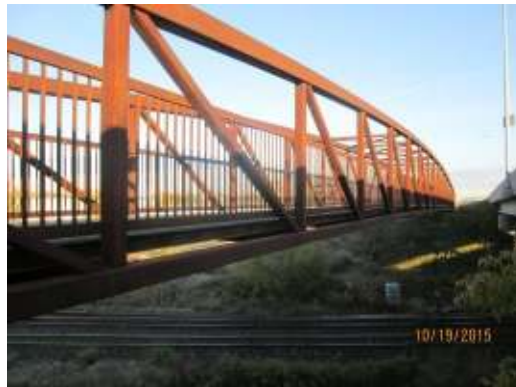
It should be noted that the replacement superstructure types assumed for our estimated capital costs would not represent a sympathetic or replica replacement structure type. Replacement superstructures would be similar to a typical pre-fabricated steel truss structure, similar to the WGP Overhead Trail Bridge (Structure 152) shown below.

**Figure 3: Prefabricated steel truss superstructure (Structure 152)**

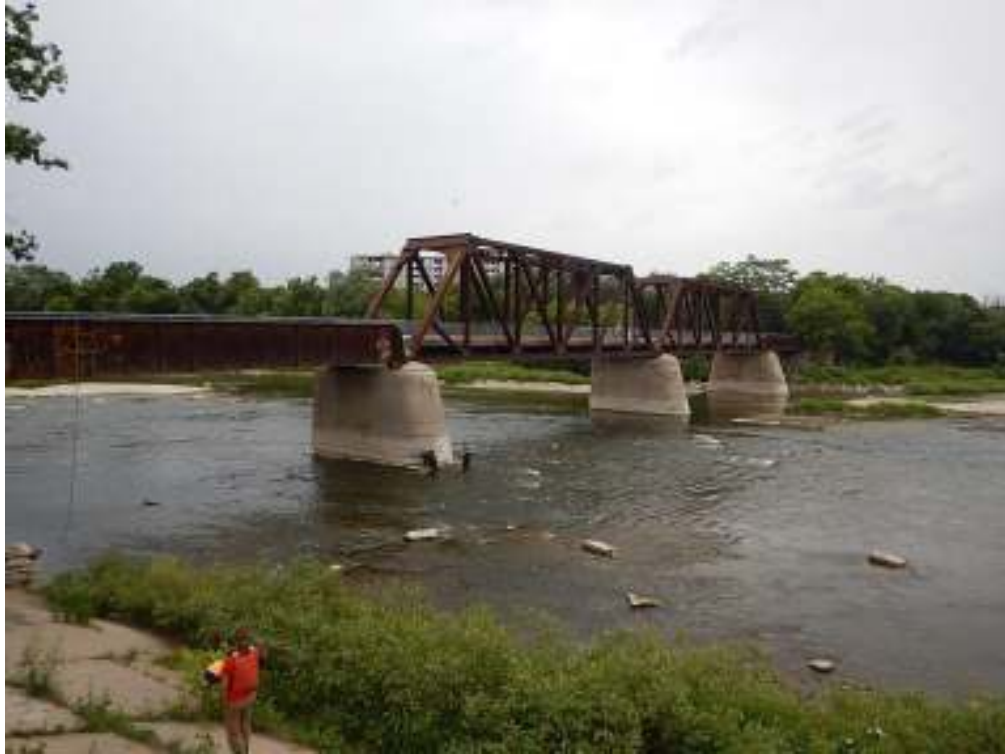
**Photograph G1: North elevation**

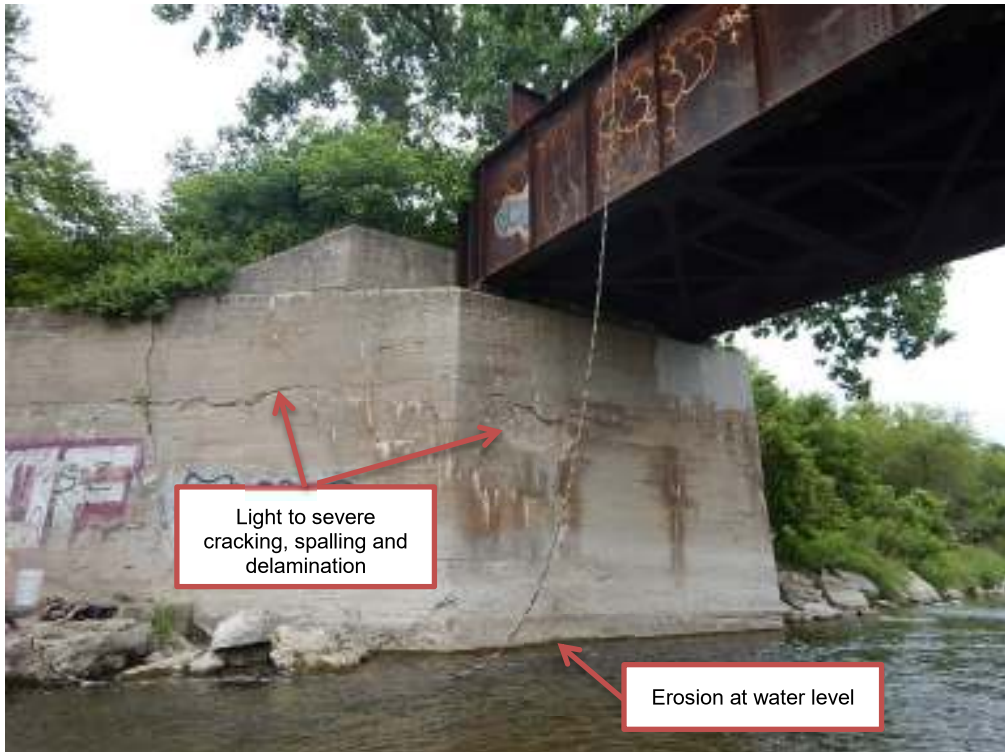
**Photograph G2: East Abutment**

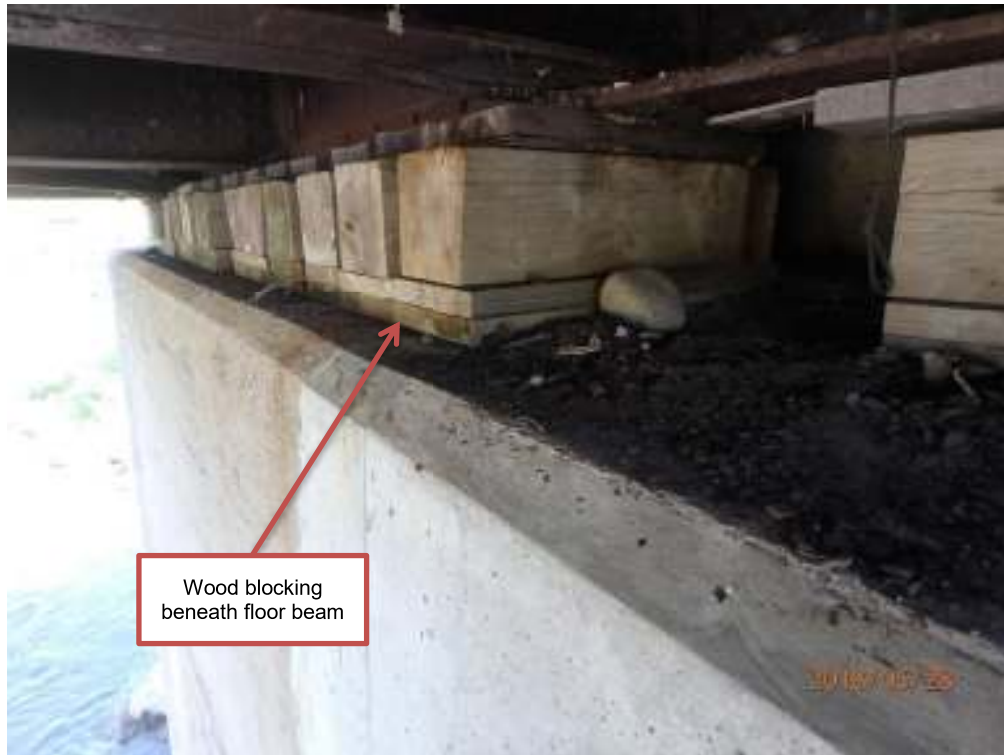
**Photograph G3:** East abutment

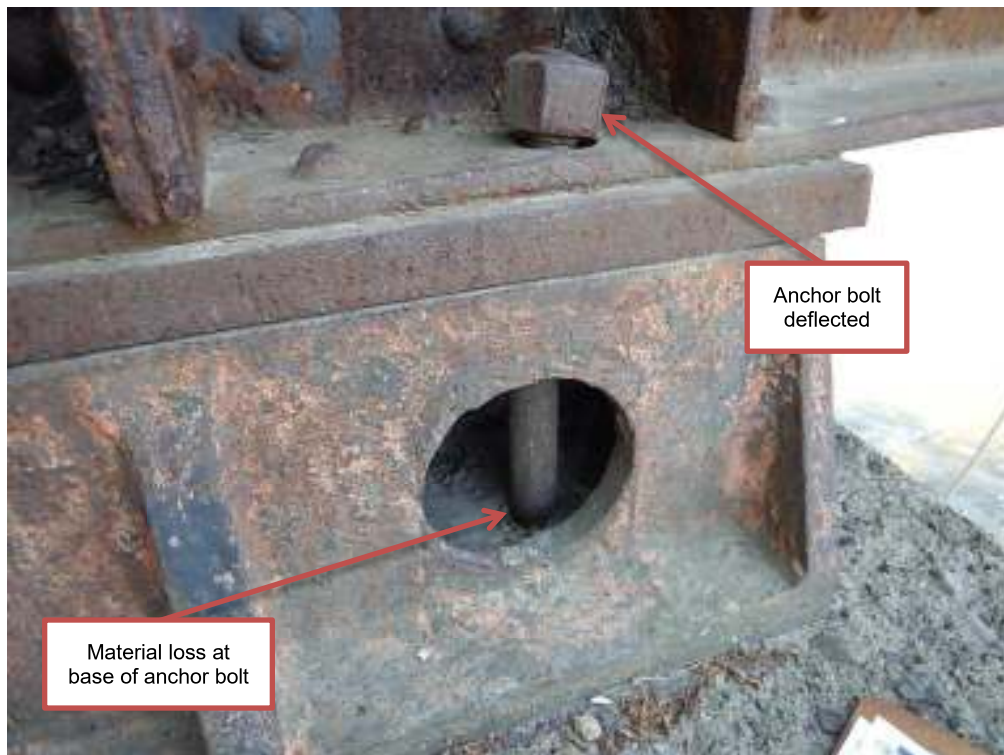
**Photograph G4:** East abutment, north bearing anchor bolt

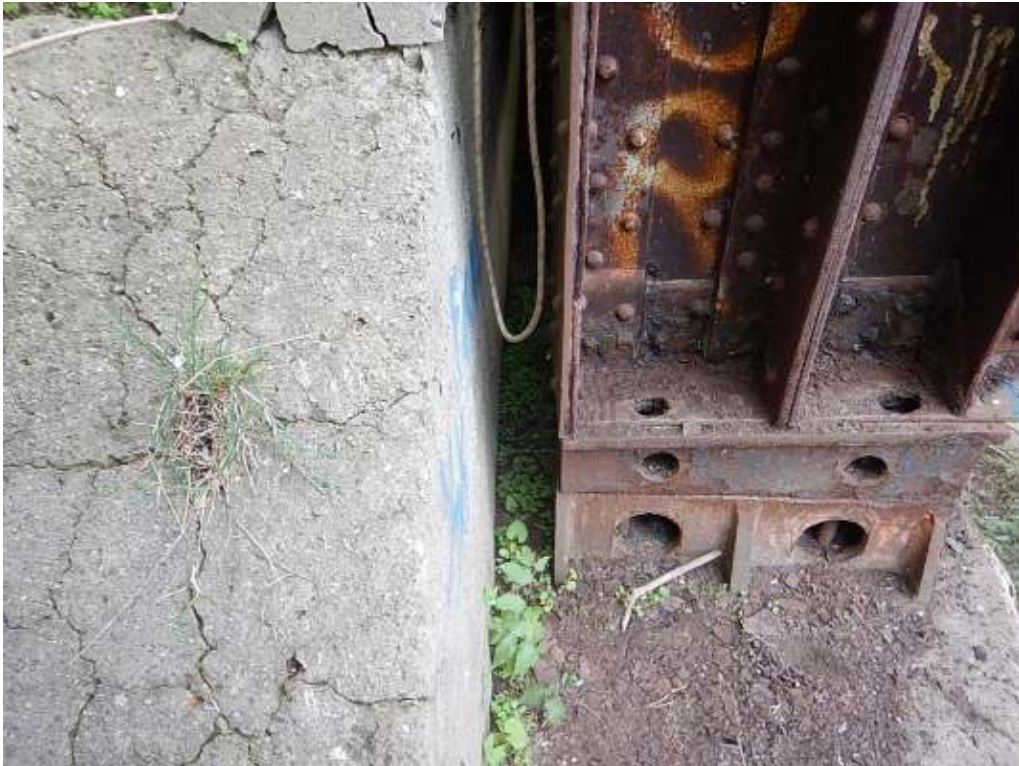
**Photograph G5:** West abutment, south bearing

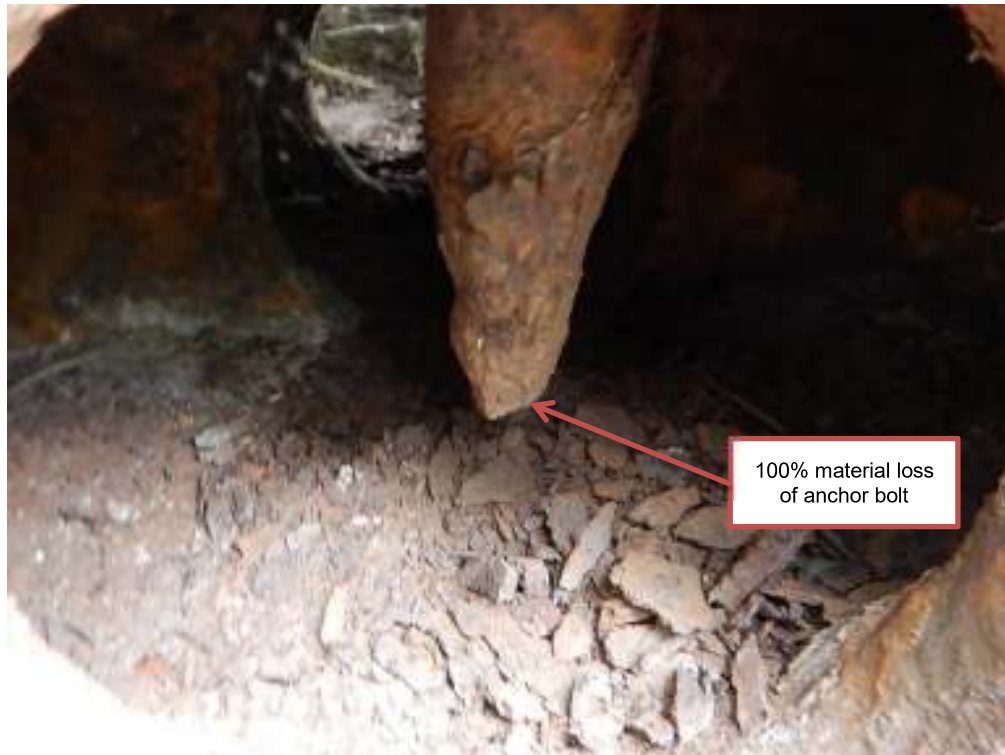
**Photograph G6:** West abutment, north bearing anchor bolt

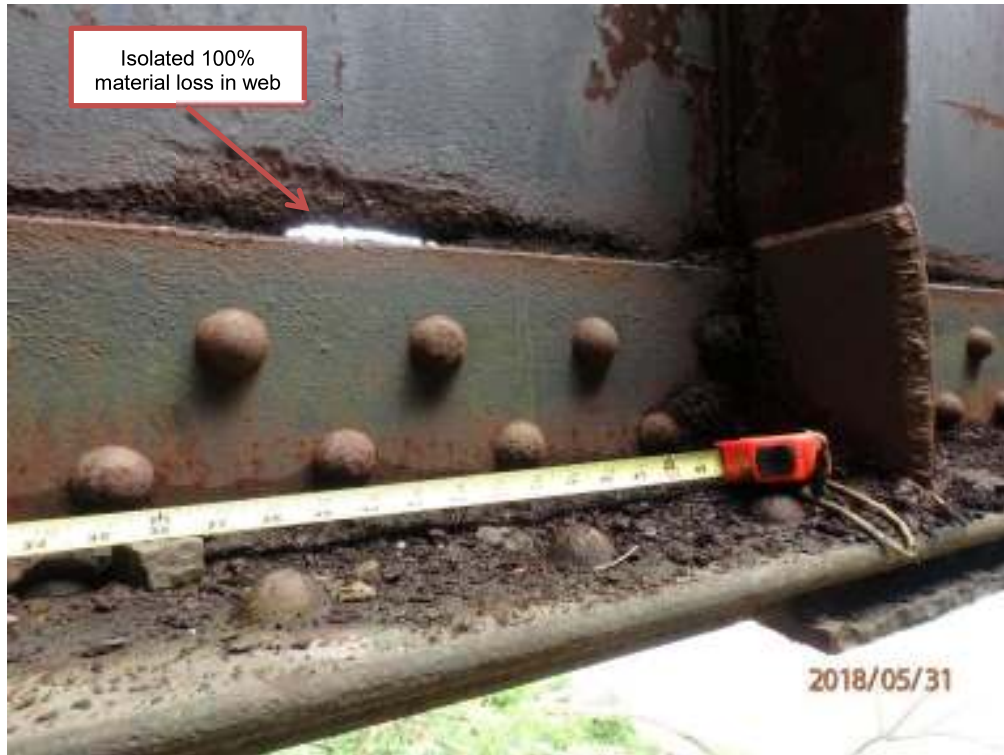
**Photograph G7:** West span, north girder

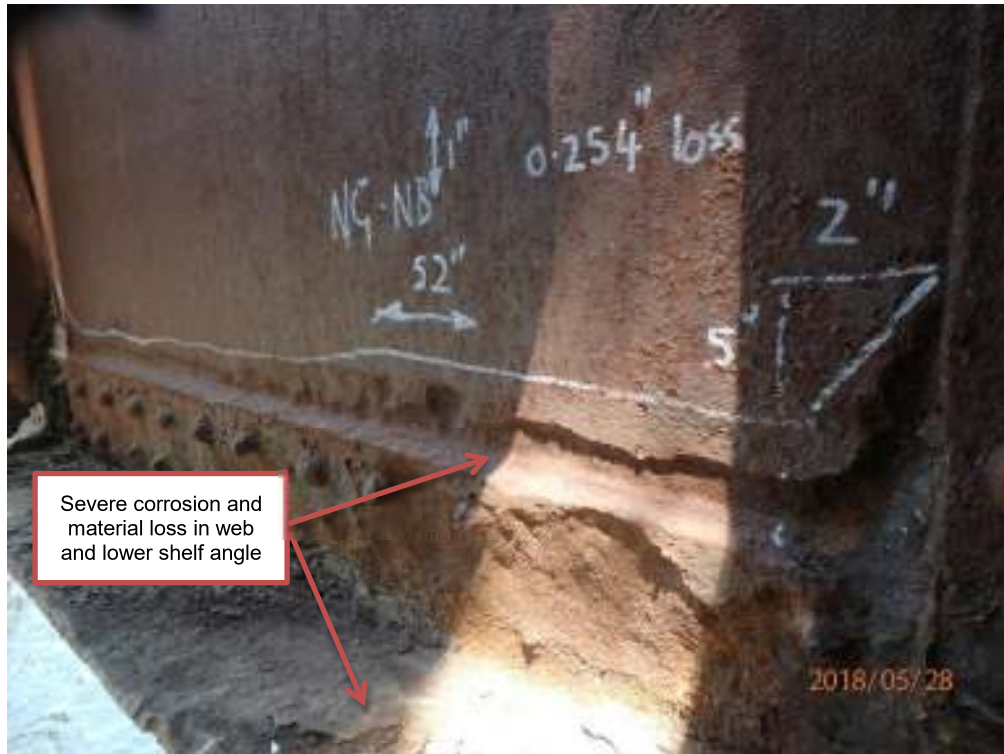
**Photograph G8:** East span, north girder interior

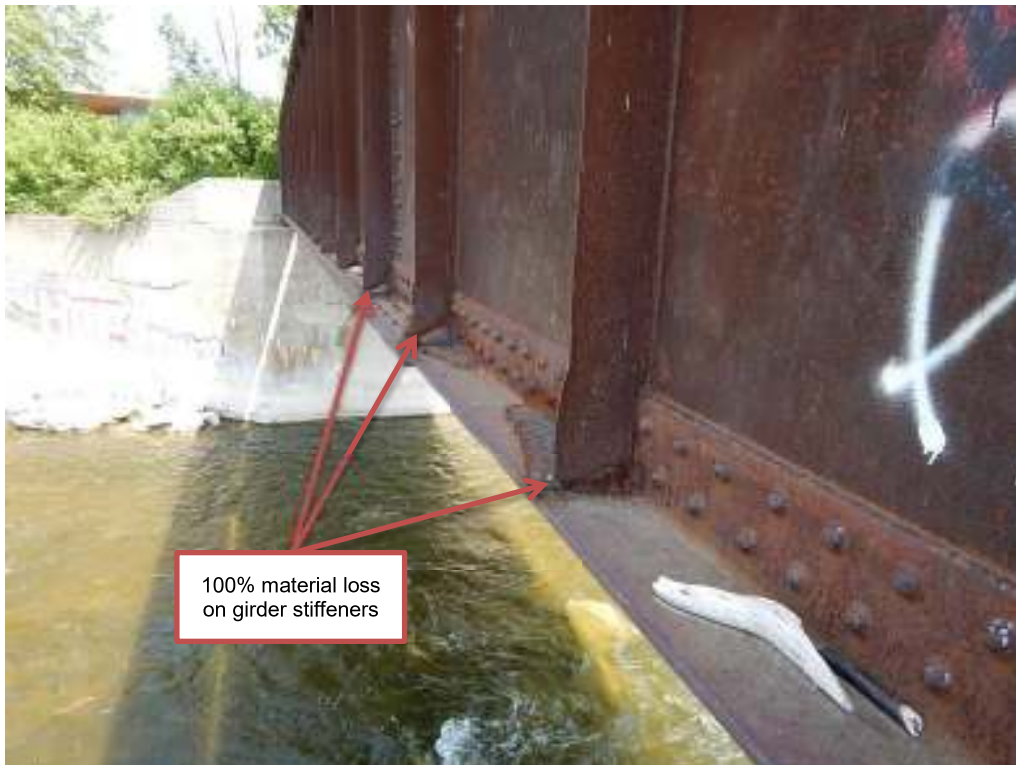
**Photograph G10:** East span, north girder exterior

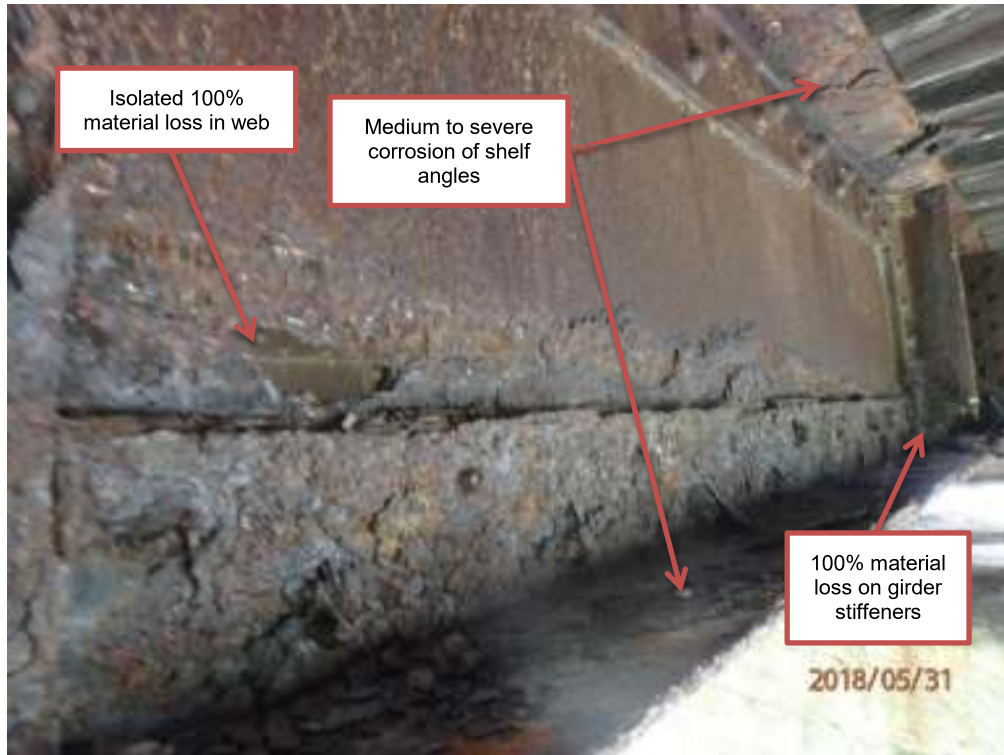
**Photograph G11:** West span, south stringer
