City of Brantford

# Lorne Bridge (Structures 117, 131, 132) Structural Evaluation Report

**GMBP File: 119104**  
**May 2021**

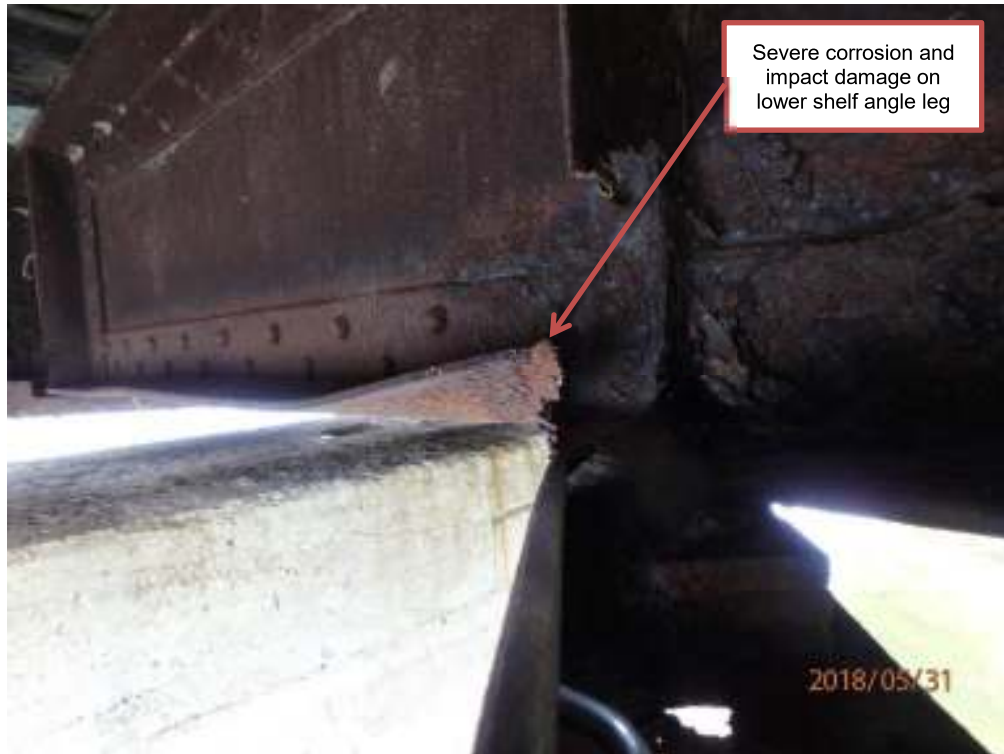
**Photograph G12:** West span, north stringer

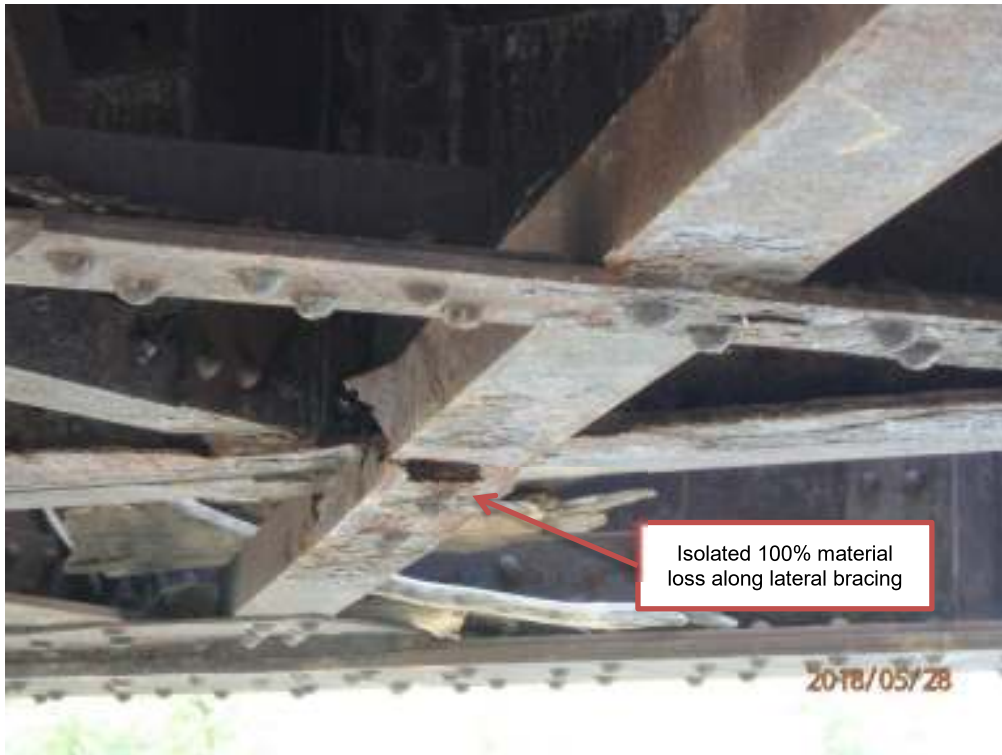
**Photograph G13:** East span, underside

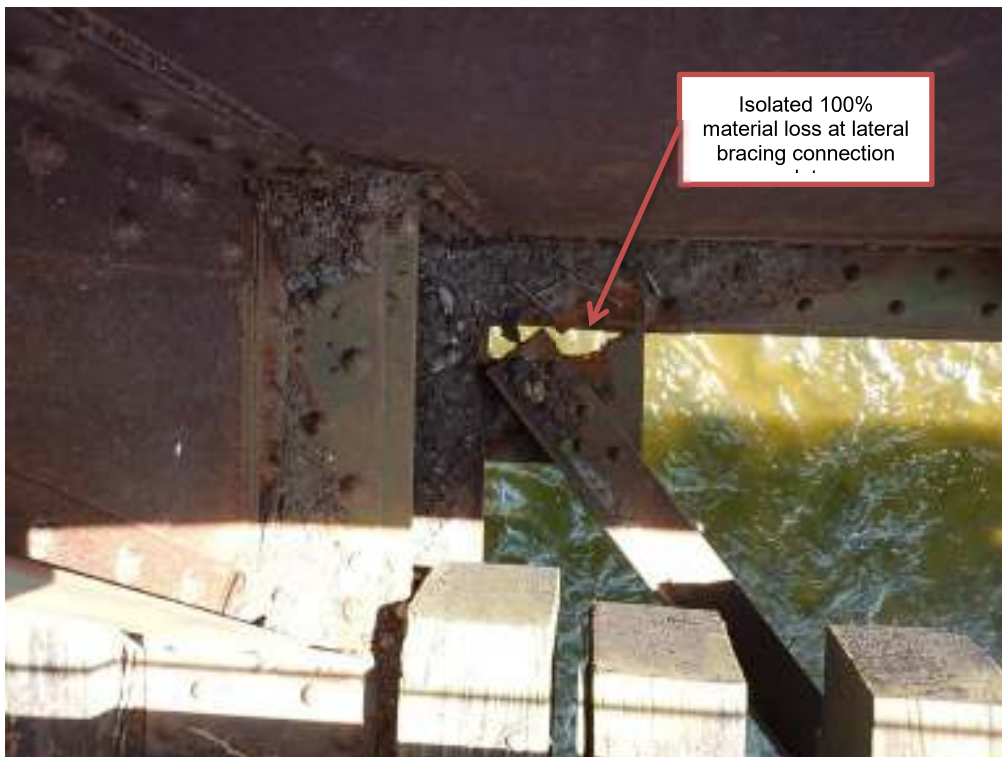
**Photograph G14:** East span, typical lateral bracing connection plate

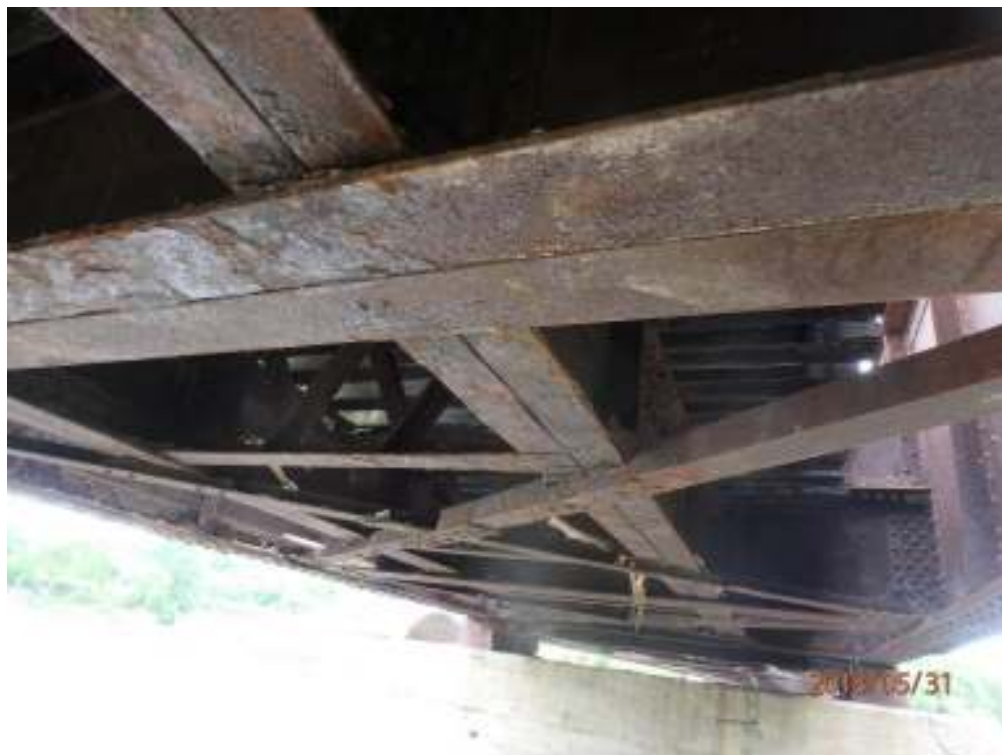
**Photograph G16:** West span underside

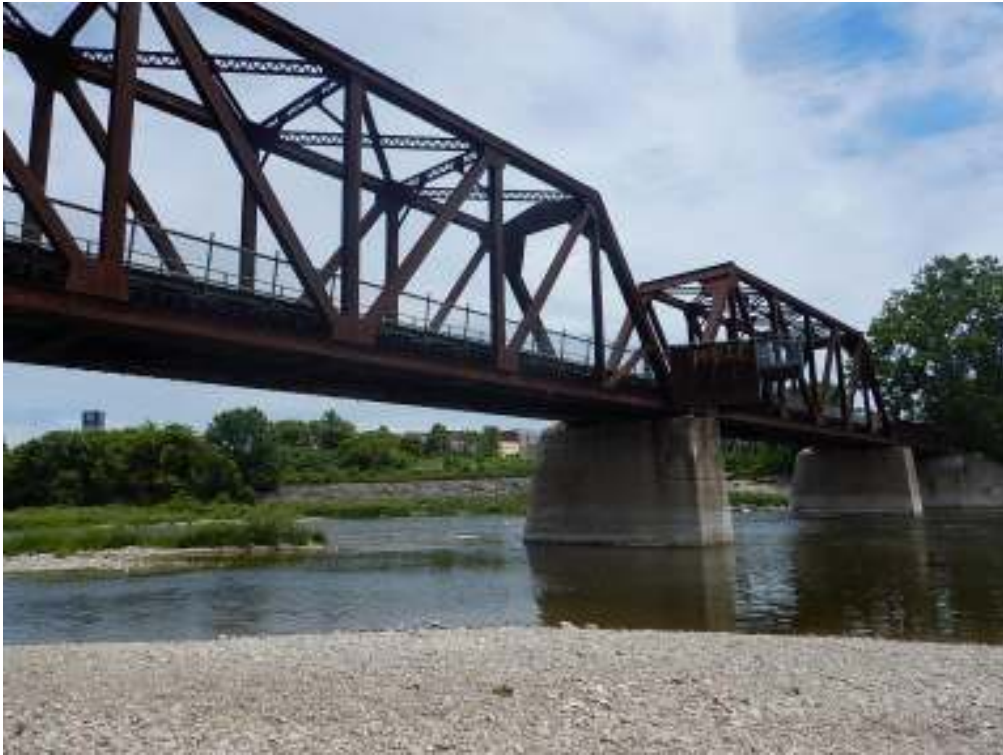
**Photograph T1:** Truss bridge span, south elevation

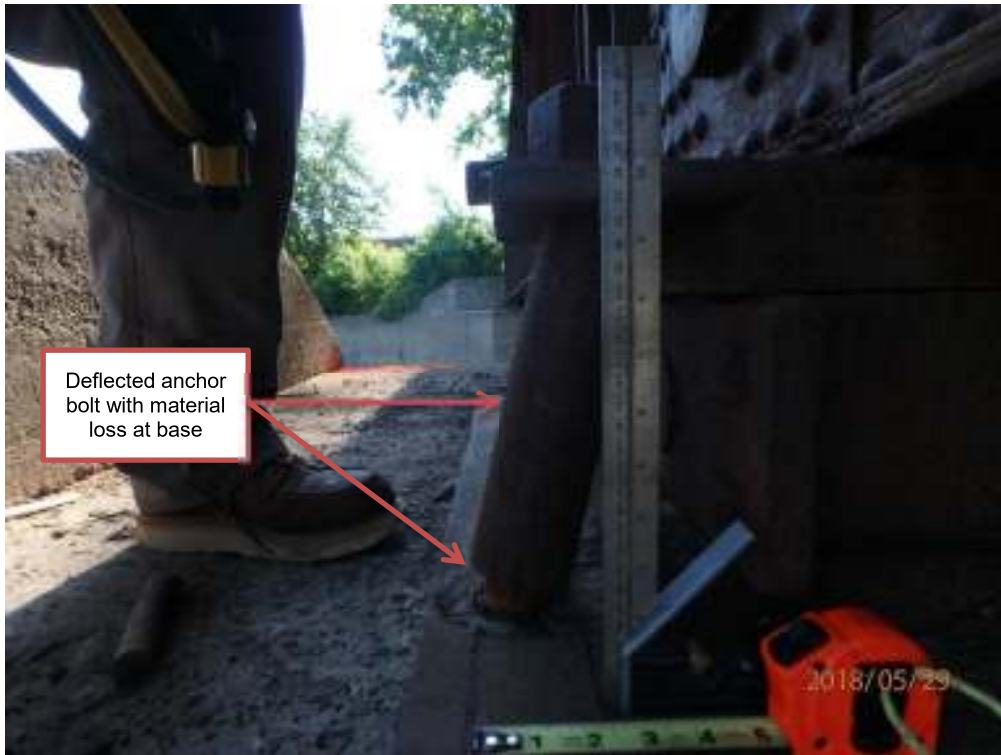
**Photograph T3:** East pier, north roller bearing

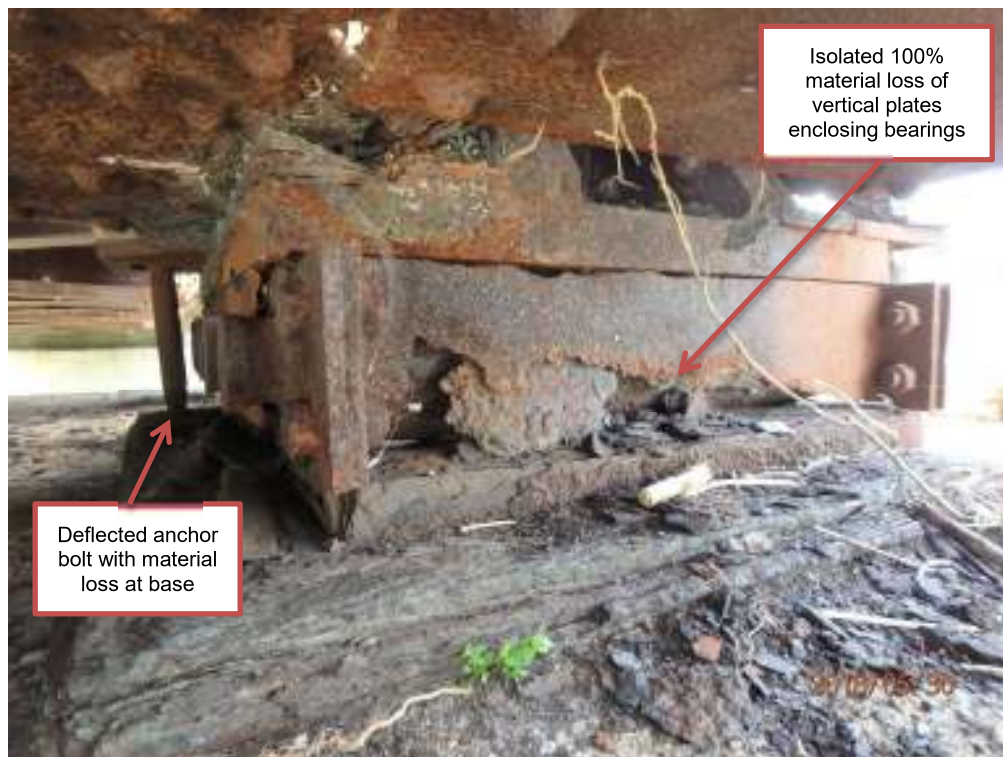
**Photograph T4:** West pier, north roller bearing

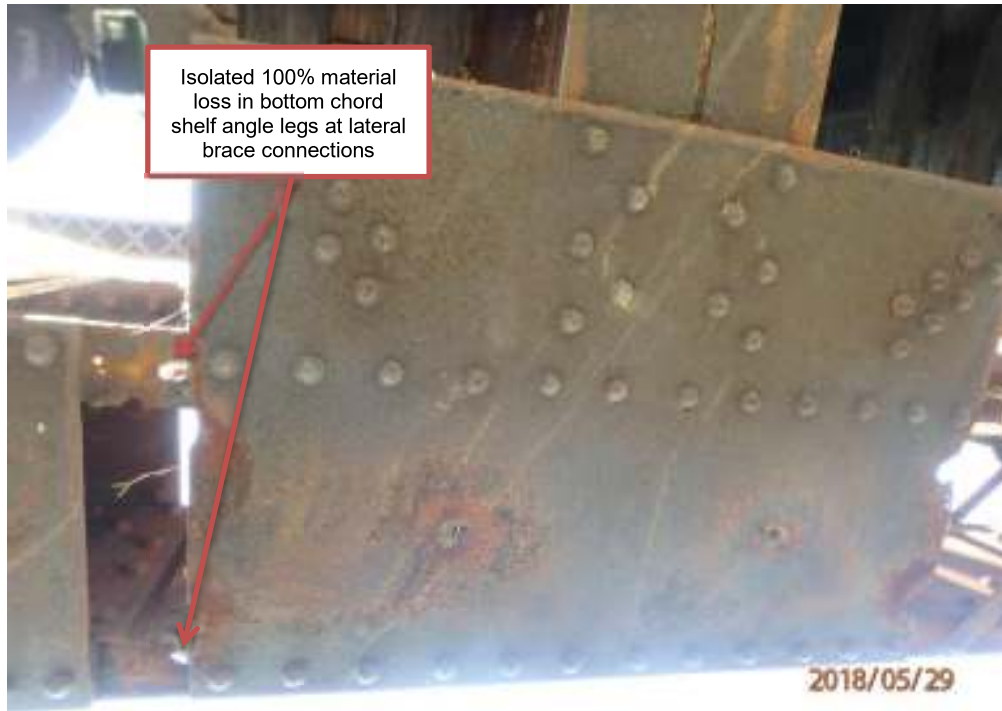
**Photograph T5:** East truss, bottom chord at lateral brace connection

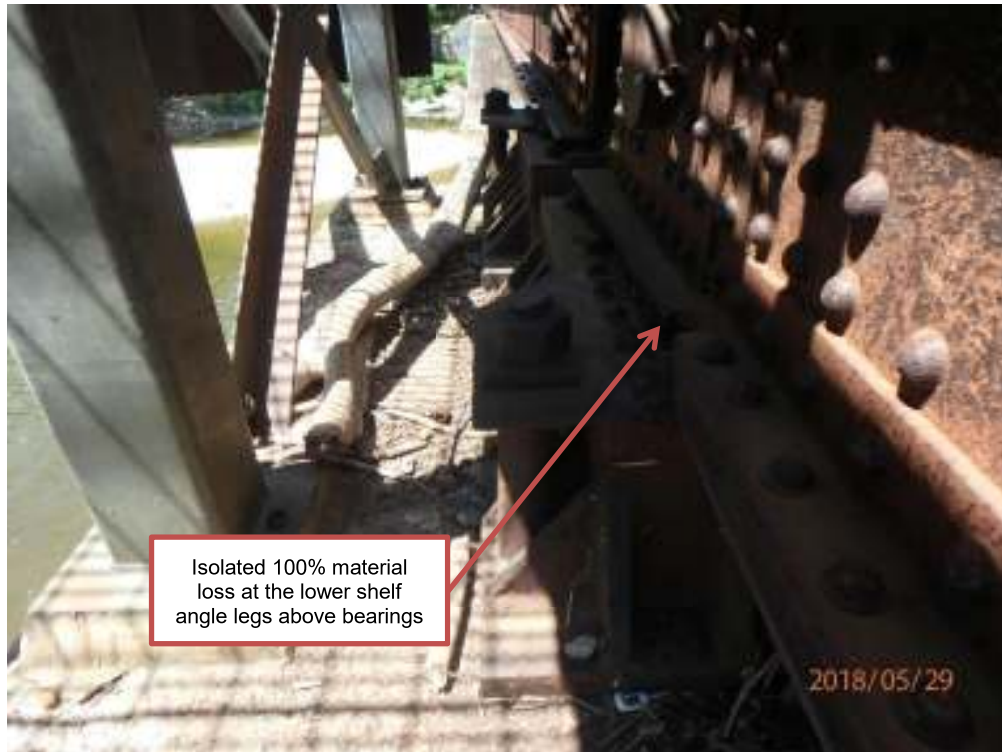
**Photograph T6:** Centre pier, southeast bearing

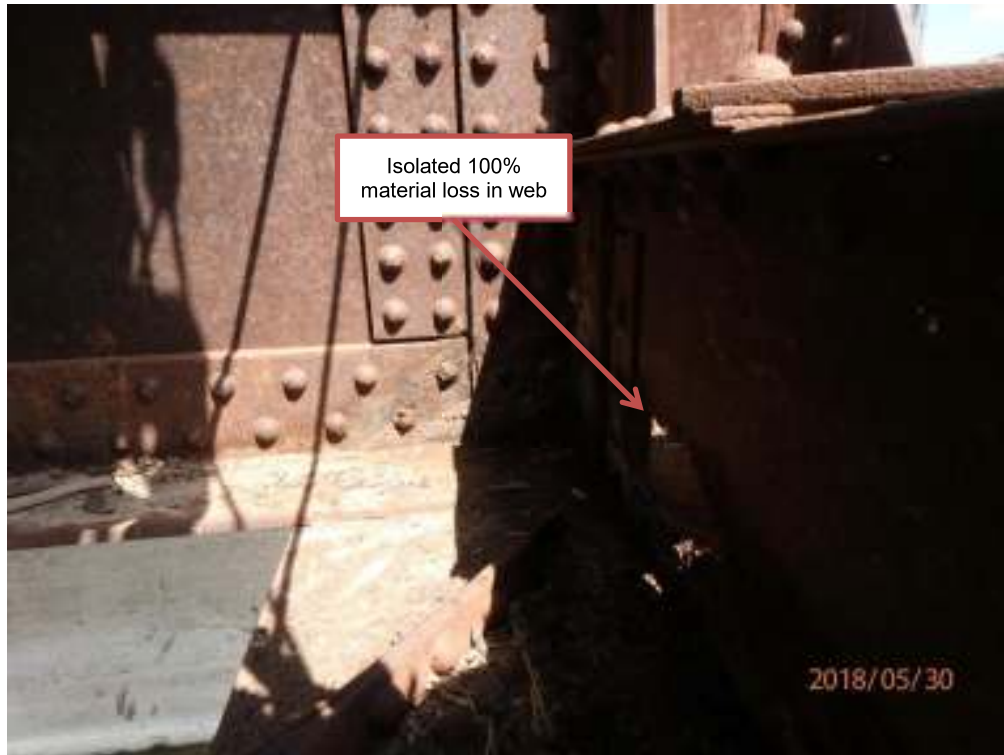
**Photograph T7:** West truss, north bottom chord (typical material loss)

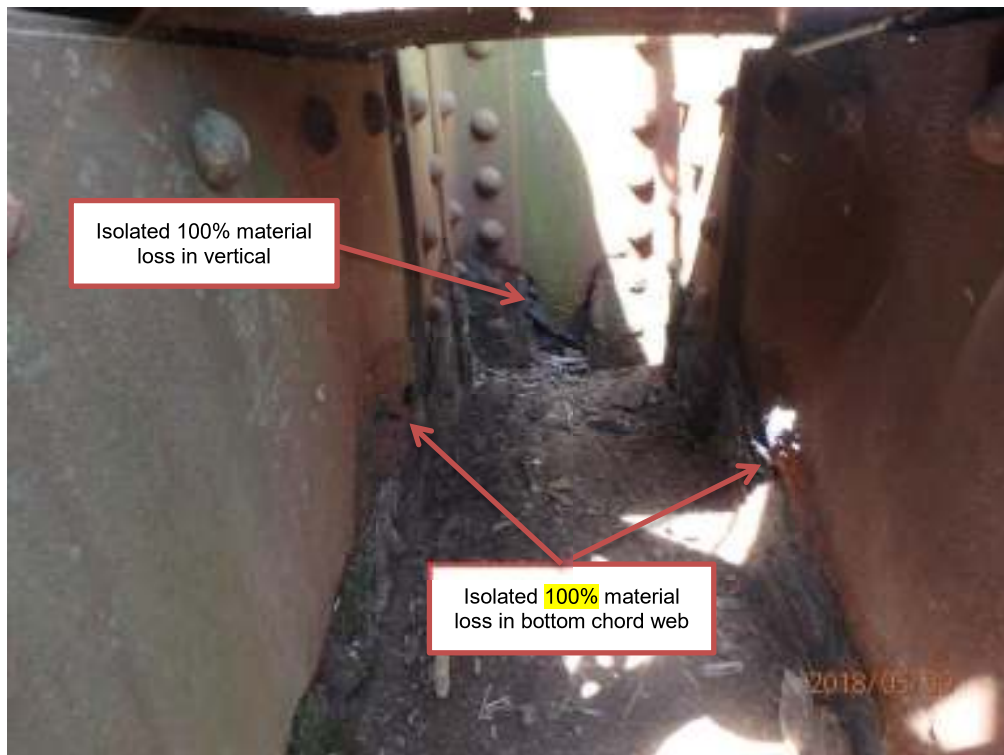
**Photograph T8:** Typical vertical connection at bottom chord

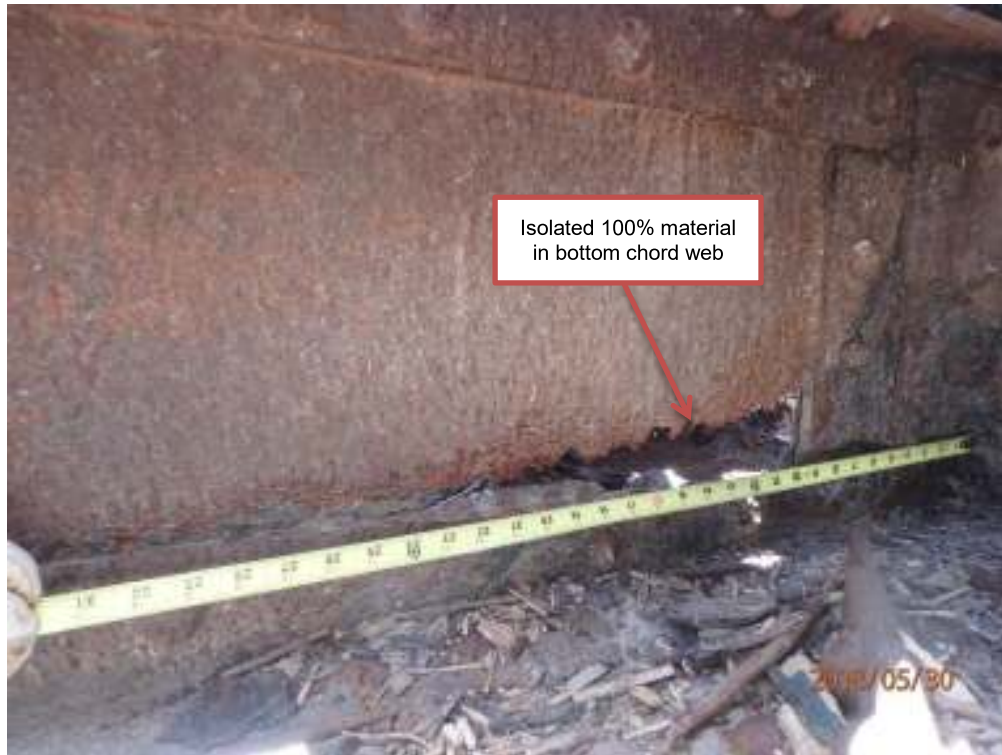
**Photograph T9:** West truss, bottom chord

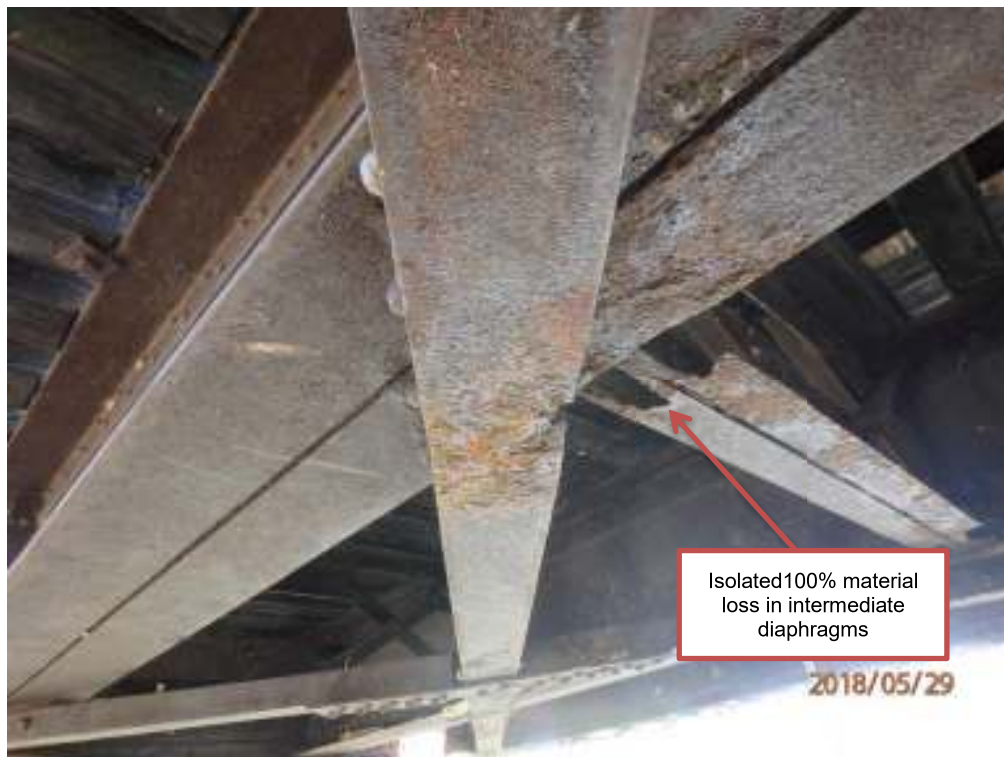
**Photograph T12: East truss, underside**

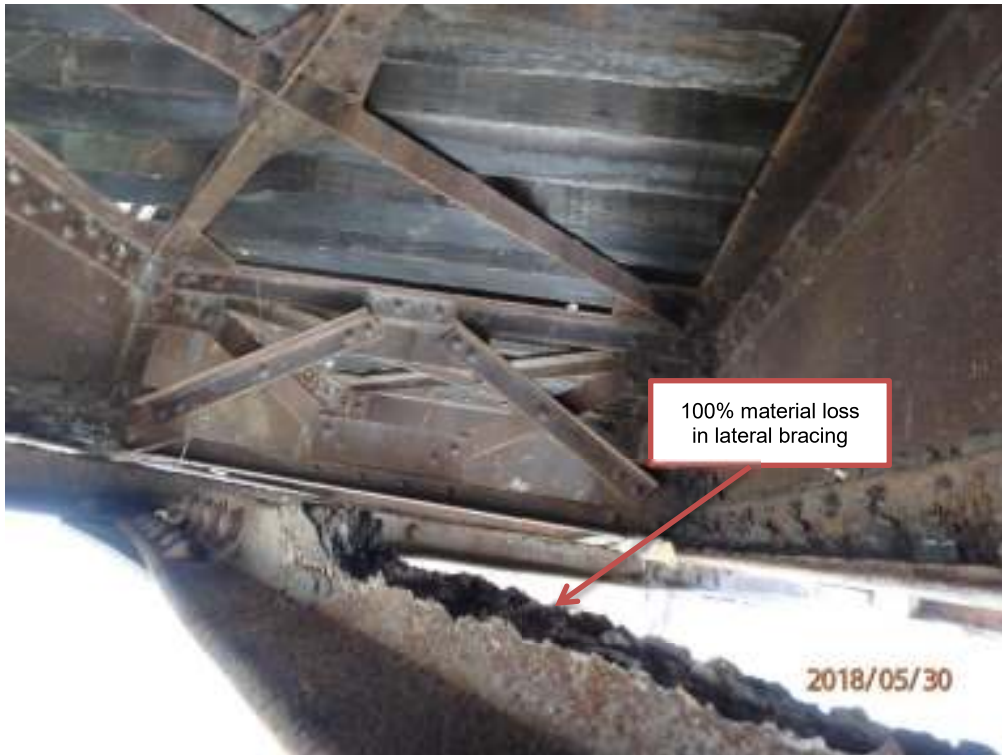
**Photograph T13:** East truss, lateral bracing

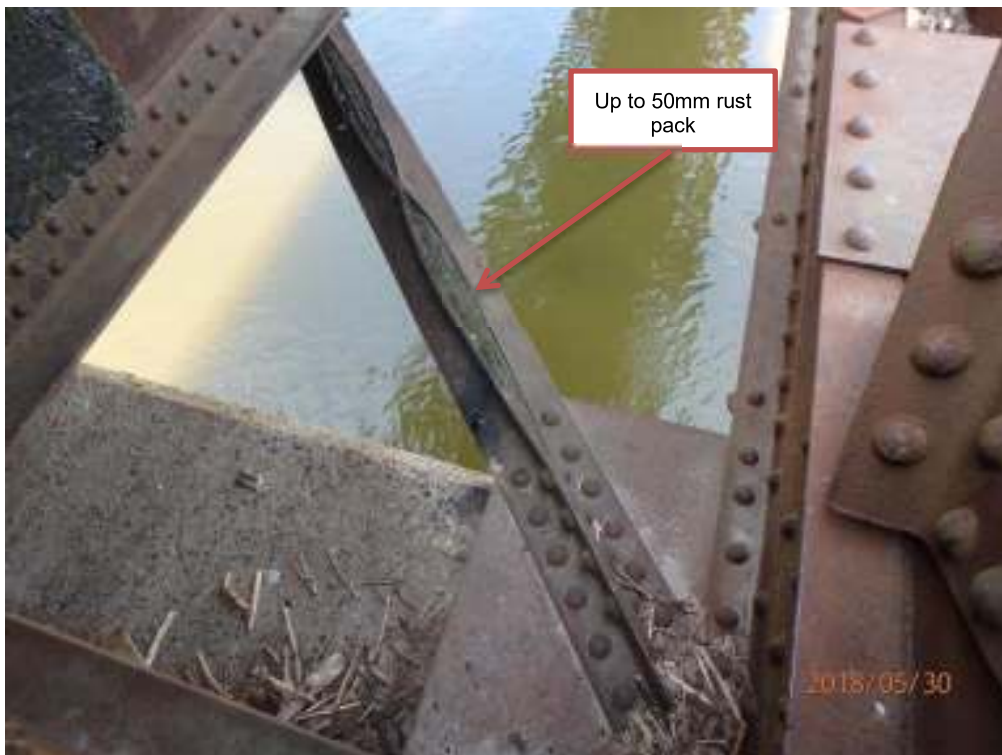
**Photograph T14:** West truss, lateral bracing

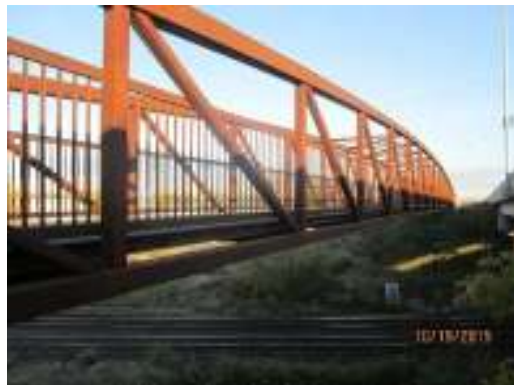
It should be noted that the replacement superstructure types assumed for our estimated capital costs would not represent a sympathetic or replica replacement structure type. Replacement superstructures would be similar to a typical pre-fabricated steel truss structure, similar to the WGP Overhead Trail Bridge (Structure 152) shown below.

**Figure 2: Prefabricated steel truss superstructure (Structure 152)**

A hydraulic assessment should be considered to determine the capacity of the replacement structure and its bearing elevations. One of the benefits of the prefabricated truss system shown in **Figure 2** below is that the underside of the superstructure would be raised by approximately 1.0 m in comparison to the existing structure while maintaining the same deck elevation. Therefore, the bearing elevation would need to increase just to maintain the existing deck elevation. This could be accomplished using similar construction details to those provided in the 2005 rehabilitation of the east abutment. If the hydraulic assessment determines that the deck elevation is to be raised above the current elevations, additional modifications to the abutment walls, wingwalls, and the approach pathways would be required. The costs of these additional modifications have not been included in the pre-engineering cost estimate provided in **Appendix D**.

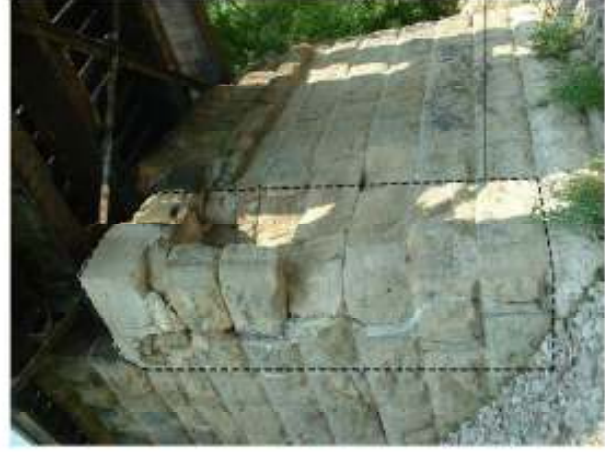
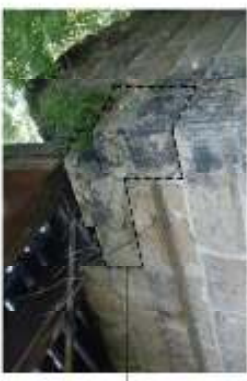
**NORTH CORNER OF EAST ABUTMENT - REPAIR DETAILS**

EXIST. BEARING AREA WITH REPAIR AREA INDICATED BY DASHED LINE.
