City of Brantford

# Lorne Bridge (Structures 117, 131, 132) Structural Evaluation Report

**GMBP File: 119104**  
**May 2021**

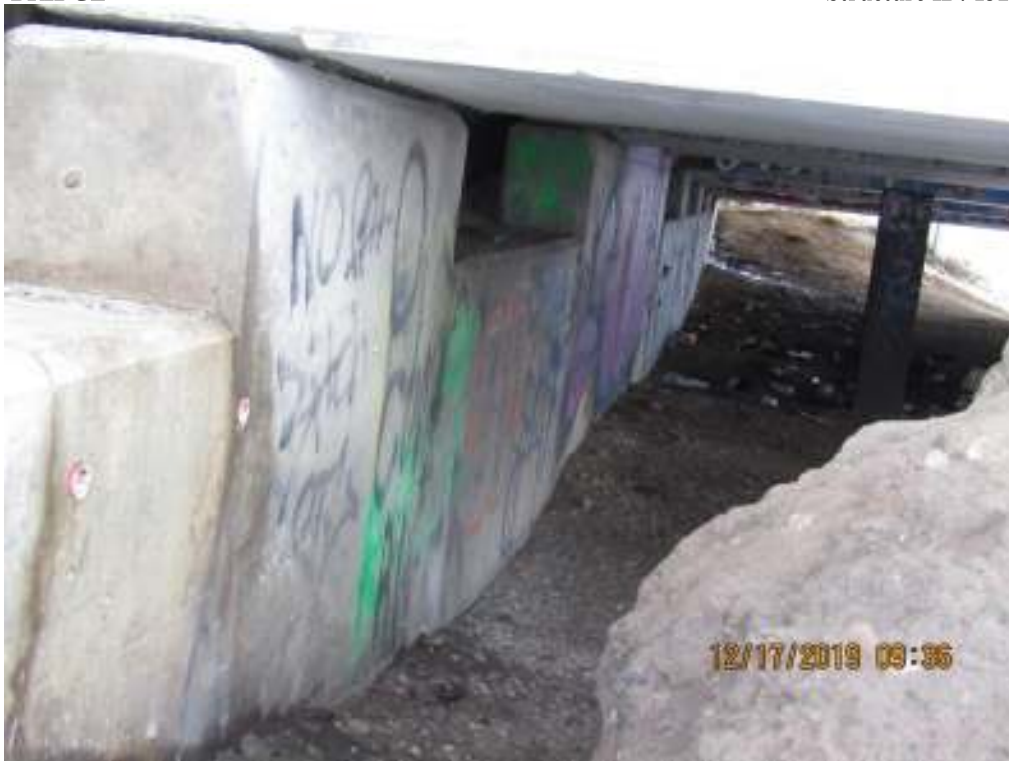
29 East abutment

Includes area of abutment and bearing pedestal. Medium to wide cracks and delamination with spalls. Light to medium scaling and wet areas. Wide horizontal crack at south west bearing pedestal. Repair deteriorated concrete and seal cracks.					
<b>Performance Deficiencies:</b> 00 None					
<b>Recommended Work:</b>		<b>Maintenance Needs:</b>			
<input checked="" type="checkbox"/> Rehab <input type="checkbox"/> Replace <input checked="" type="checkbox"/> 1 - 5 Years <input type="checkbox"/> 6 - 10 Years		<input type="checkbox"/> Urgent <input type="checkbox"/> 1 Year <input type="checkbox"/> 2 Years 00 None

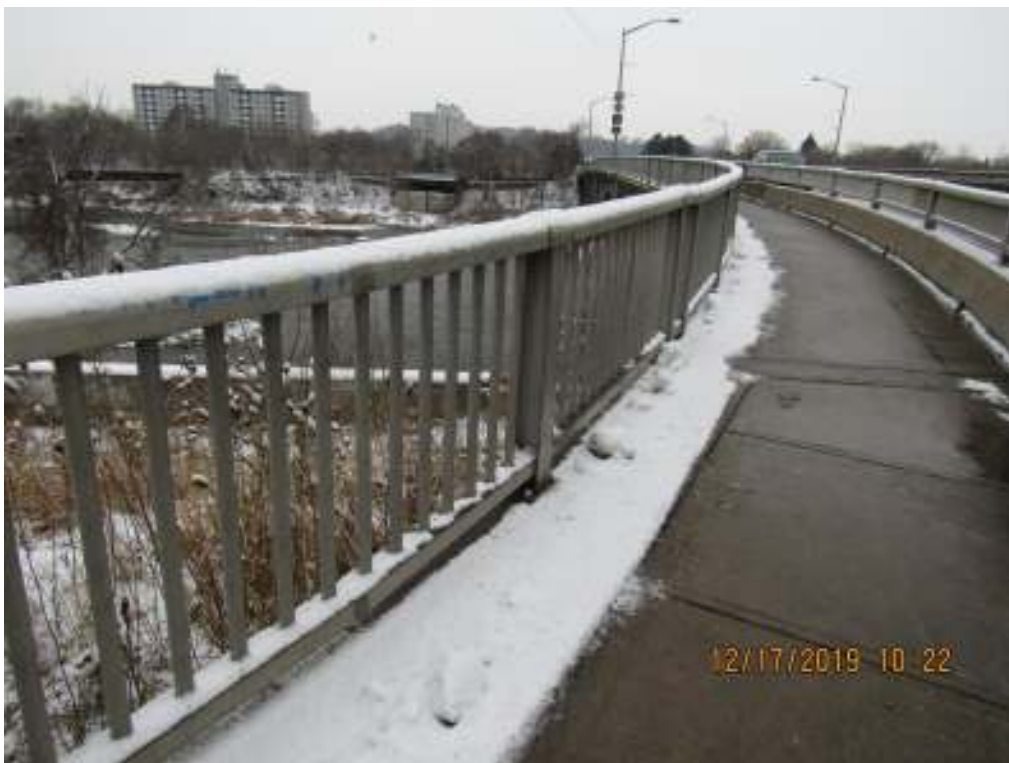
64 South Railing

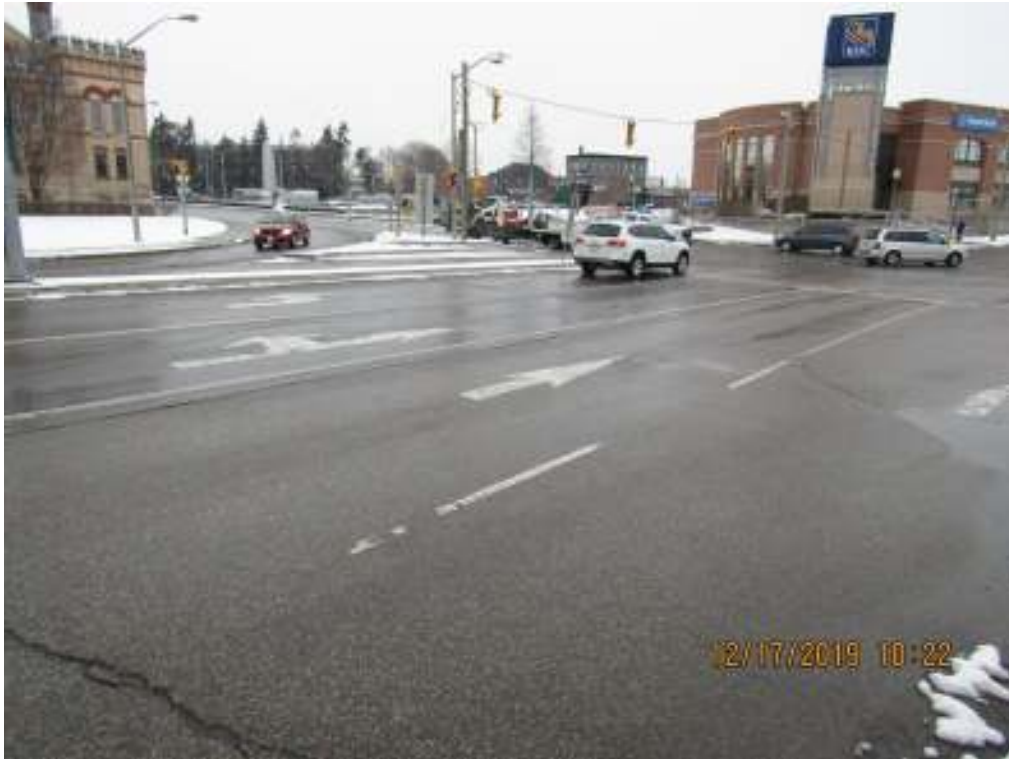
65 East approach

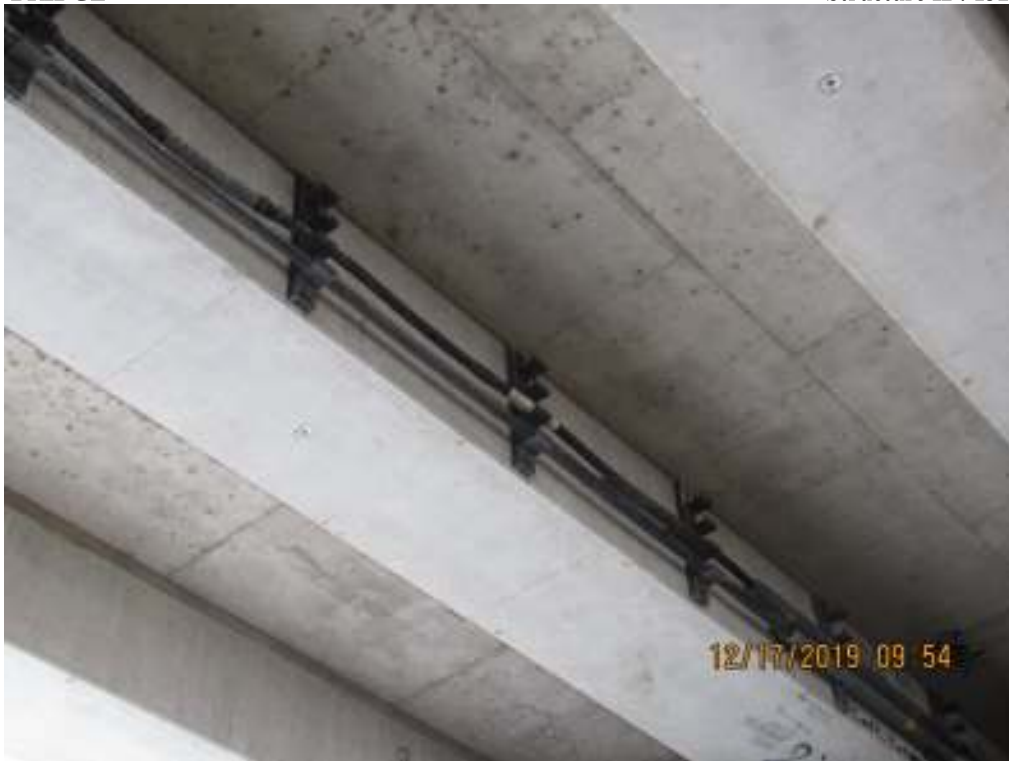
75 Utilites on girder

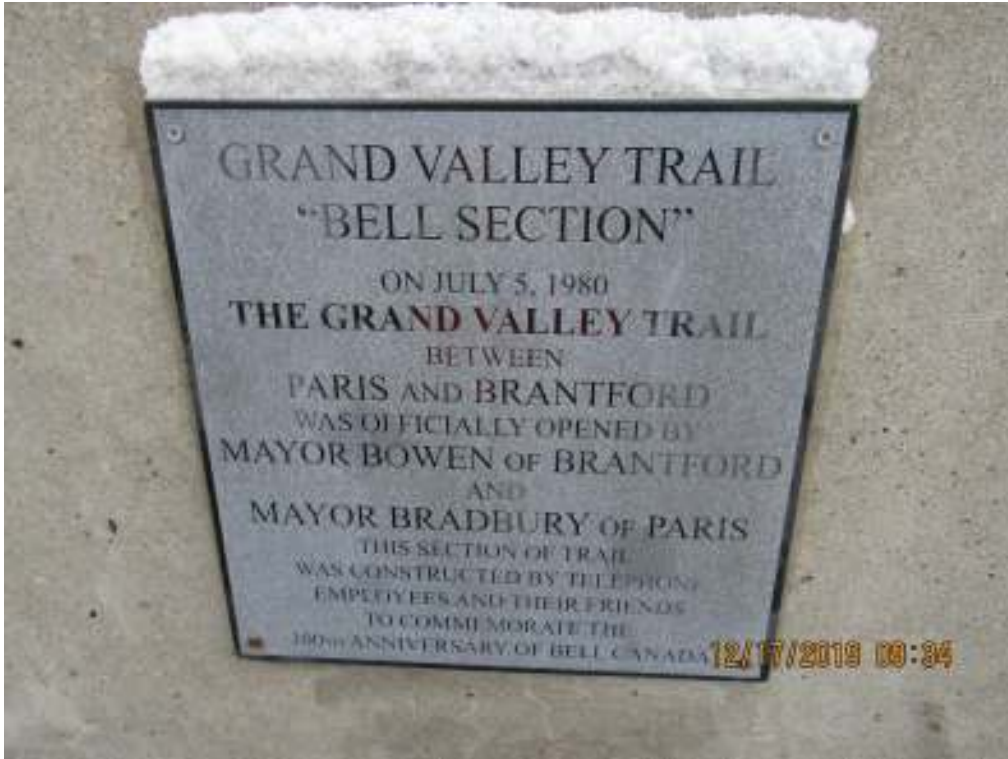
79 Plaque on Bridge

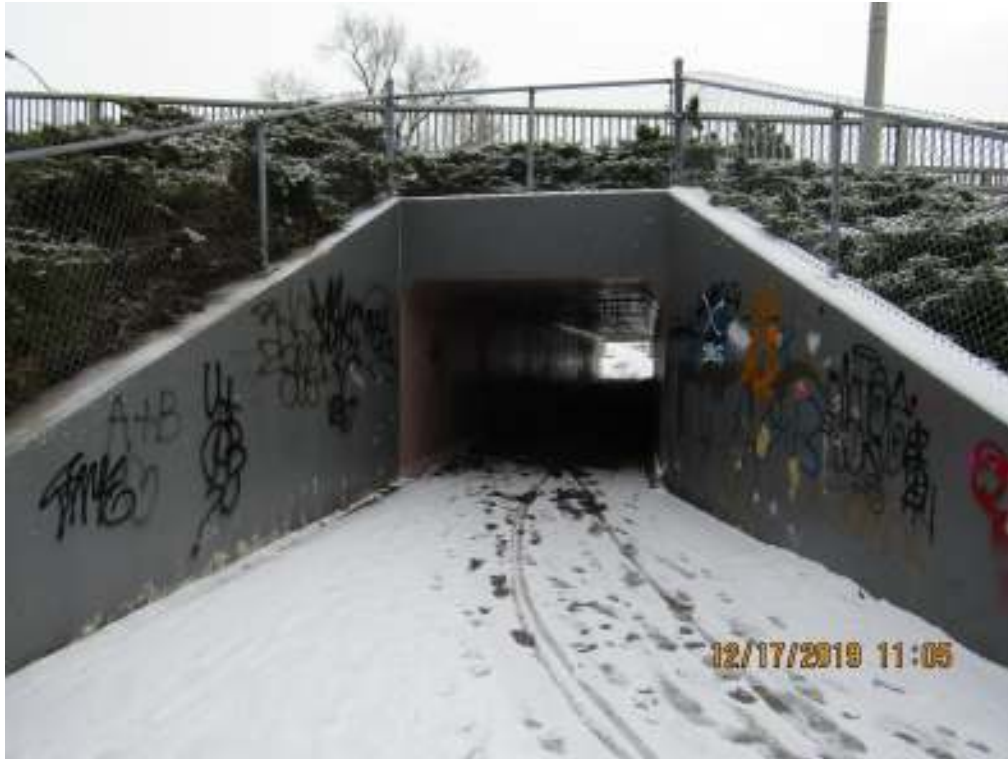
01 North Elevation

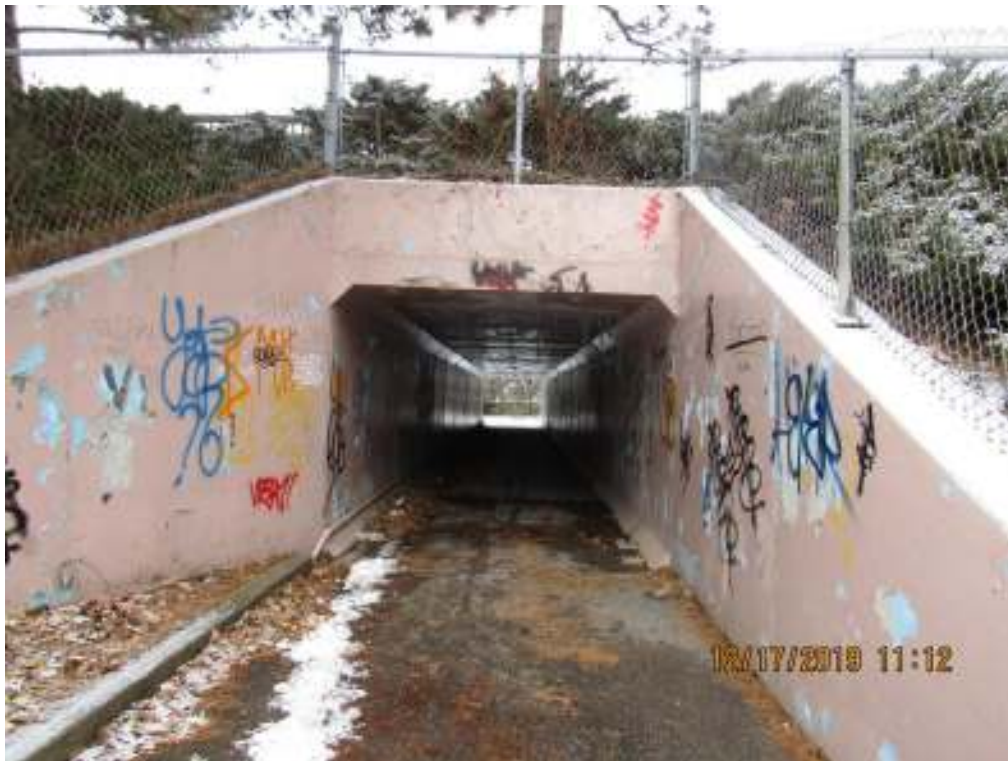
02 South elevation

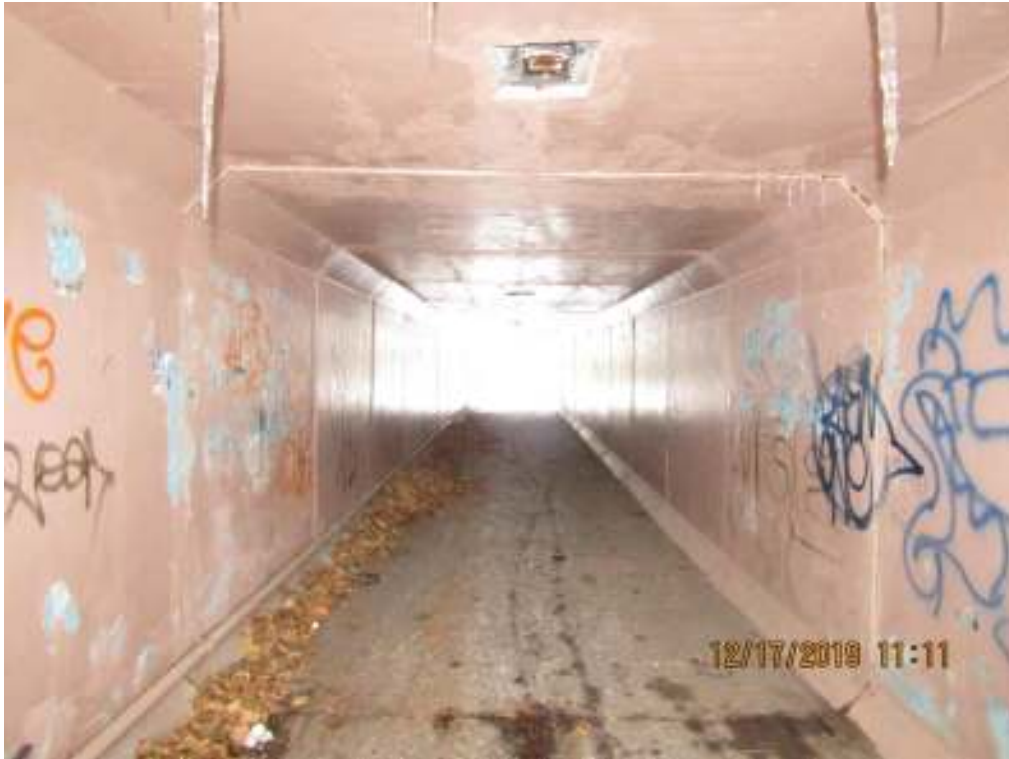
05 Barrel, looking north

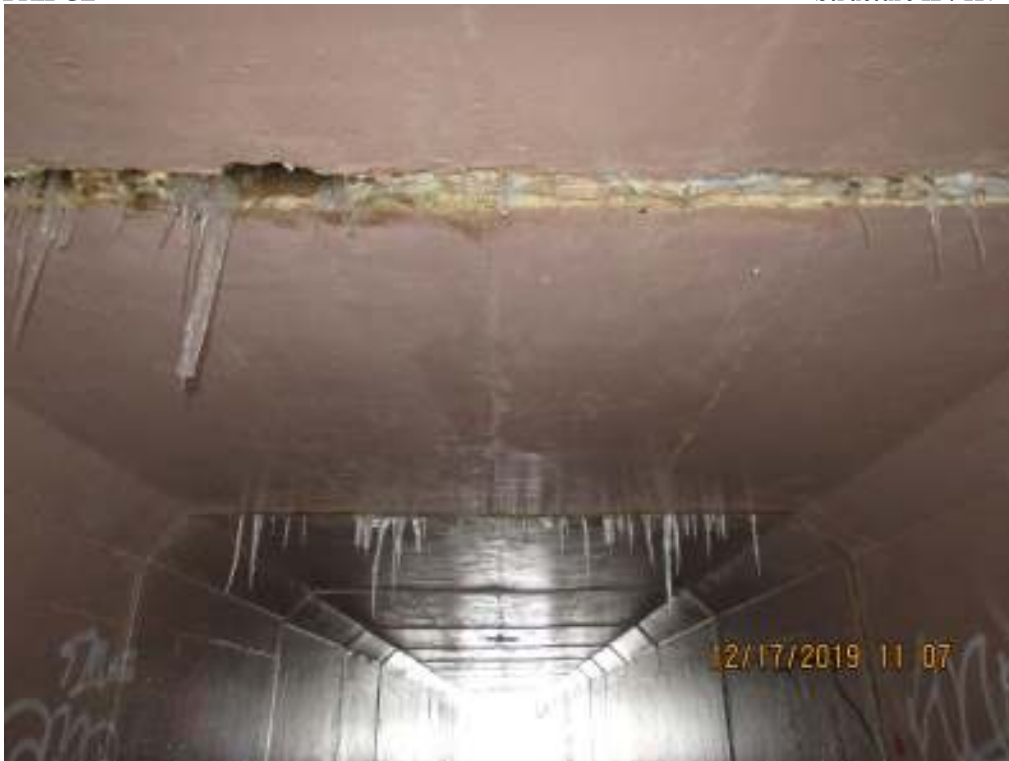
07 Typical barrel soffit

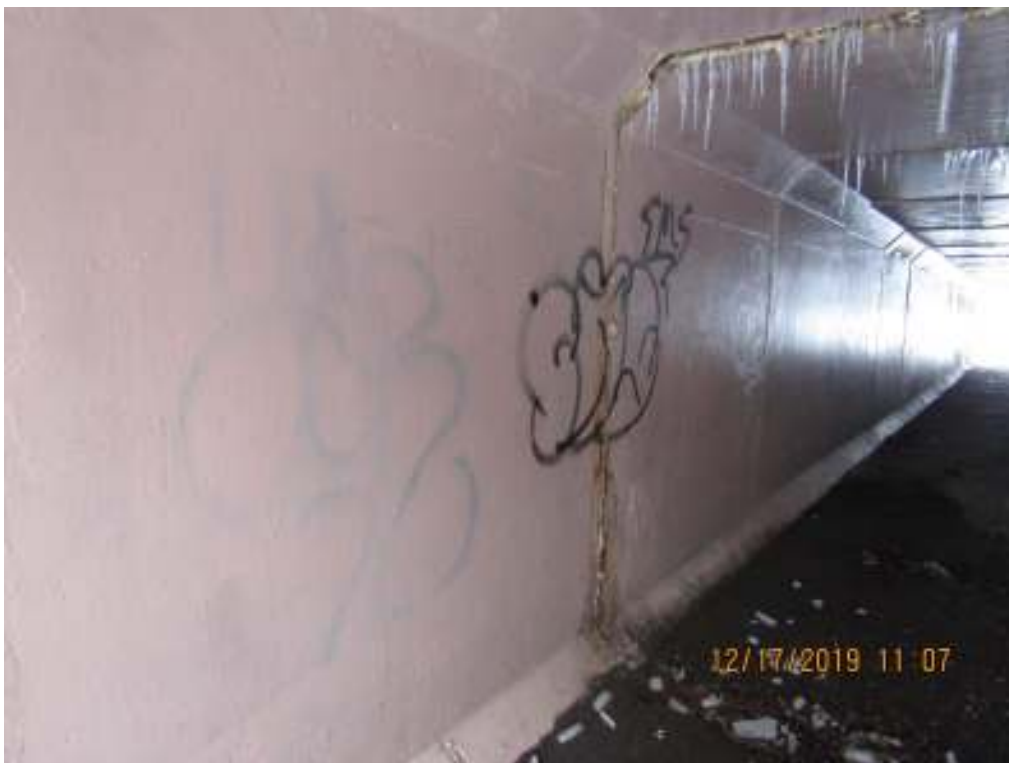
08 Barrel east wall

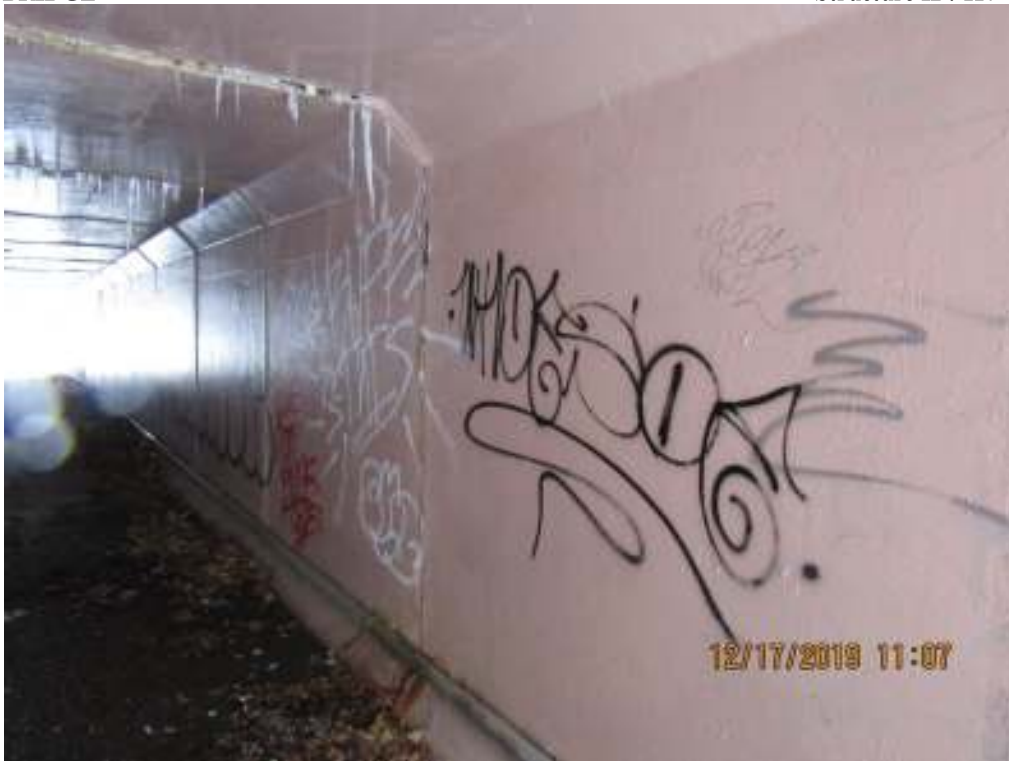
09 Barrel west wall

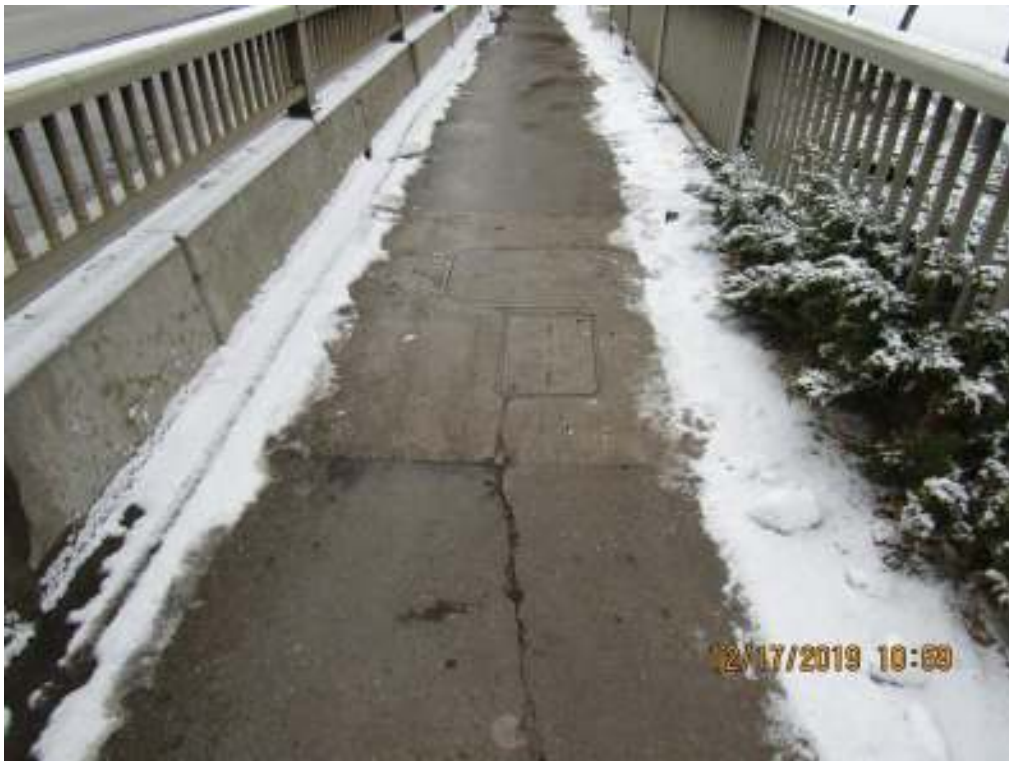
28 North Sidewalk

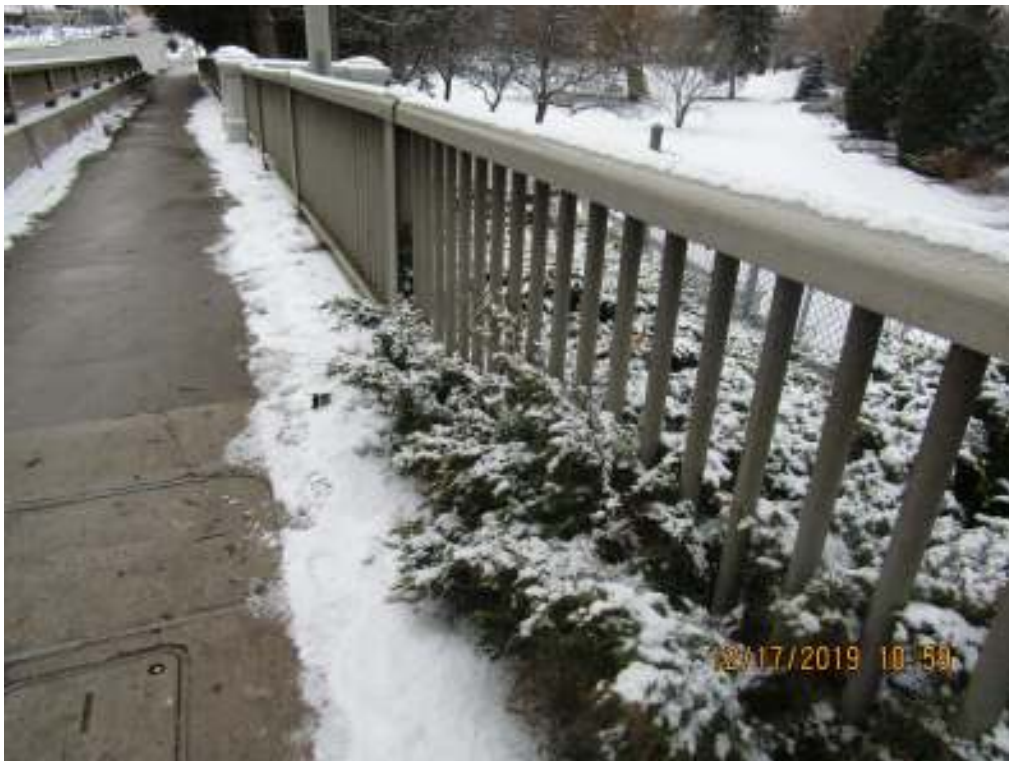
30 North Railing

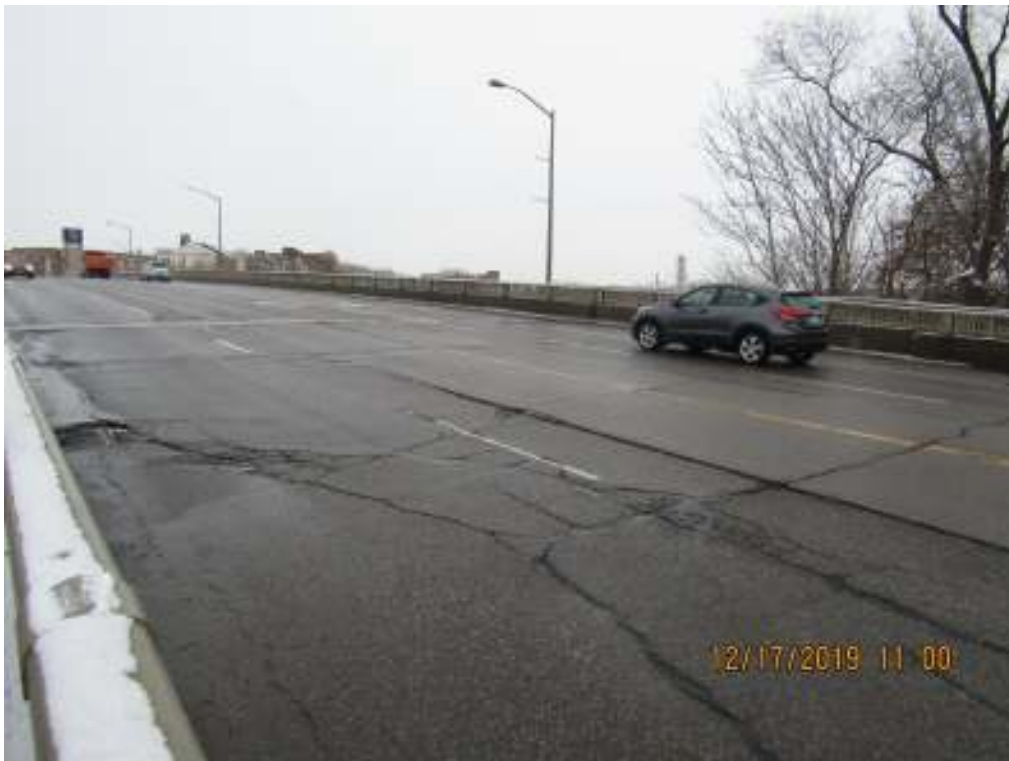
32 East approach

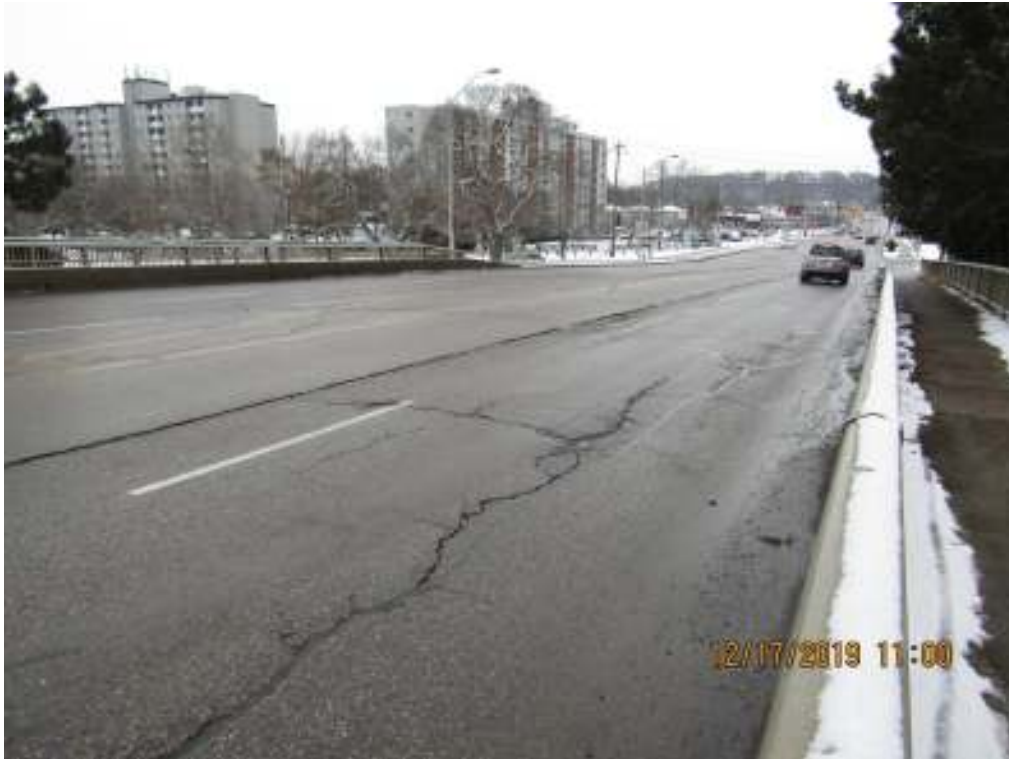
33 West approach

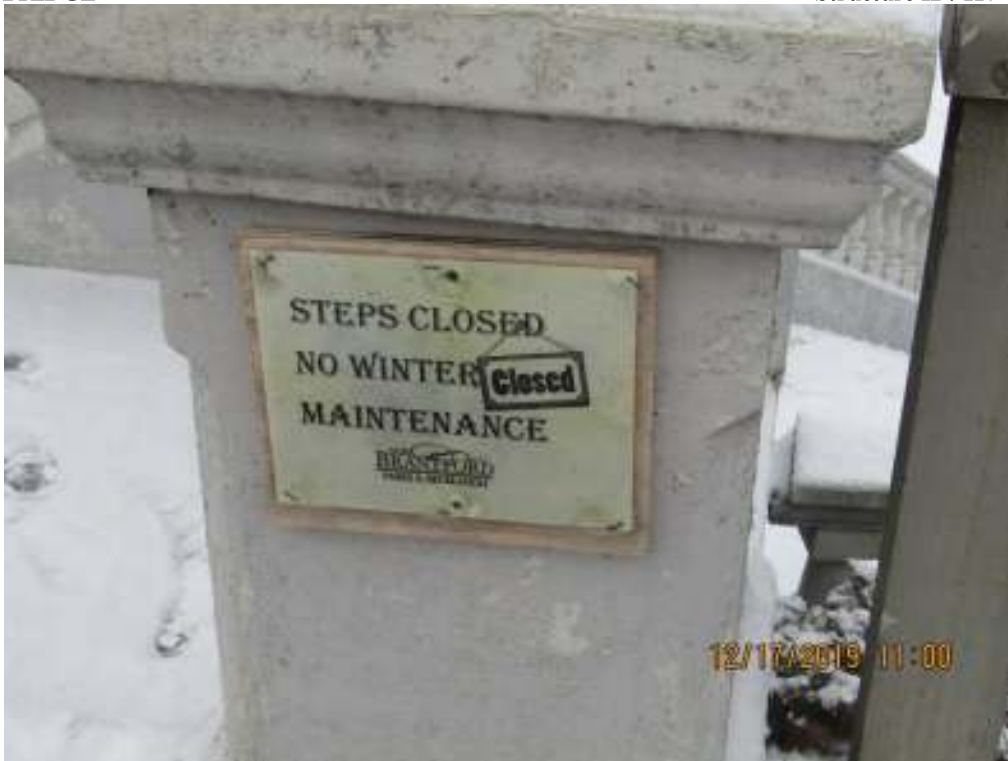
39 Plaque on concrete post

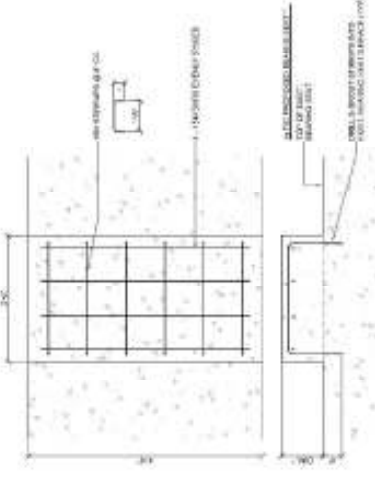
**NORTH CORNER OF EAST ABUTMENT - REPAIR DETAILS**

EXIST. BEARING AREA WITH REPAIR AREA INDICATED BY DASHED LINE.

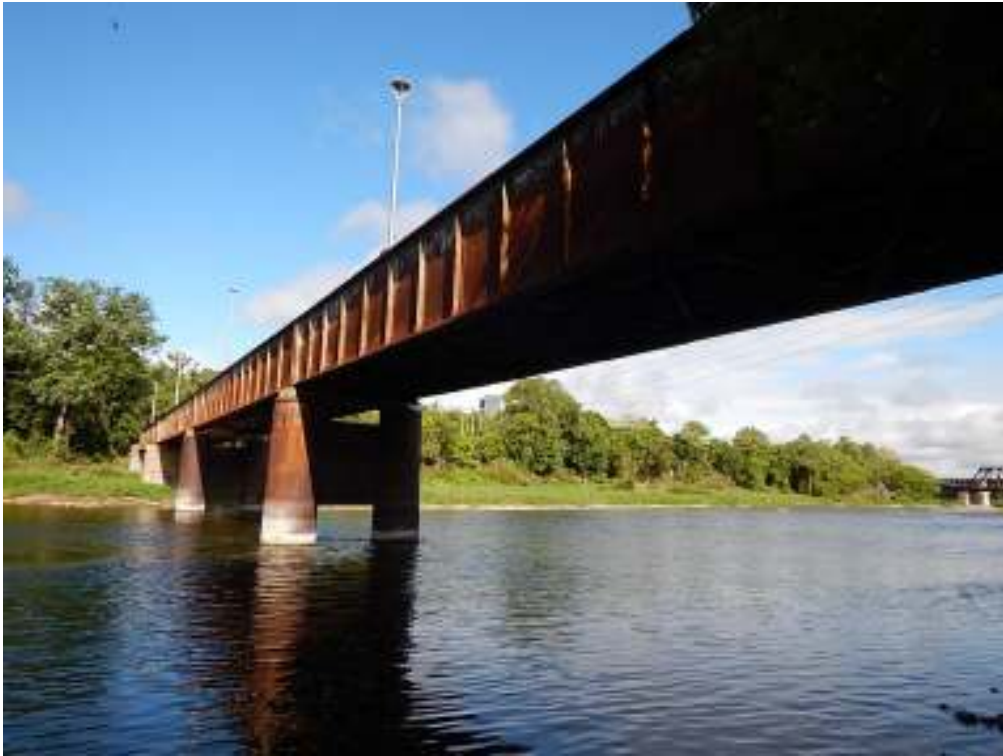
**Photograph 1: South elevation**

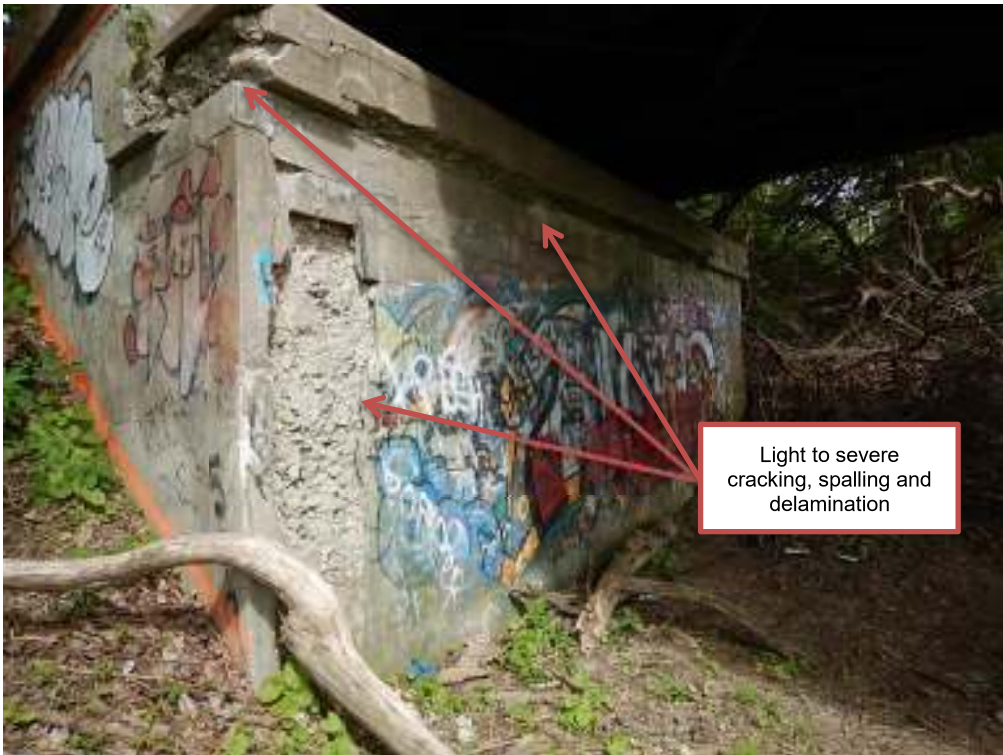
**Photograph 2: West abutment**
